# ATHMAR PARK BUILT ENVIRONMENT ASSESSMENT

## I. INTRODUCTION

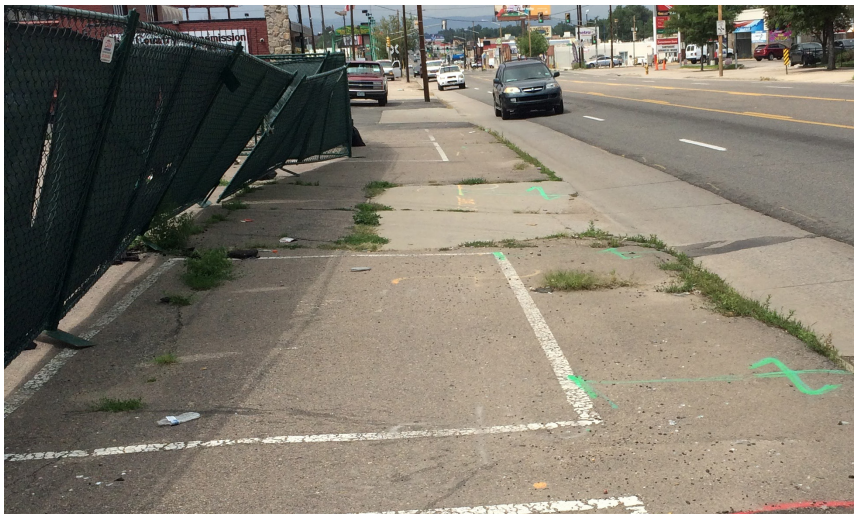
*Low quality pedestrian environment on W. Alameda Ave.*

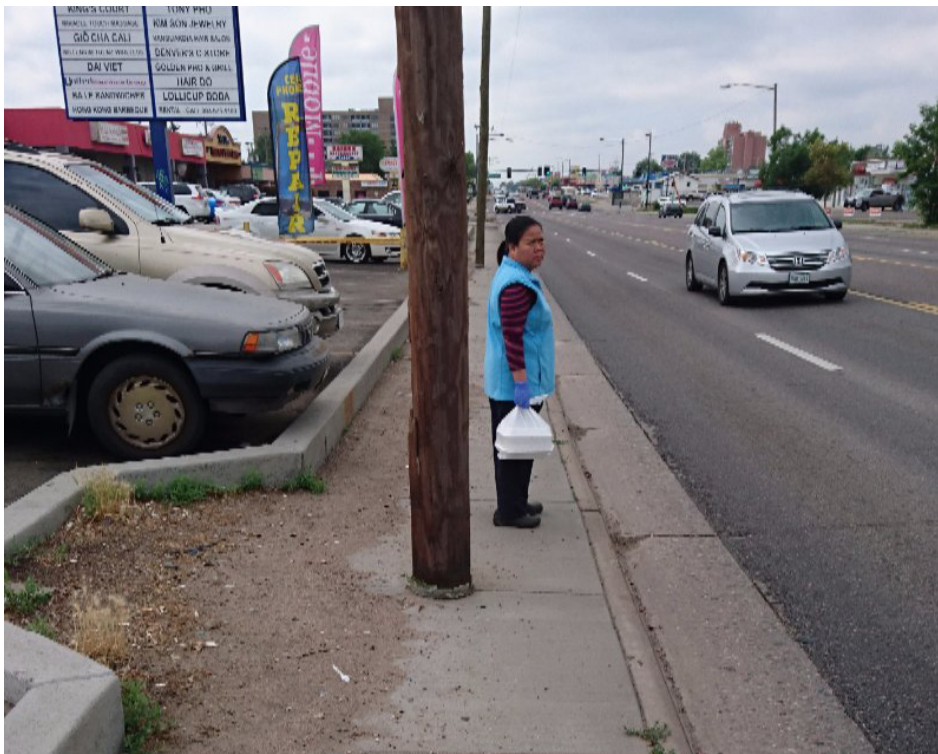
A utility pole obstructs the sidewalk on S. Federal Blvd.

Ultimately, all of South Federal Boulevard and West Alameda Avenue should have five foot wide detached sidewalks with trees and other quality landscaping in the tree lawn. Sidewalks should be clearly demarcated from parking lots and driveways and should be free of significant cracks or obstructions.

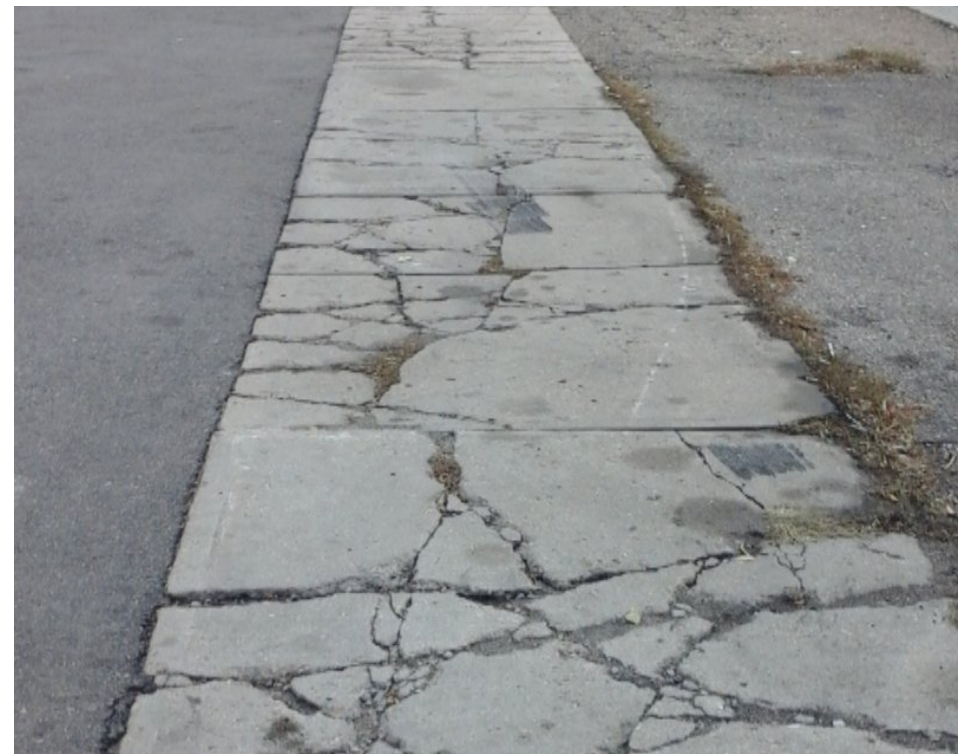
Significant sidewalk cracks on S. Federal Blvd.

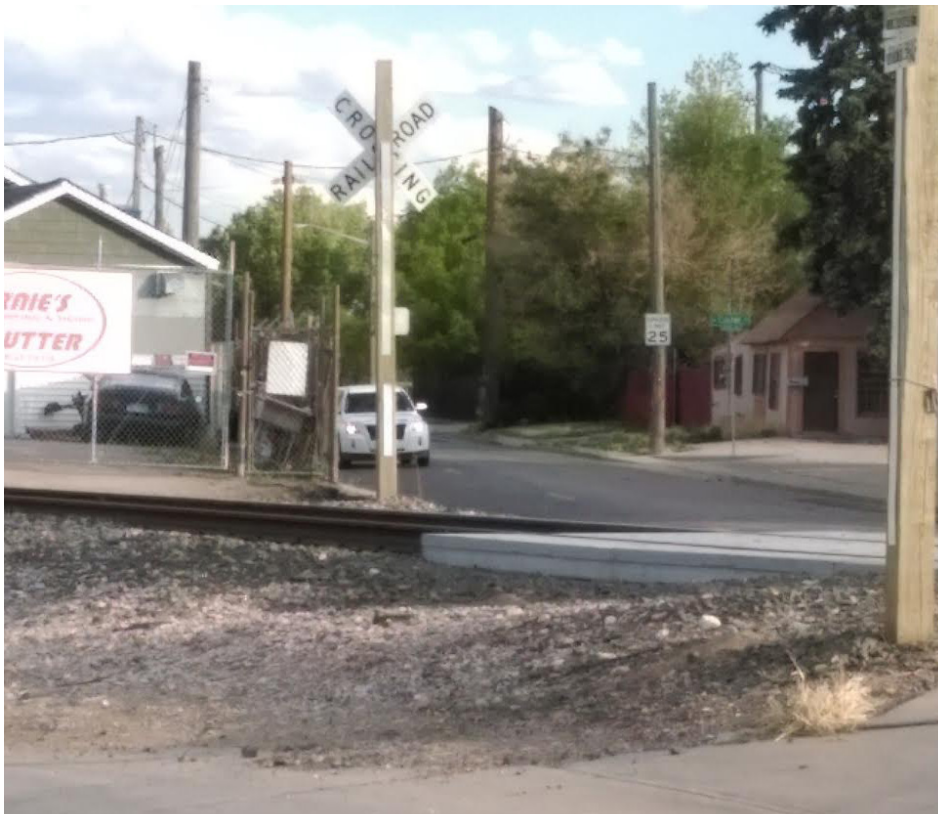
Limited visibility at W. Virginia Ave. and S. Lipan St.

The crossing of West Virginia Avenue with South Lipan Street also needs particular attention. Visibility is reduced due to off-set street alignment and the additional intersection with the railroad tracks causes further potential for conflicts. Stop signs should be installed on South Lipan Street, which will also help reduce traffic speeds. A painted crosswalk and additional signage will help alert drivers to the presence of bicyclists and pedestrians.

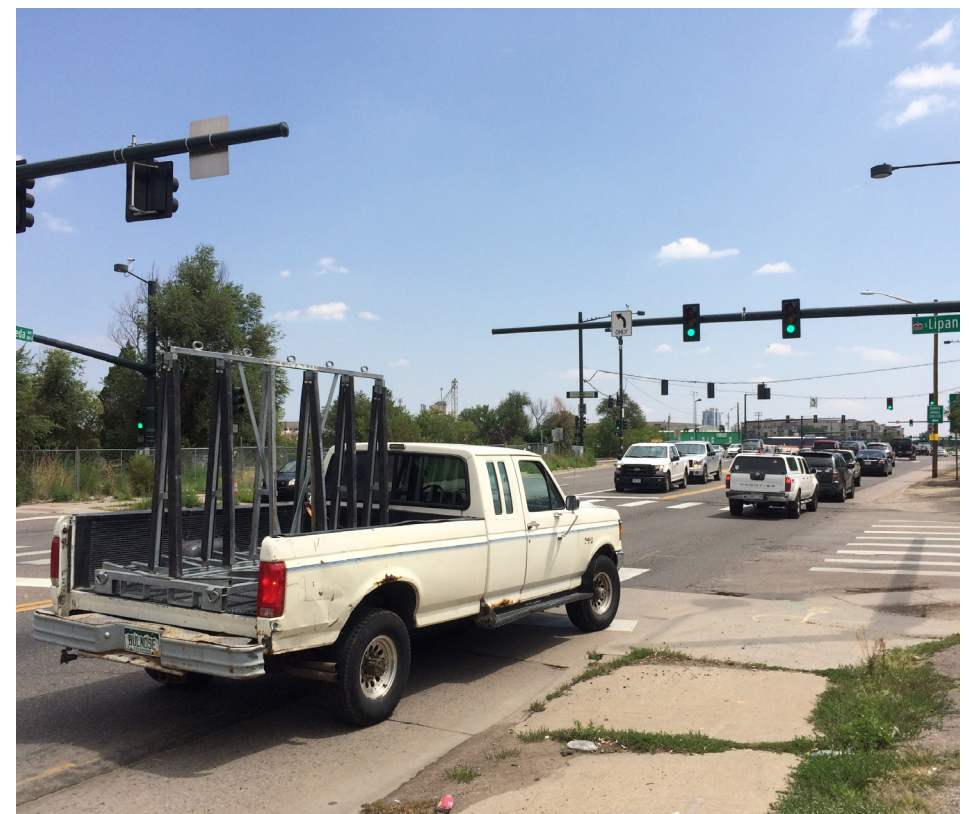
Heavy traffic on W. Alameda Ave.

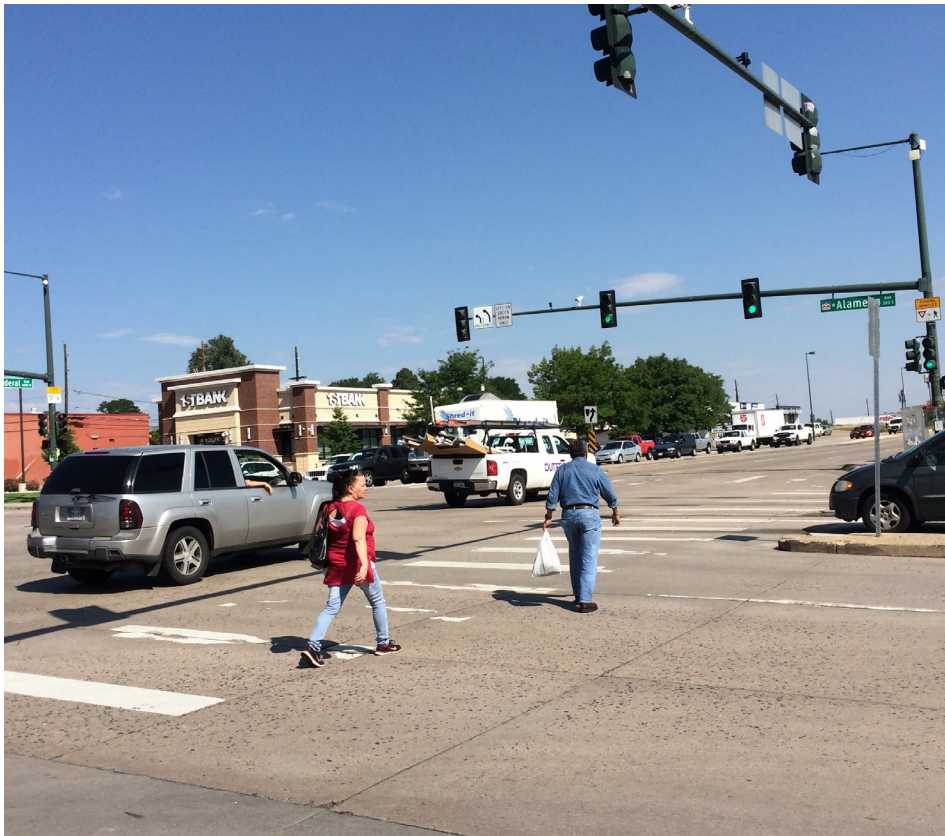
***Pedestrians must cross eight lanes of traffic at the intersection of S. Federal Blvd. and W. Alameda Ave.***

*Pedestrians cross eight lanes of traffic on W. Alameda Ave.*

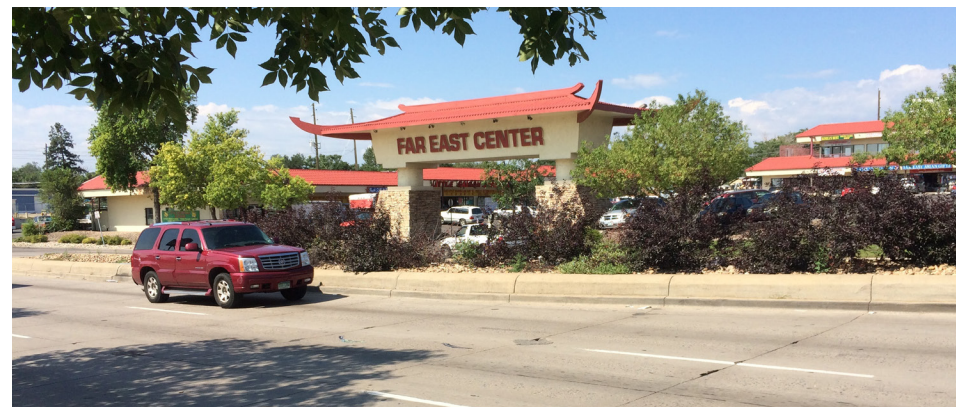
The few median islands in Athmar Park tend to be located at busy intersections on major roads. In most cases they do not appear to be designed as refuges for pedestrians; they are either very narrow or are covered in shrubs, like the median in the middle image on the right. Bulb-outs are similarly few and far between, though they are at least designed to improve pedestrian crossings and are associated with high quality ratings. There are three bulb-outs on West Kentucky Avenue adjacent to Huston Lake Park.

The few median islands that exist are not pedestrian-friendly.

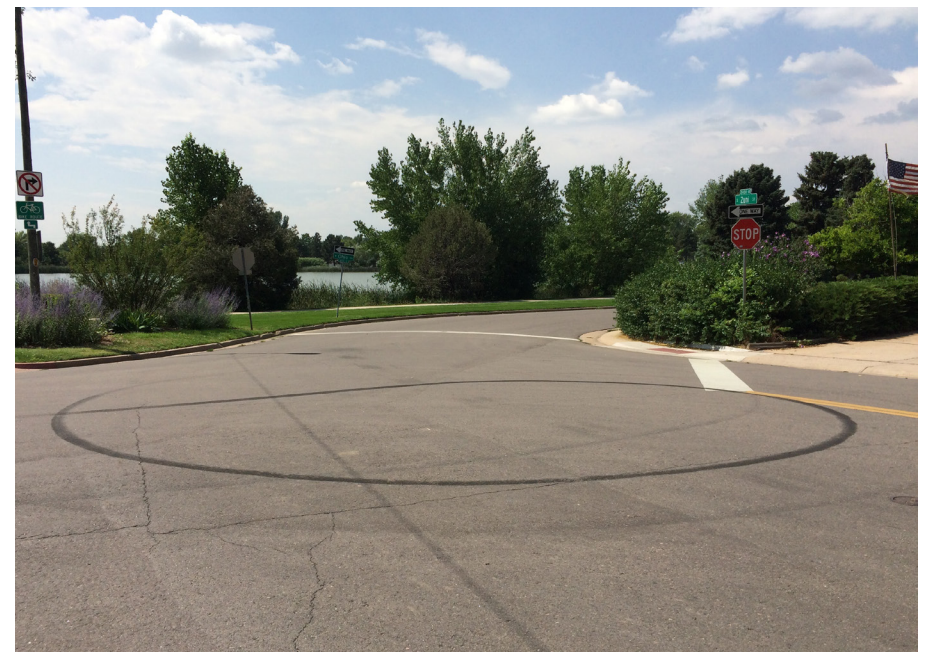
*...but community members still report speeding and other safety issues.*

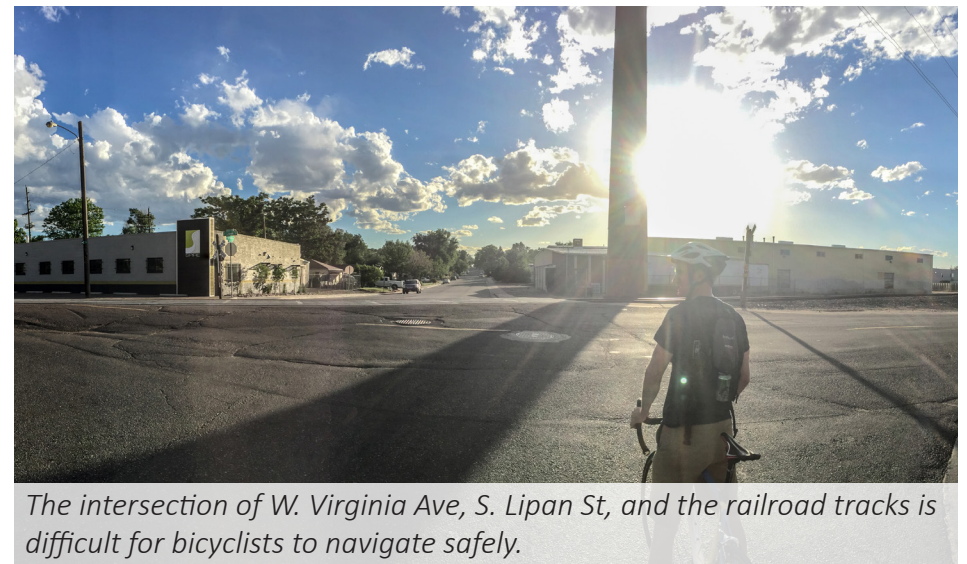
Bicyclists found certain intersections to be particularly stressful, such as the intersection of West Virginia Avenue and South Federal Boulevard, due to the high volume and speed of vehicles. At West Virginia and South Lipan Street, the intersection with the railroad tracks and the odd angles and bad sight lines that it creates also makes for an uncomfortable bicycling experience.

*The intersection of W. Virginia Ave, S. Lipan St, and the railroad tracks is difficult for bicyclists to navigate safely.*

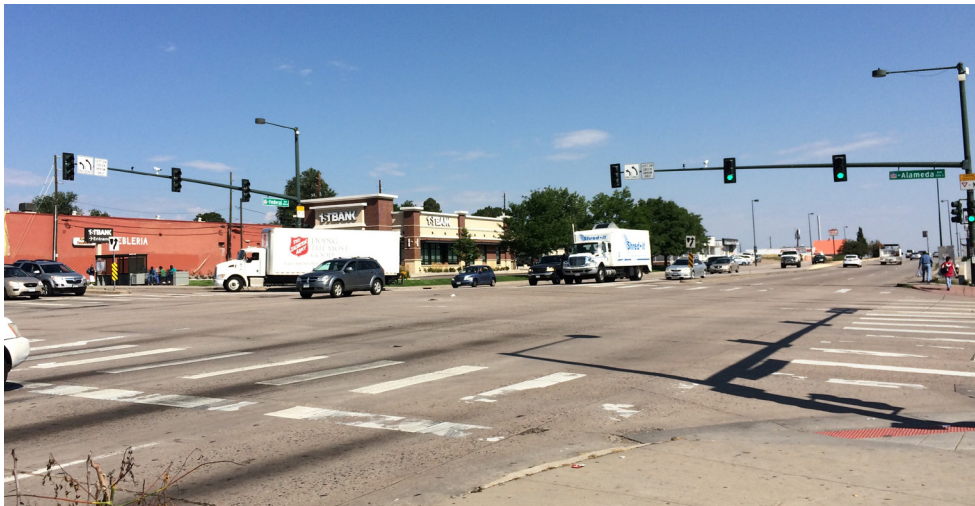
*There were 14 crashes involving pedestrians and/or bicyclists at S. Federal Blvd. and W. Alameda Ave. between January 2012 and May 2017.*

Intersections with a high number of pedestrian and bicycle-involved crashes, particularly South Federal Avenue at West Alameda, Virginia, Kentucky, and Mississippi Avenues, and those adjacent to schools, such as West Alameda Avenue and South Tejon Street, should be made safer for pedestrians and bicyclists. Enhanced-visibility crosswalks, smaller corner radii, and wider median islands are potential options. Enhanced-visibility crosswalks may help to better capture drivers' attention as they approach the crosswalk. Reducing the size of corner radii will require vehicles to slow before making right-hand turns and

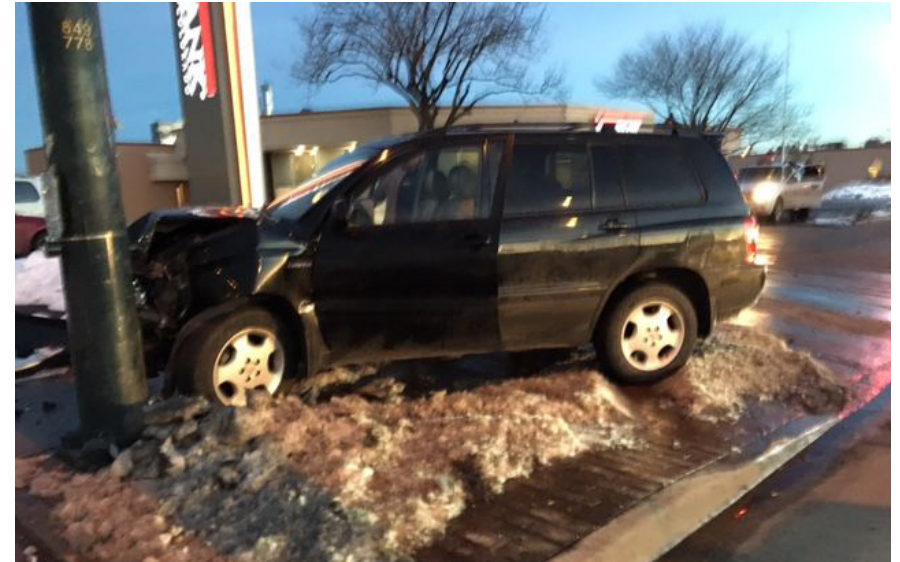
*Car crash at S. Federal Blvd. and W. Louisiana Ave.  
Source: Sofia Chavez*

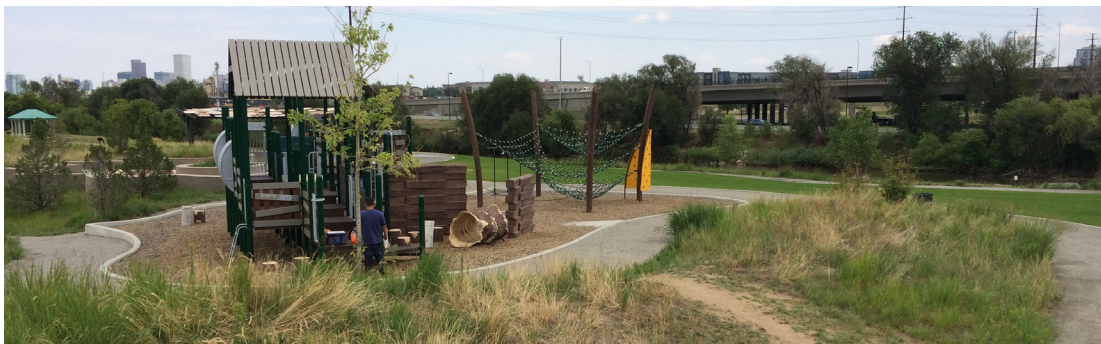
*Many community members consider Johnson-Habitat Park to be a community asset, but feel that sufficient connectivity to the neighborhood is lacking.*

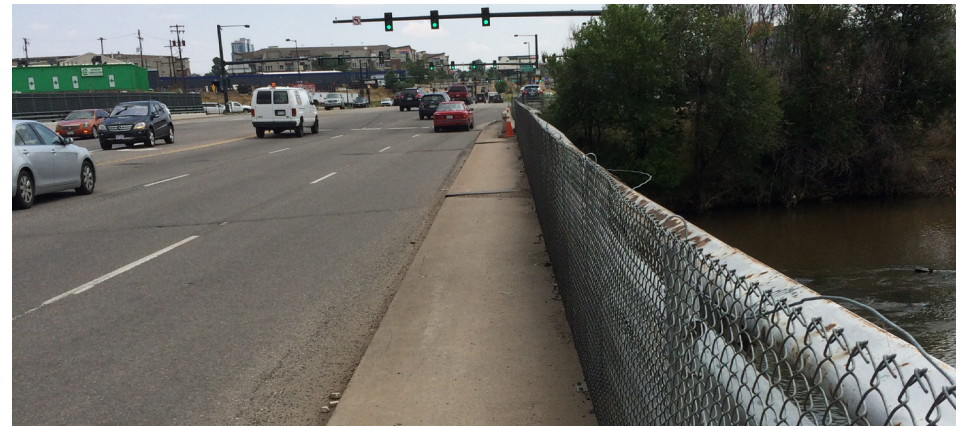
Finally, the connection to the Alameda Light Rail Station on the opposite of Interstate 25 needs significant improvement. The image below illustrates the current condition of this corridor; it is unsurprising that so many residents reported feeling unsafe here. The West Virginia Avenue bicycle and pedestrian bridges recommended by the *Alameda Station Area Plan* would provide a safe and convenient way to access the station.

*Sidewalk on W. Alameda Ave. across the South Platte River.*
