# College-View South Platte

## Federal Boulevard Bus Stop Assessments

Planning Methods, Fall 2019

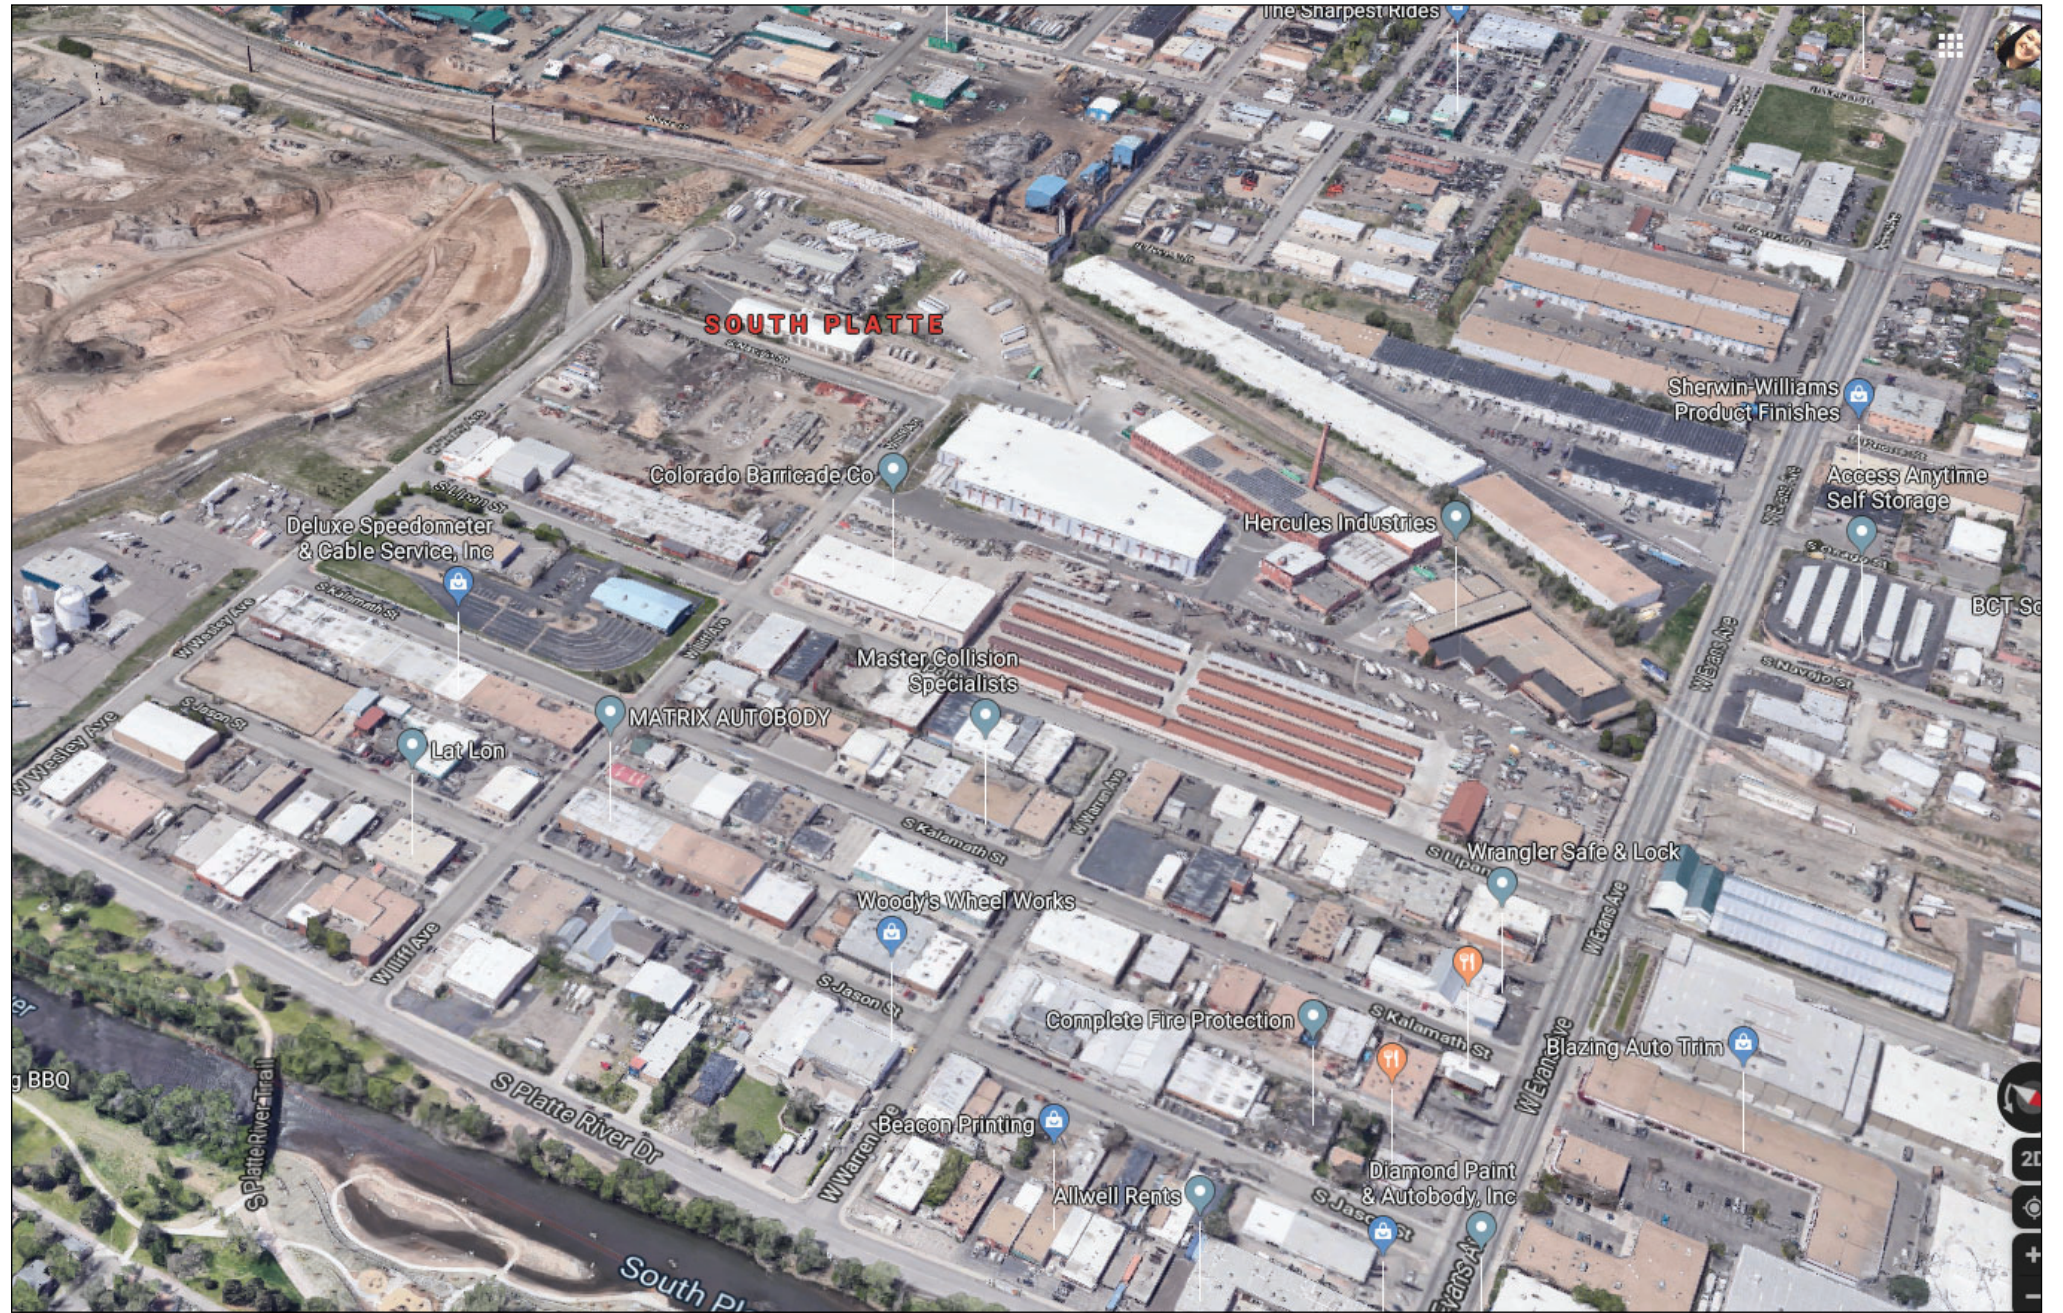
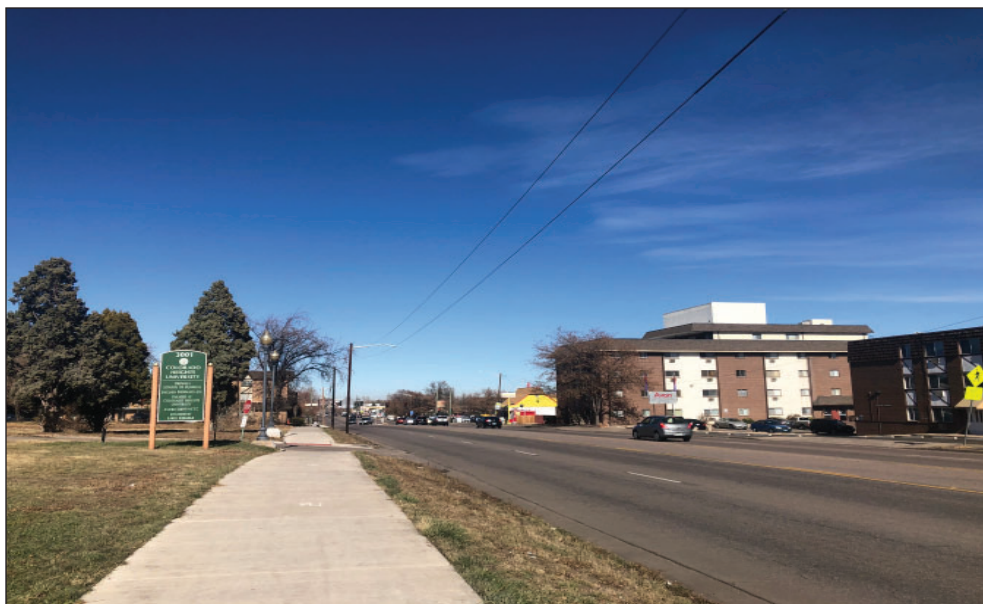
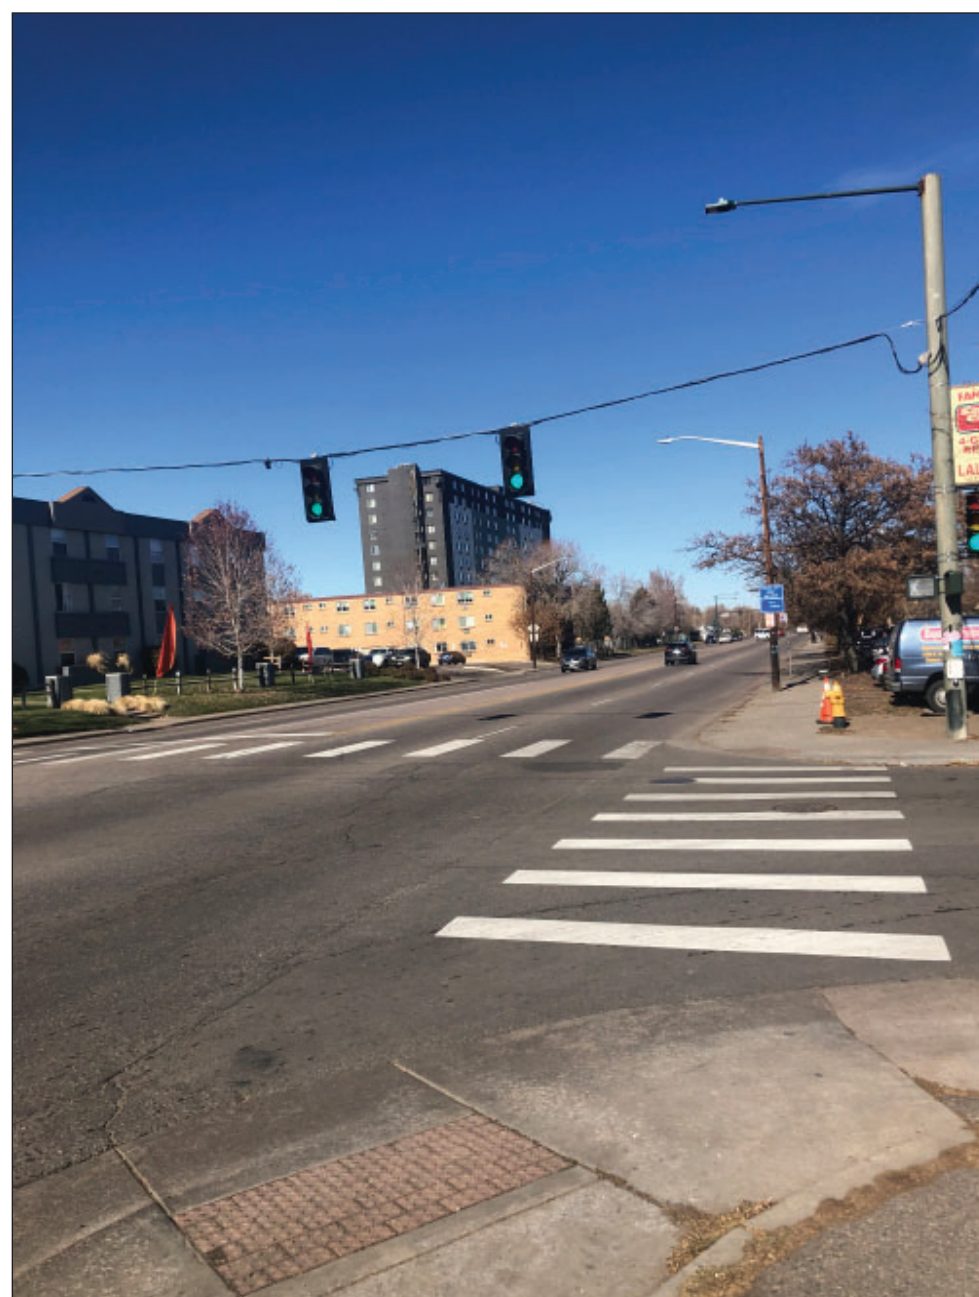
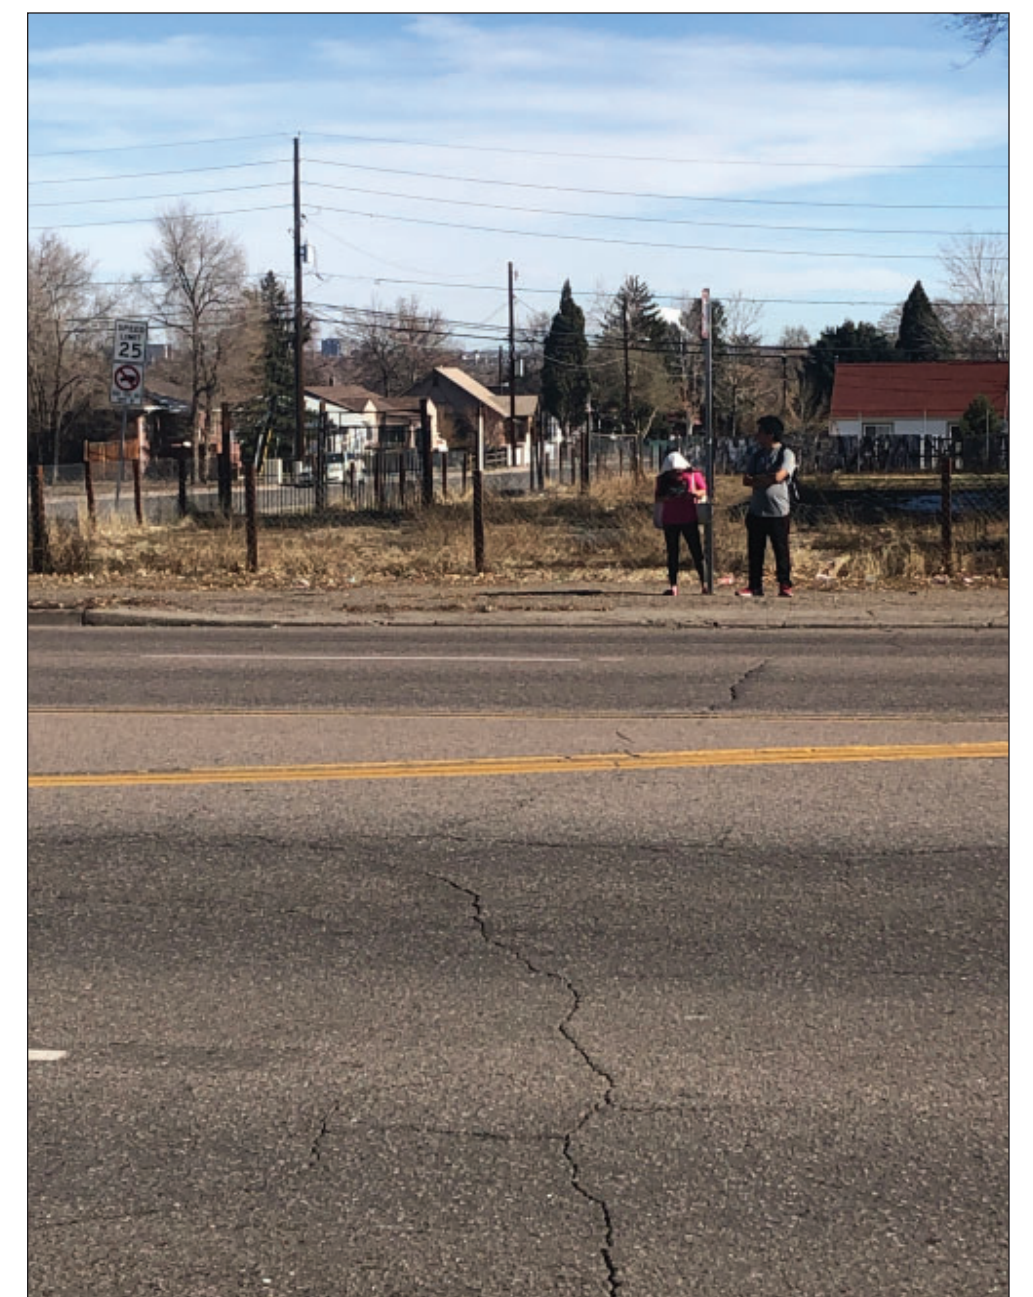
College View is a low-density neighborhood with primarily one and two-story residential lots. Historically, the neighborhood was platted for small-scale farms in half-acre lots. Although no longer a rural community, the College View neighborhood retained its sprawling nature. Today, there is a commercial corridor with multi-family housing development along Federal Boulevard, where buildings are two to four stories tall. Most buildings in the area are older and in need of repair. Roughly 12% of houses were built before 1940, and the area has a lower than average housing vacancy rate (Shift Research Lab). In terms of topography, the area is primarily flat with a few rolling hills. South Platte is industrial in nature, with one and two-story warehouse buildings and auto repair centers lining the streets. The area's urban fabric is captured in the following photos.

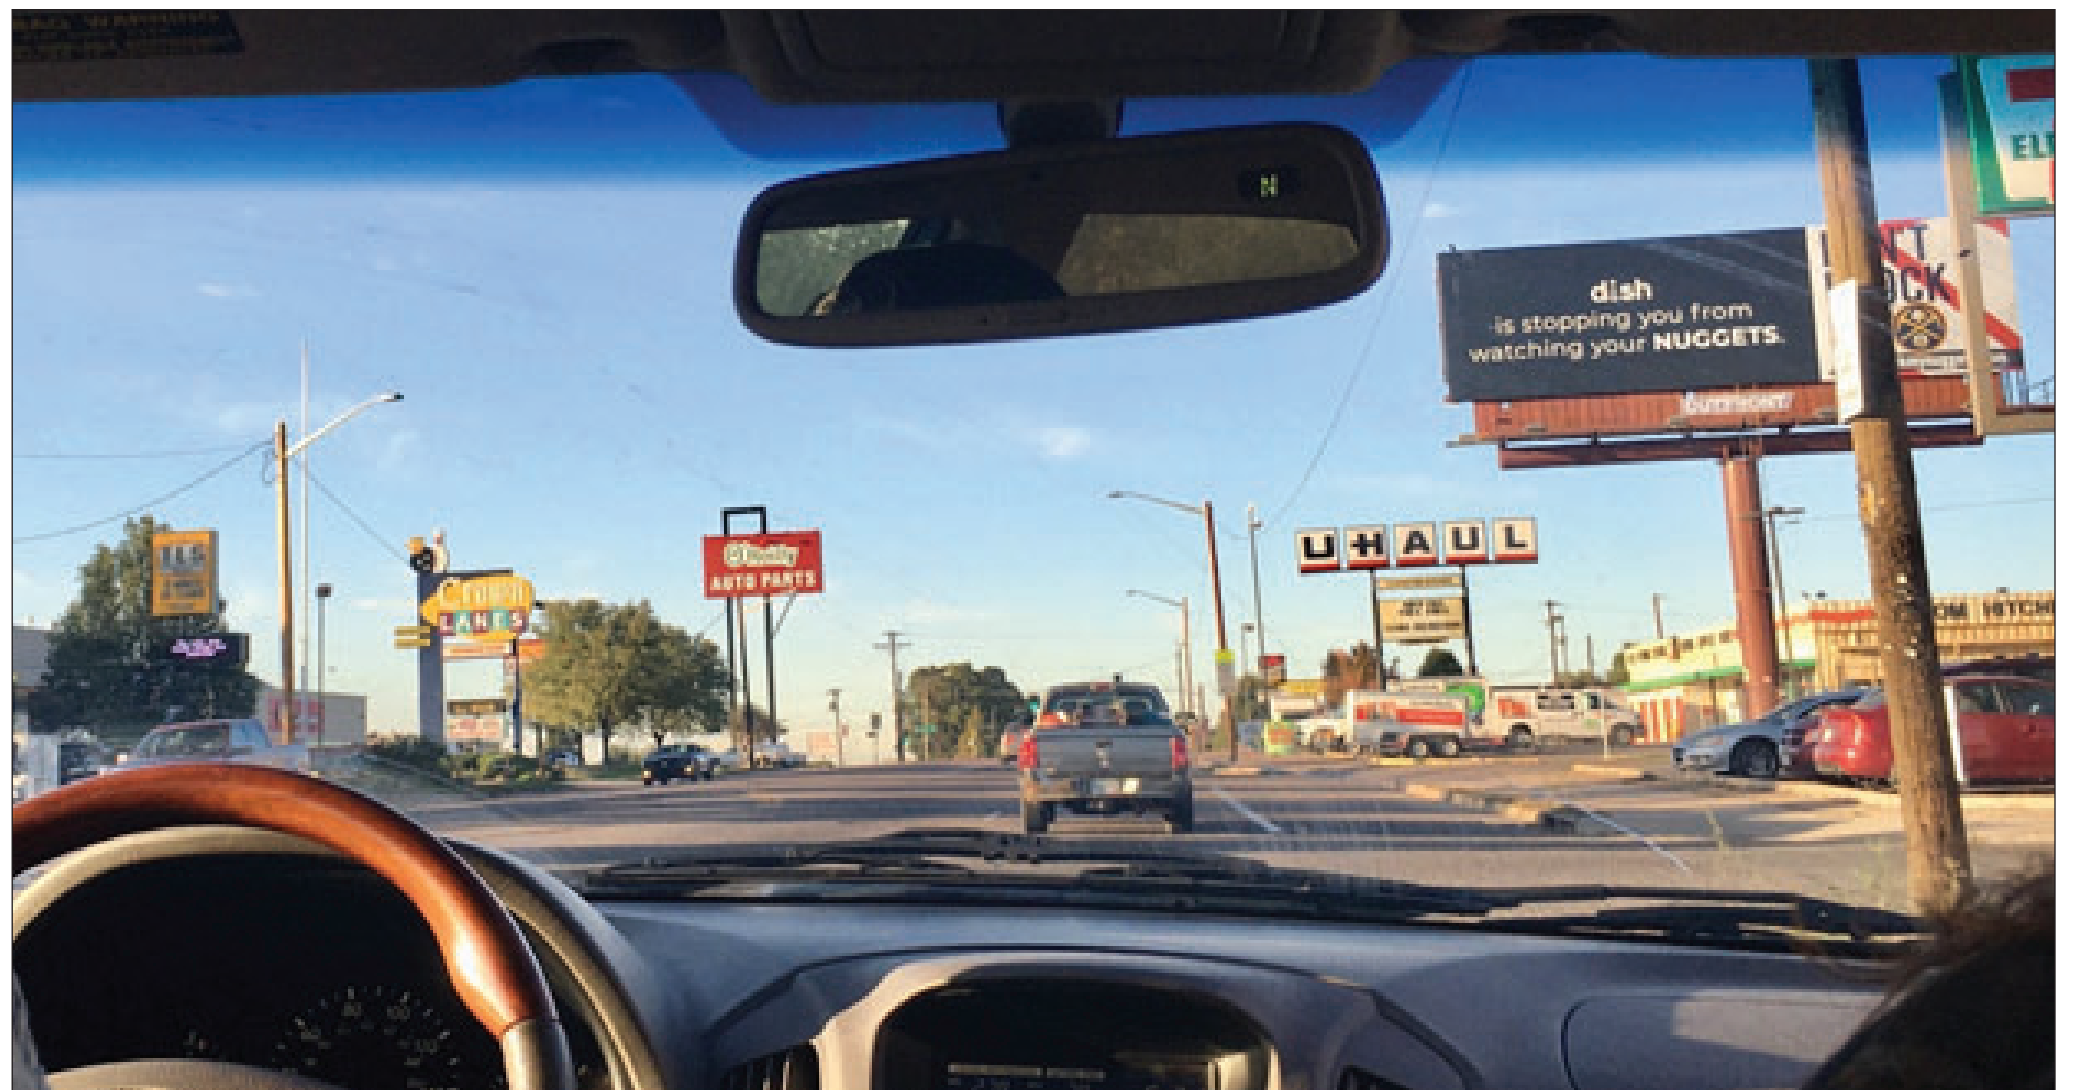
speeds and wide lanes on South Federal Boulevard, coupled with a lack of sidewalks on the east side of the street as potential safety hazards and impediments to connectivity and walkability.

Looking north on South Federal Boulevard

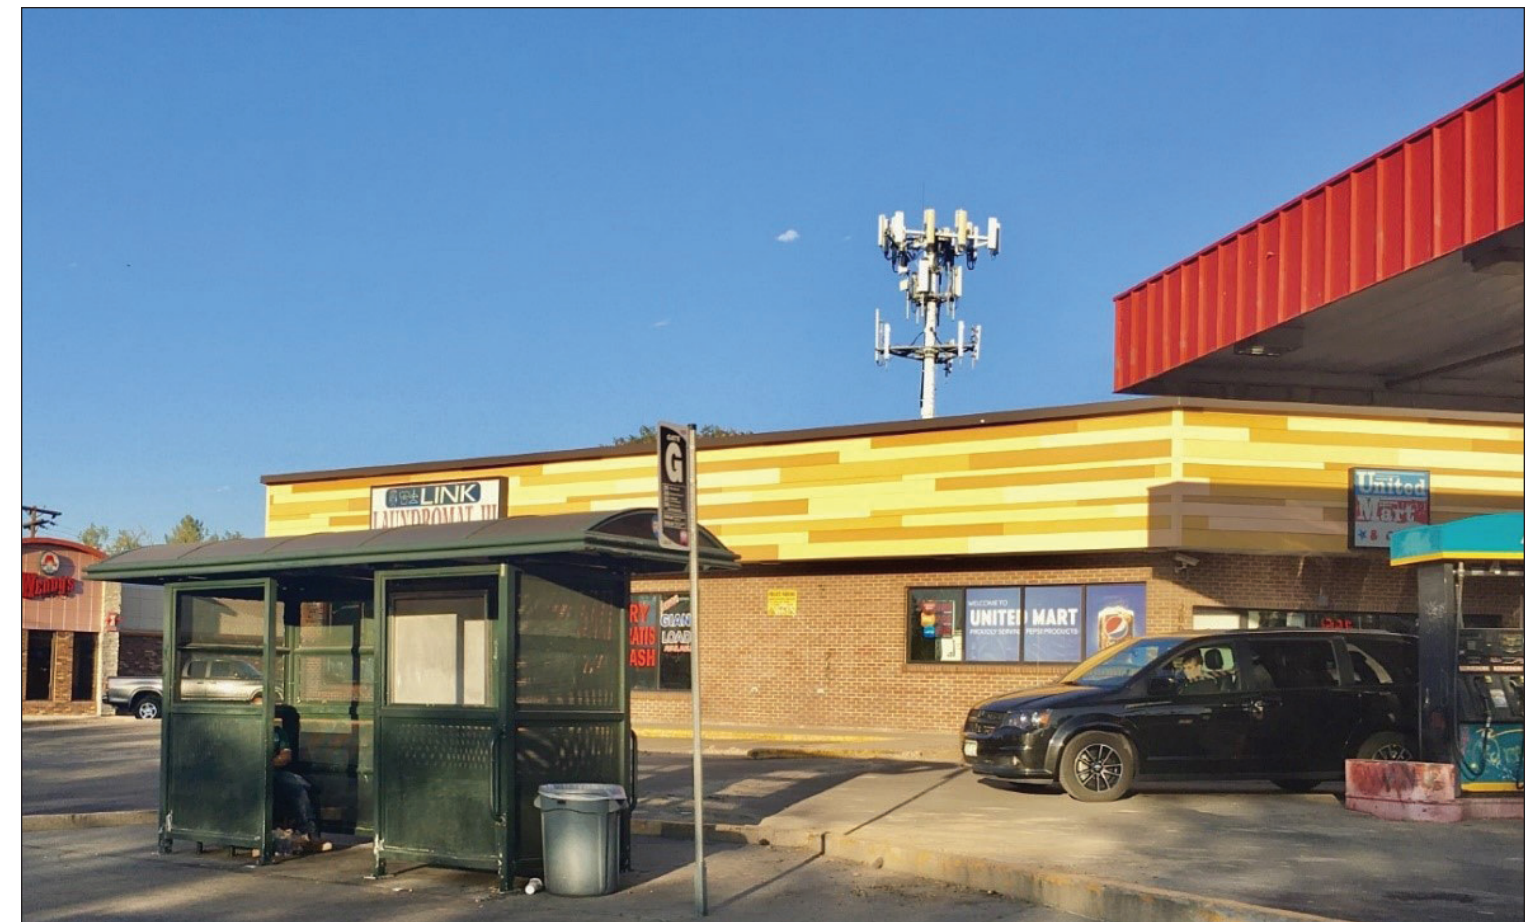
## 1 Bus Stop ID #13809

The Evans and Federal bus stop was one of the highest rated due to access, cleanliness, connectivity, and physical condition. Safety was rated as a 3 due to high traffic speeds along Federal Boulevard. In regards to connectivity and access, the stop is located within the commercial corridor along Evans Avenue, and sidewalks are in good condition. A crosswalk along Federal is close enough to the stop that almost all transit riders would choose to use it. A shelter and trash can are on site, so the stop was generally clean. The authors also noted that the storefront by the stop was active, which increased feelings of safety.

Evans and Federal - good conditions

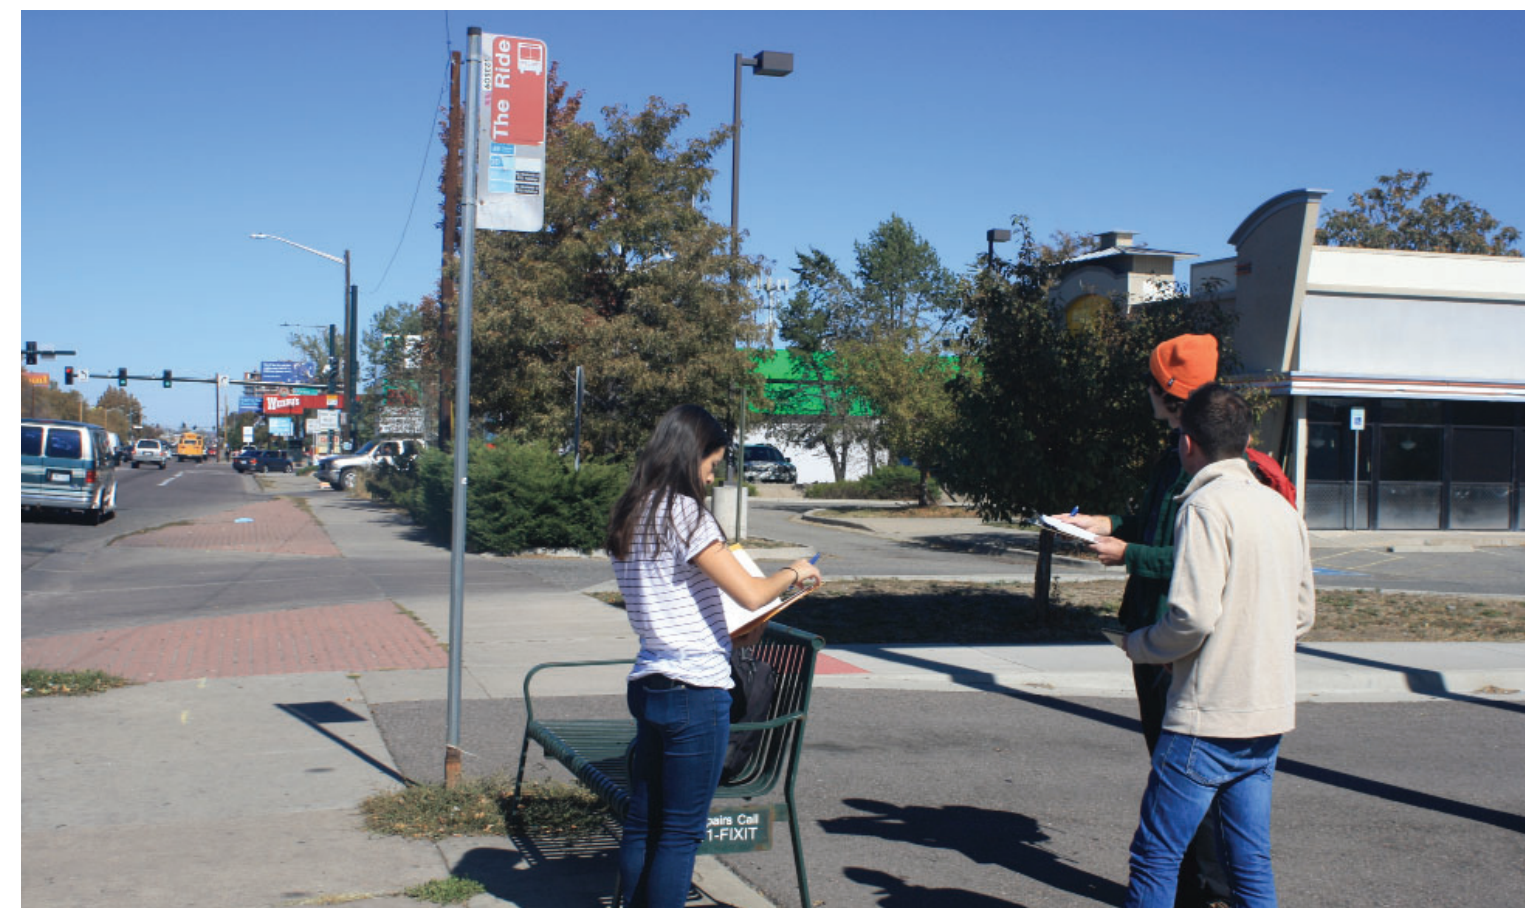
## 2 Bus Stop ID #23509

The Warren and Federal bus stop received an overall rating of 3. The stop has a bench and a sign, but it is located in front of multiple vacant storefronts. Additionally, lack of lighting was a concern for the authors. However, the authors collected observations during the day, so they could only speculate about nighttime conditions. The authors also observed multiple jaywalkers due to distant crosswalks. All of these factors resulted in a lower safety rating. While the stop is located near a commercial corridor, the transit rider would need to walk through large surface parking lots before reaching the place of business.

Warren and Federal - adequate conditions

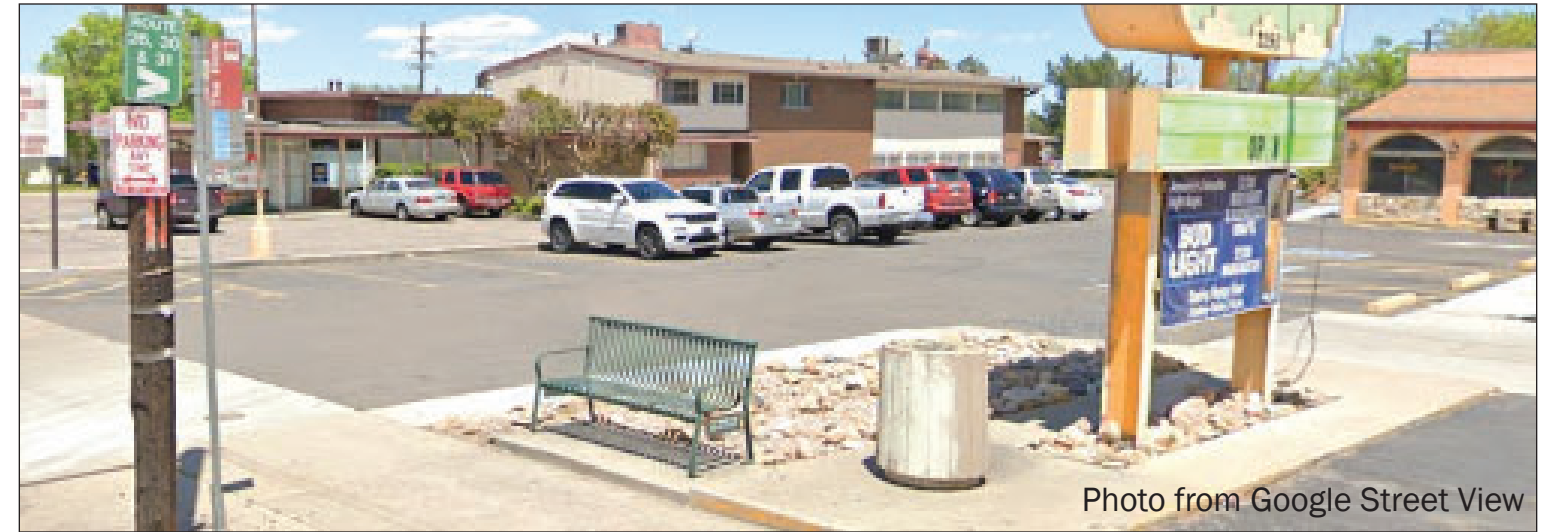
### 3 Bus Stop ID #13822

Federal and Iliff received average ratings across the board. Although this stop has a bench, trash can, and wide sidewalks, the stop was not particularly clean or accessible. The main issue at this stop is pedestrian connectivity. The stop is far enough away from a crosswalk that very few people are likely to walk to use one.

### Iliff and Federal - adequate conditions

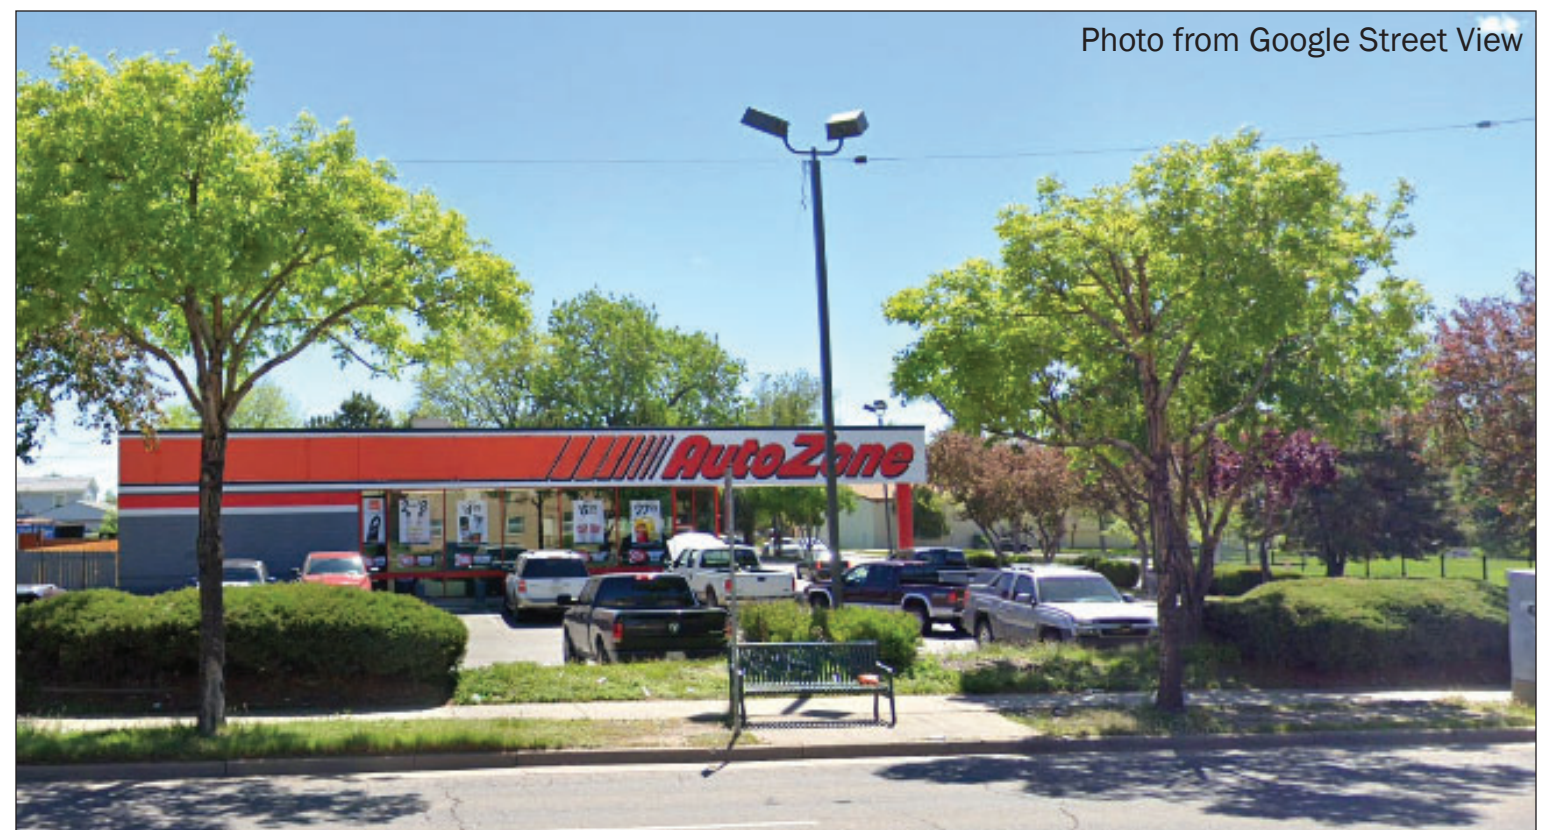
### 4 Bus Stop ID #13819

The bus stop at Federal and Harvard consists of only a bench and a sign. Therefore, it was ranked as one of the lowest in the study area. With an overall score of 2, the most critical issue was cleanliness. Though the storefront is active, this seems to exacerbate the problem since the stop lacks a trash can. Furthermore, high traffic speeds and low lighting contributed to a low safety rating. Crosswalks are close enough that most transit riders would use them, but narrow sidewalks and lack of destinations to walk to decreased the overall score.

### Harvard and Federal - needs improvement

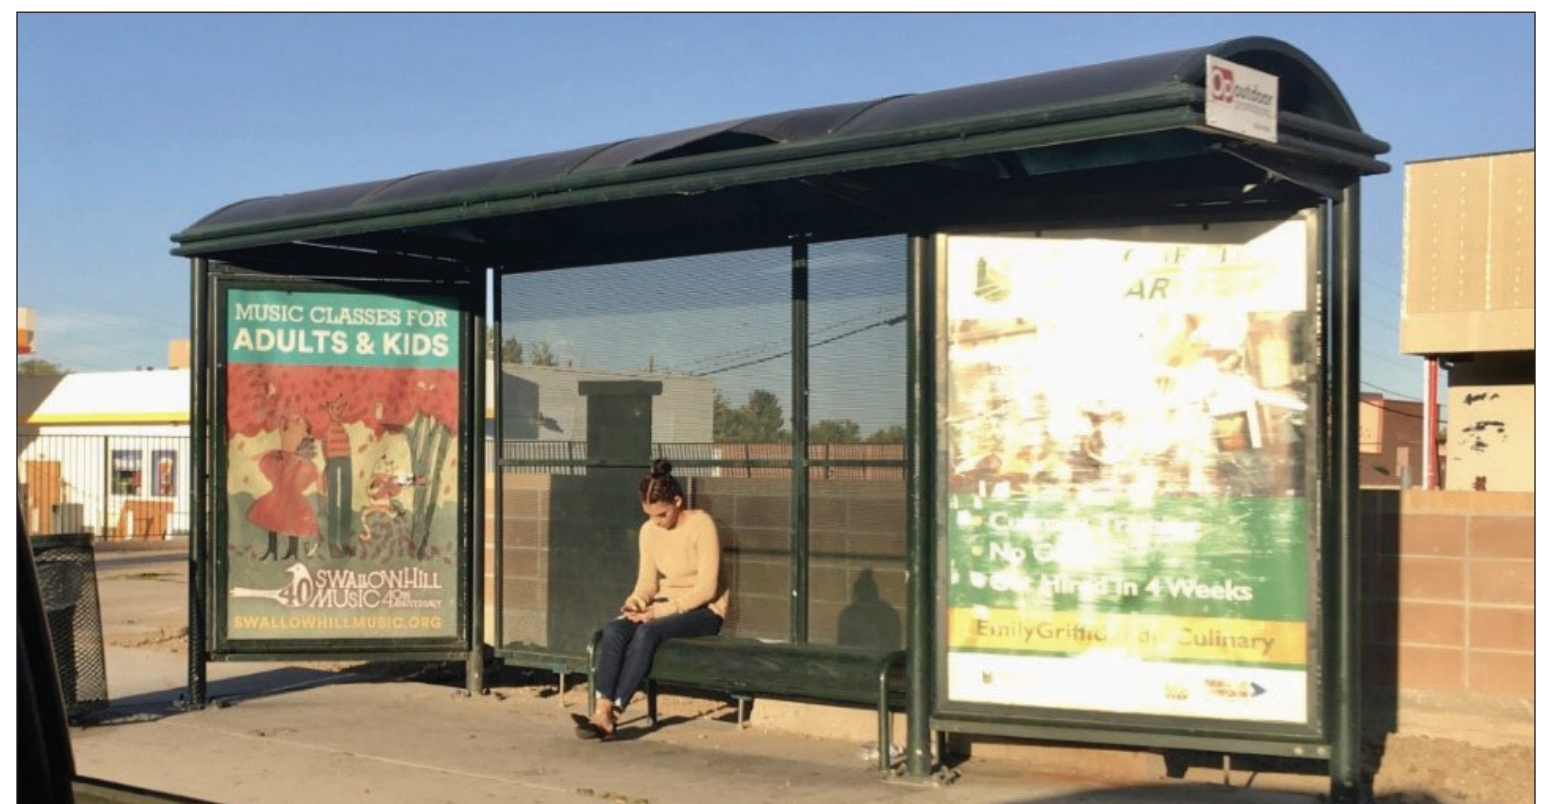
### 5 Bus Stop ID #13855

The Yale and Federal bus stop was one of the highest rated in the study area. It contains a shelter and trash can, and it is near enough to a crosswalk that many people would use it. It also connects residents from nearby multi-family housing to a bus line. Wide sidewalks increase access to riders with limited mobility, and the active storefront increases feelings of safety.

### Yale and Federal - good conditions

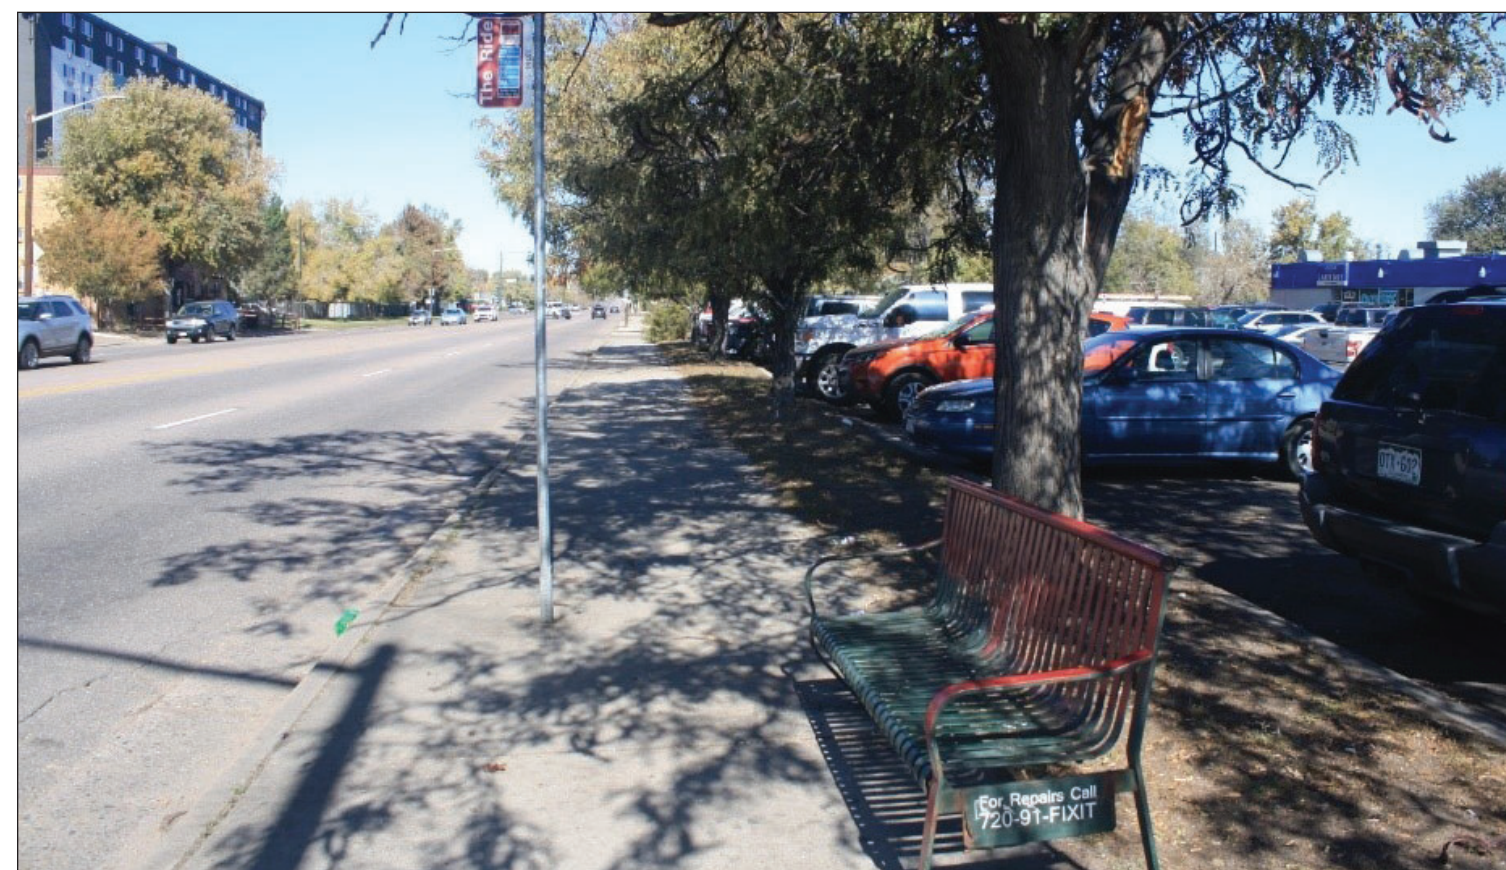
## 6 Bus Stop ID #13783

The bus stop at Amherst and Federal consists of a single bench but is located under a shady tree. The bench is usable but in poor condition. Overall, the stop was relatively clean, with a few cigarette butts and chip bags littering the area. The stop is in front of a very active storefront and is close to a crosswalk. There is also a streetlight nearby. All of these factors have positive implications for safety. However, high traffic speeds and narrow sidewalks decreased the safety rating. Overall, this bus stop received average ratings in every category.

Amherst and Federal - adequate conditions

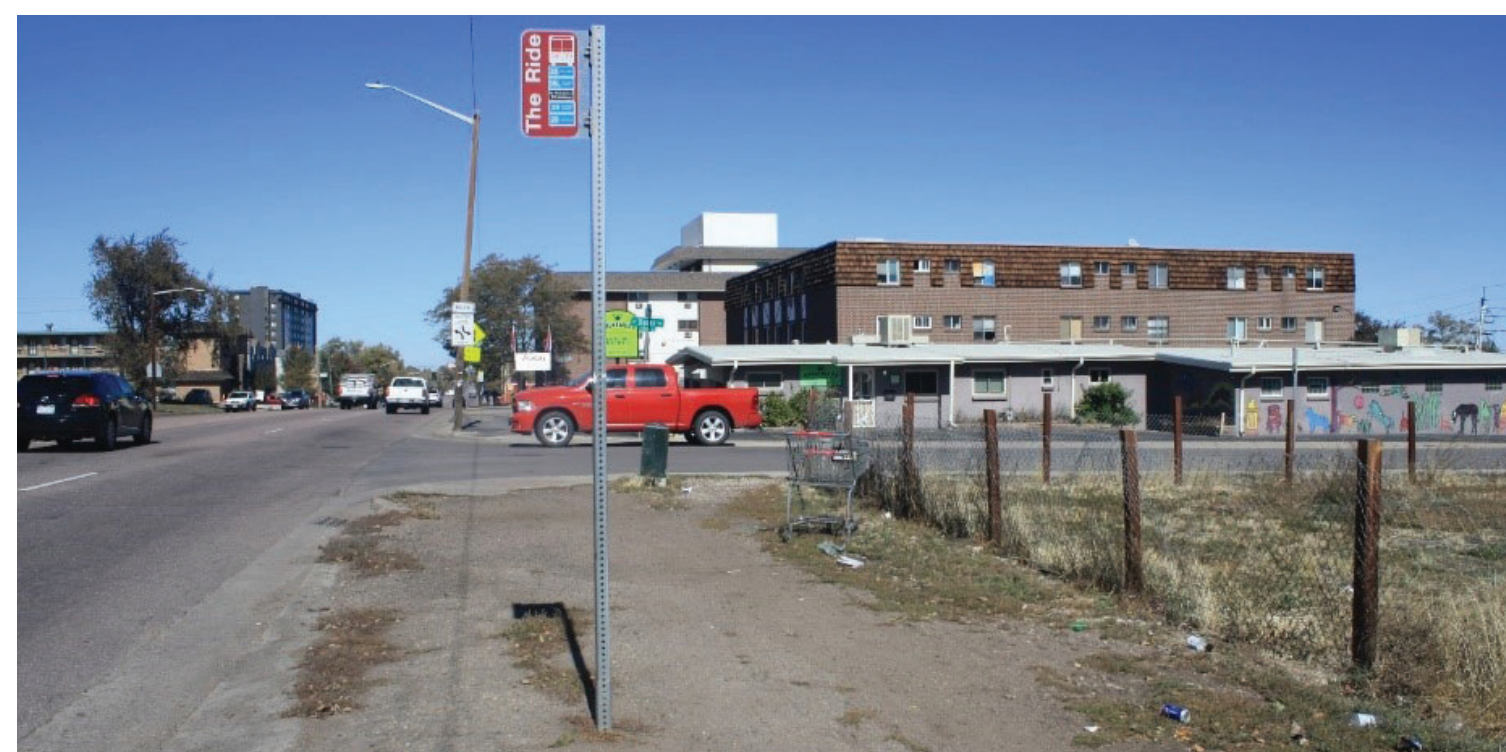
## 7 Bus Stop ID #13786

The Bates and Federal bus stop was the worst rated stop in the study area. This is because there are no amenities and high amounts of trash. The stop provides little access to those with limited mobility and almost no pedestrian connectivity. Not only is the stop entirely dirt and gravel, there is not a crosswalk nearby enough for people to use. A run-down apartment building is located near the stop, and combined with high traffic speeds, the stop feels very unsafe. Overall, the stop had a rating of 1.

Bates and Federal - bad conditions

The final micro recommendation is the removal of the Federal and Bates bus stop. While many infrastructure improvements can be made to this stop, increasing the ridership experience would take much funding and effort, and bus stops in better condition with more amenities are within a quarter mile walking distance both north and south of the stop. Federal and Bates, which is shown in the photo below, lacks lighting, benches, a trash can, a proper sidewalk, and is near a vacant lot with no activity nearby. As such, the group recommends removing the stop and investing in the other, busier transit stops within the study area and improving the experience elsewhere.

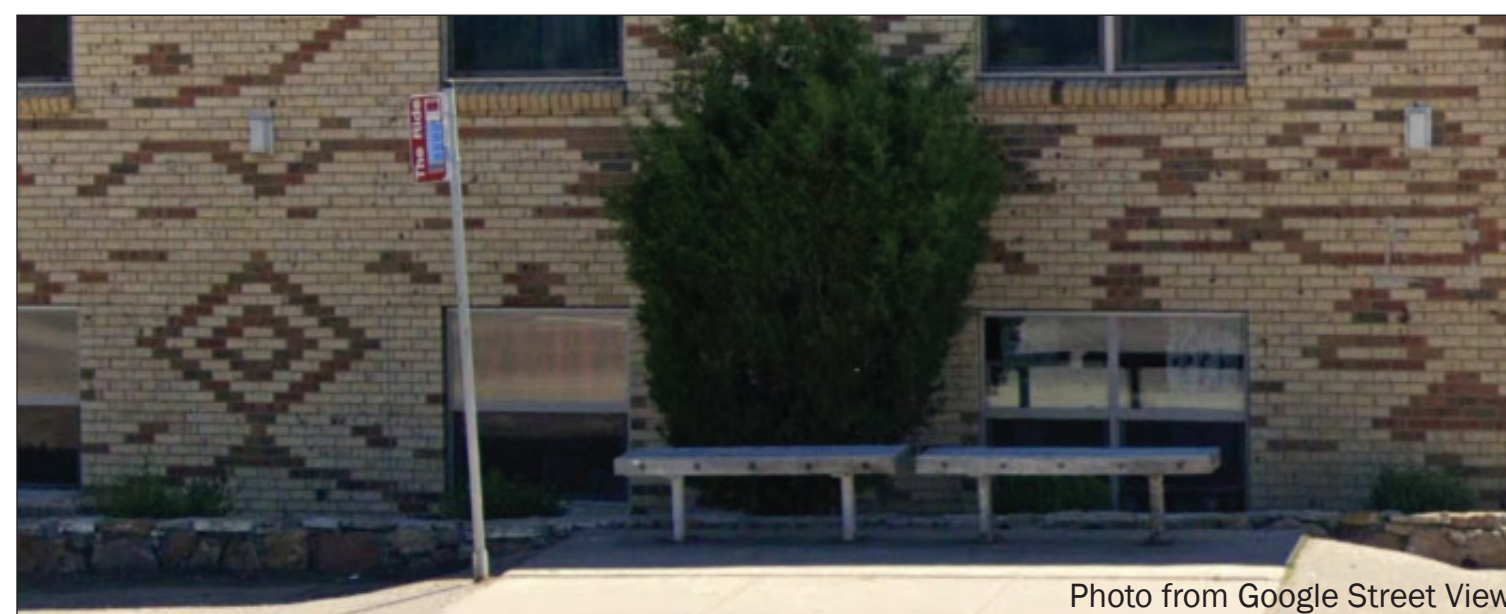
## 8 Bus Stop ID #13806

The stop at Cornell and Federal is near multiple multi-family buildings and a few commercial uses. It has a sign and two wooden benches but no other amenities. Overall, the stop was relatively clean. Wide sidewalks increase access, and lighting from nearby buildings increases the feeling of safety. However, there is no crosswalk within reasonable walking distance of the stop.

Cornell and Federal - adequate conditions

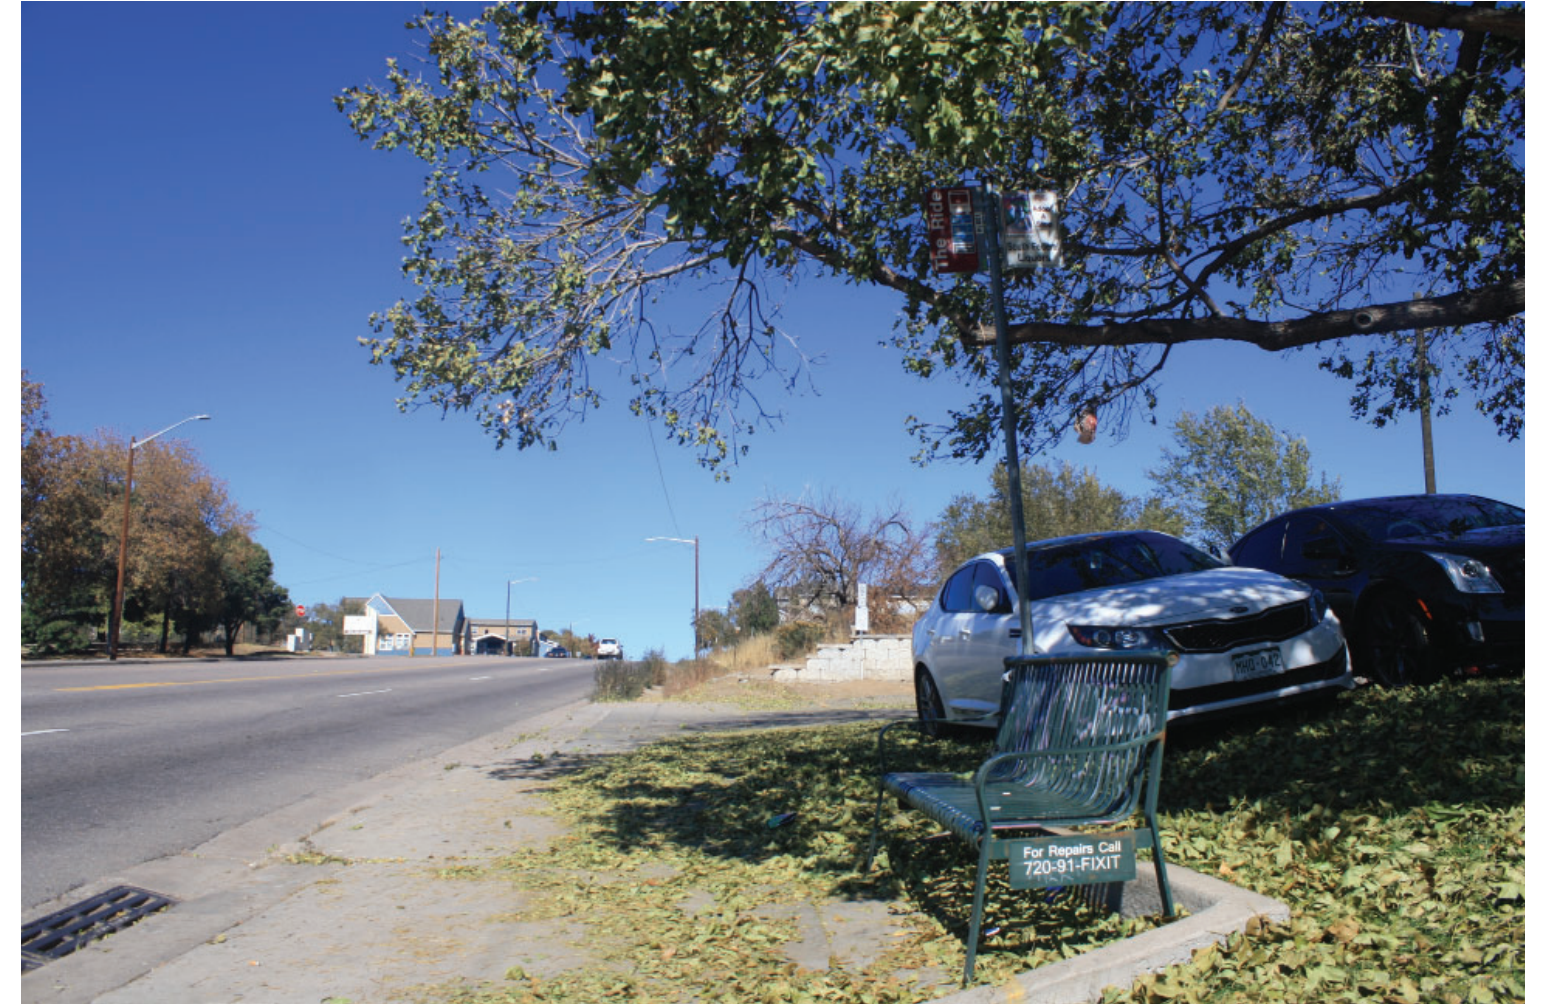
## 9 Bus Stop ID #13816

The Floyd and Federal Stop is in front of a well-kept apartment building and had a high cleanliness rating, even without a trash can on-site. A bench is located under a shady tree, though falling leaves may pile up. At night, only streetlights provide light, and there are no active commercial uses in the area. This presents safety concerns. Furthermore, there is no crosswalk in sight, and destinations other than the nearby housing are too far to walk to. Therefore, connectivity was scored low. However, three separate transit riders were waiting at the stop when the authors completed the assessment, so the stop may seem more connected compared to an outsider's perspective.

## Floyd and Federal - adequate conditions
