# College-View South Platte

## Federal Boulevard Bus Stop Assessments

Planning Methods, Fall 2019

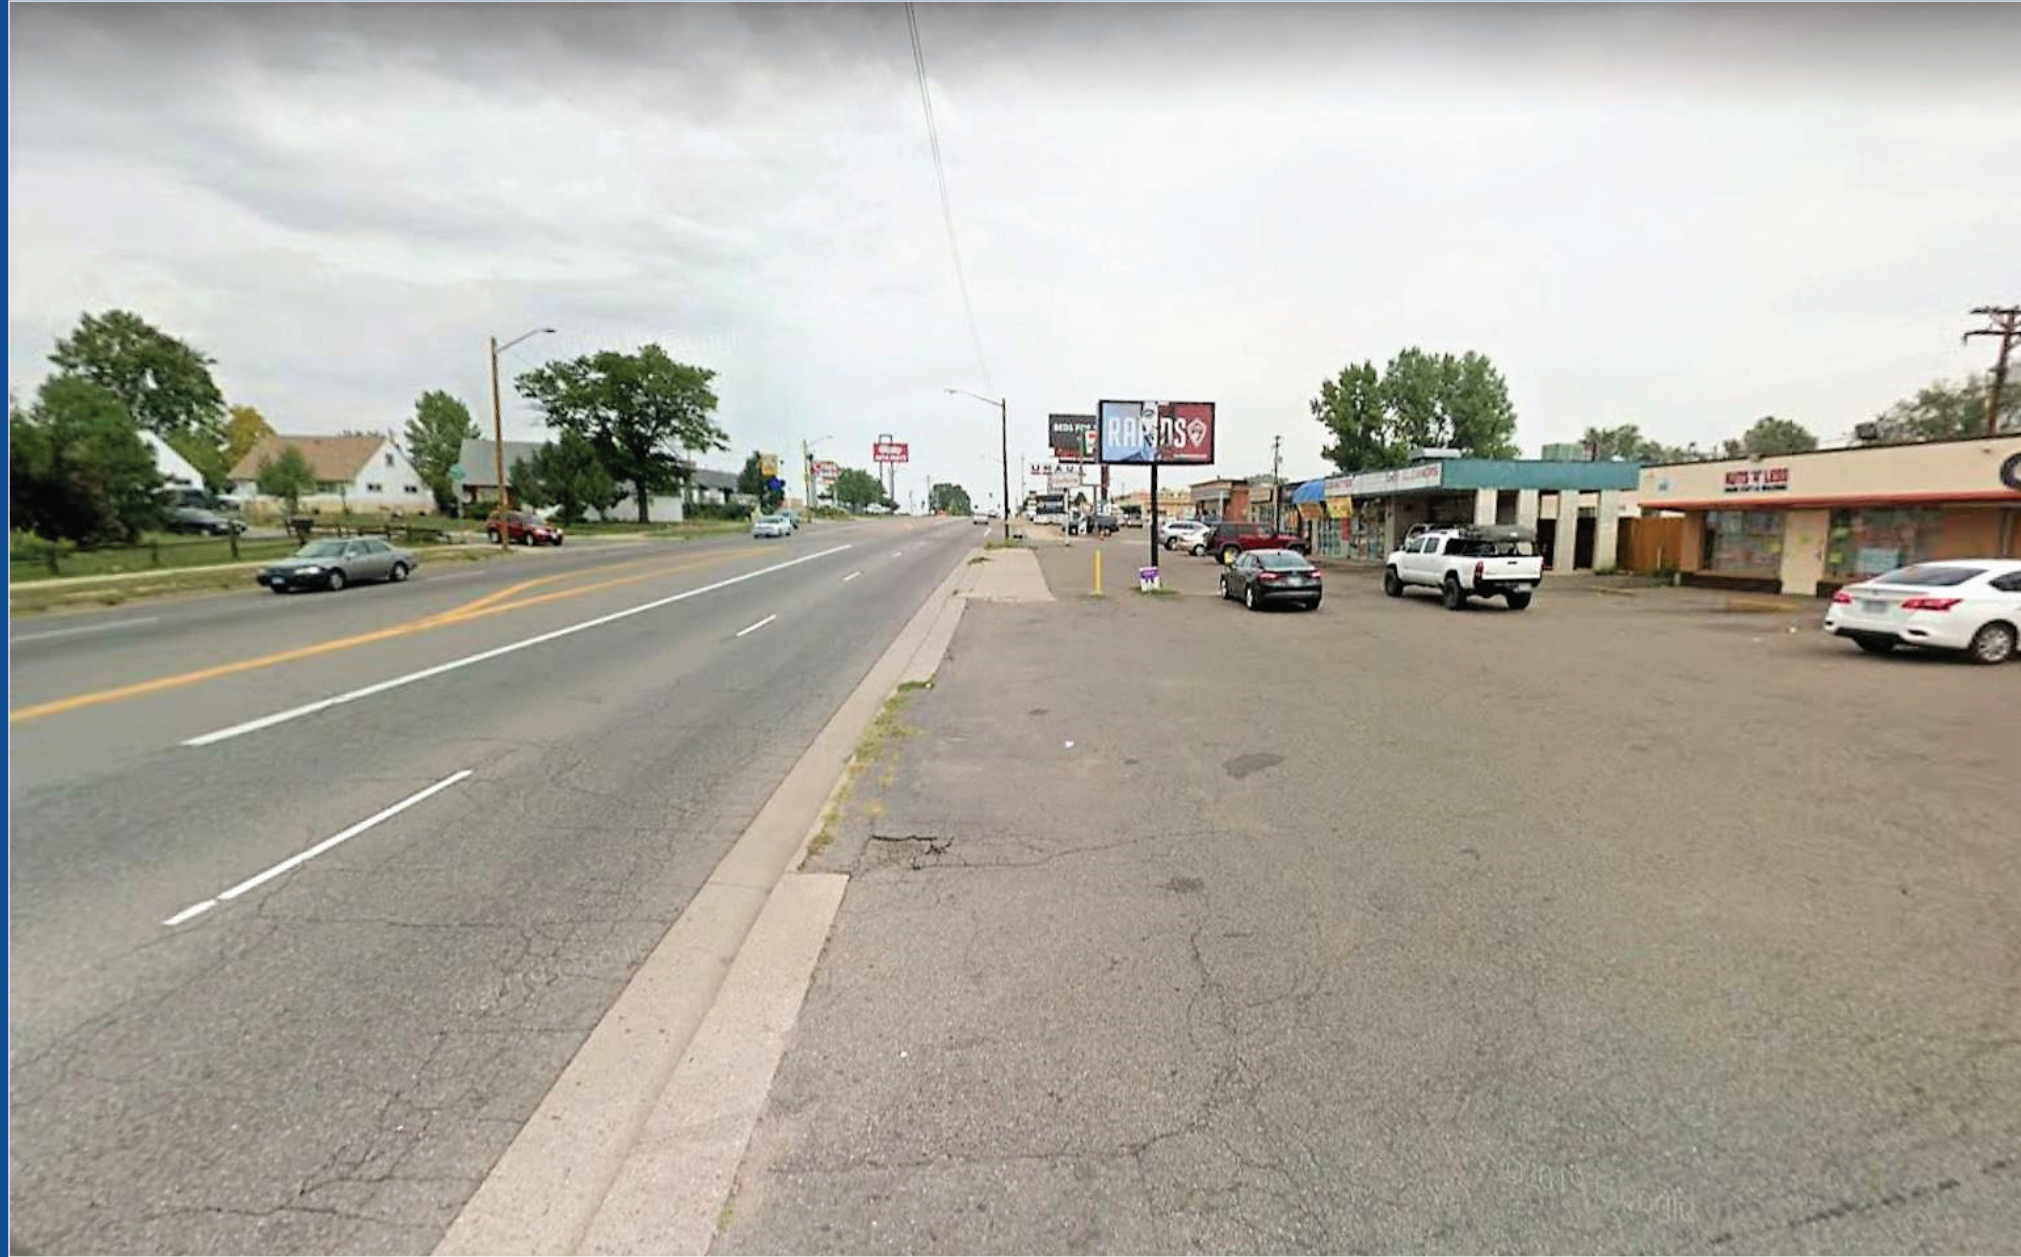
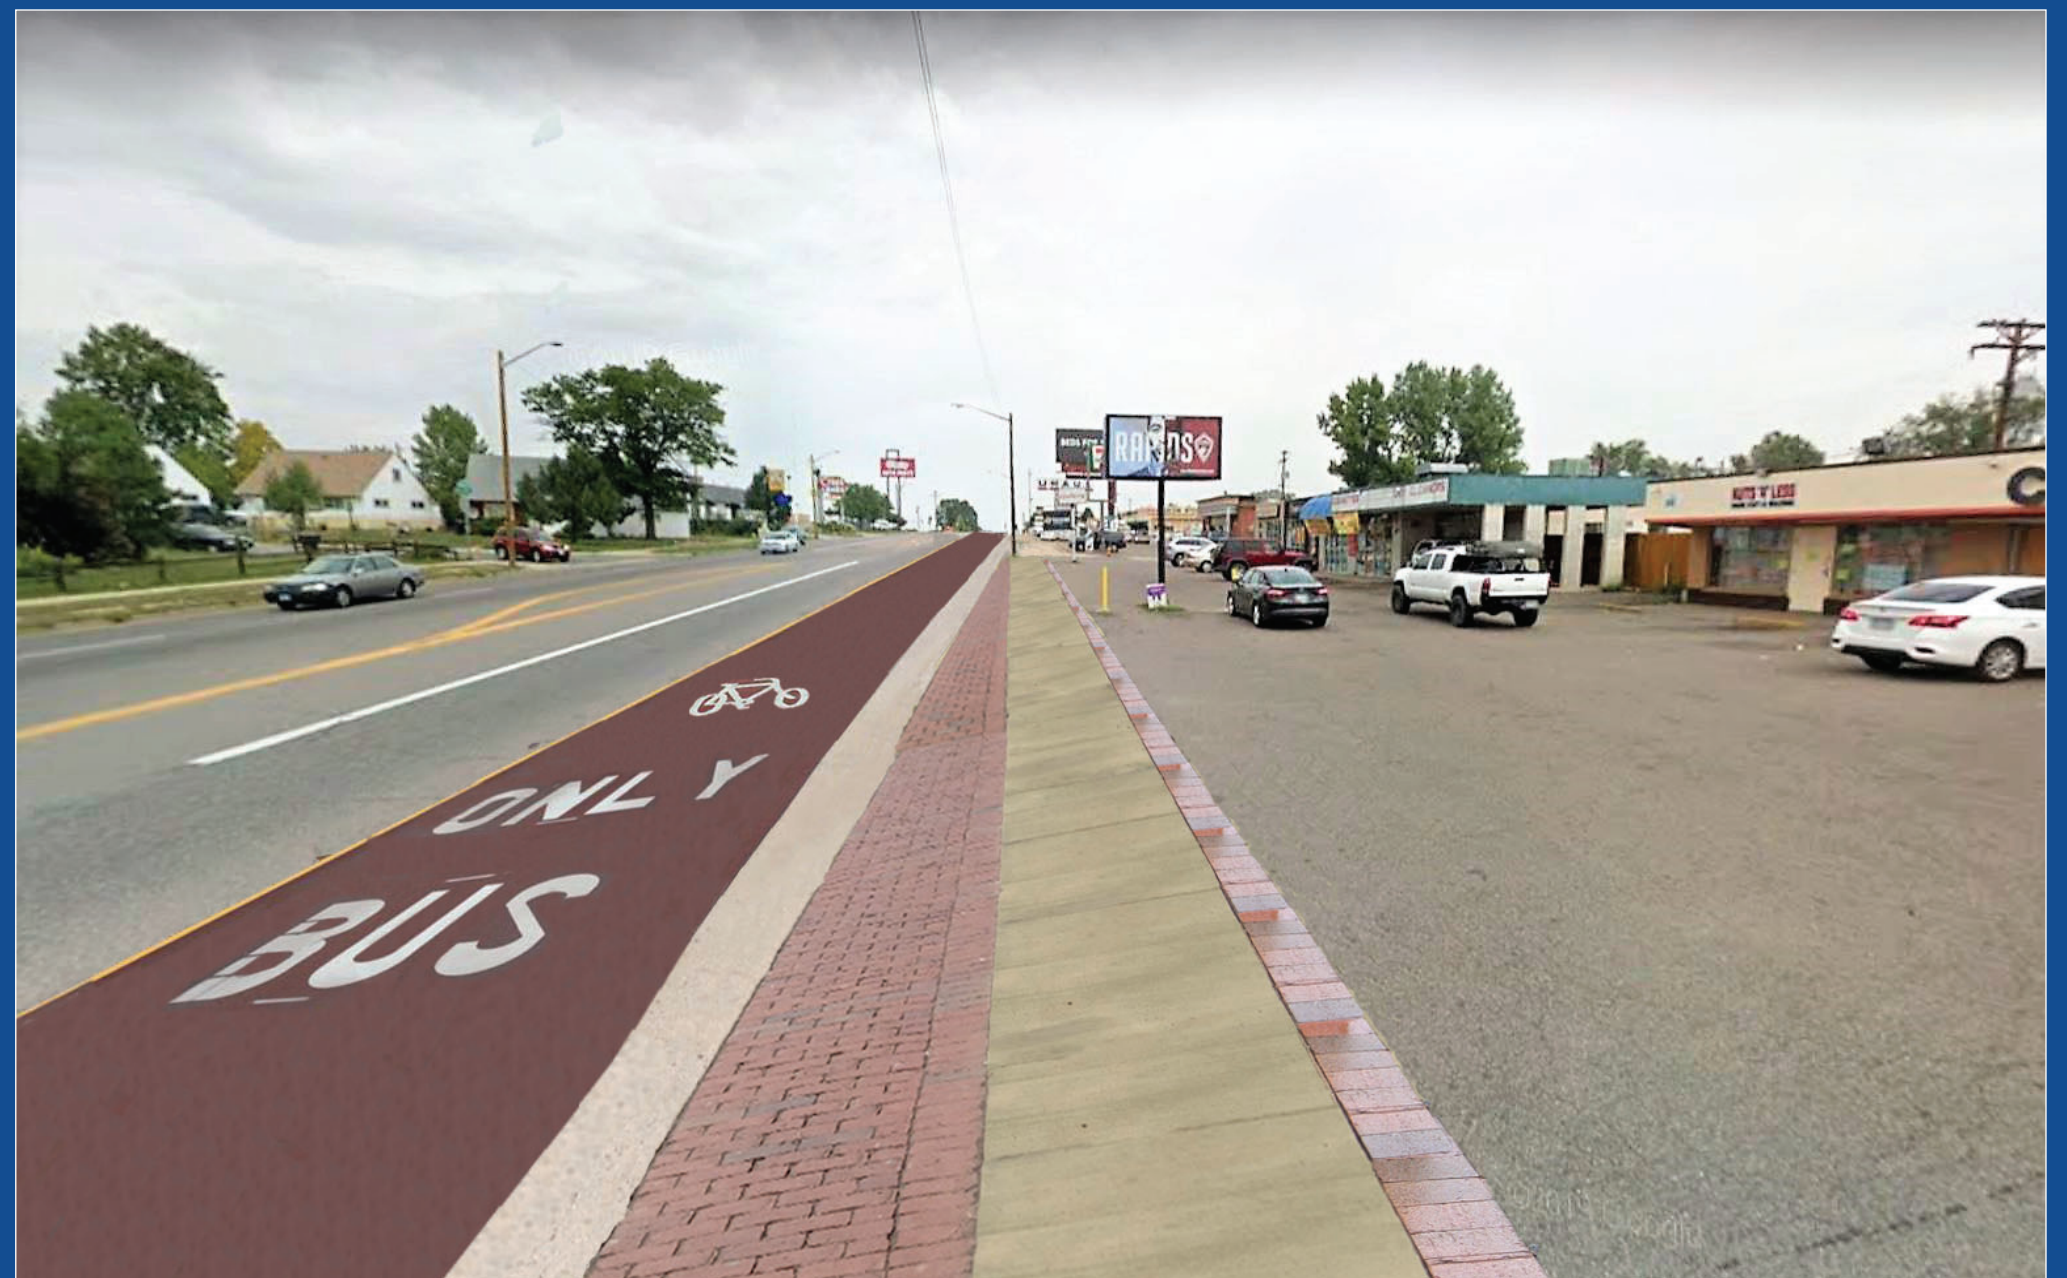
# Macro Gaps and Recommendations

Incomplete sidewalk network and poor conditions

Lack of bus lane and bike lane

In terms of macro recommendations for transit/pedestrian infrastructure, the project group has many recommendations. The first is to setback bus stops from Federal Boulevard through the widening of sidewalks. By increasing the setback of these stops, transit riders feel and are safer while waiting for their bus. Increased setbacks also increase the pedestrian experience for non-transit riders, increasing walkability along Federal and creating space for both types of pedestrians. A subtask of this recommendation is to complete the sidewalk network along Federal. Completing this will increase connectivity, mobility, and safety for all pedestrians.

Dedicated bus lane + dedicated bike lane = slower vehicle speeds
