Regis & Berkeley

Walk Denver and The City of Denver

URPL 5010 Planning Methods Fall
2019

Ahmad Alhammadi, Ian Conrardy,
Bryn McKillop, Andrea Vaughn

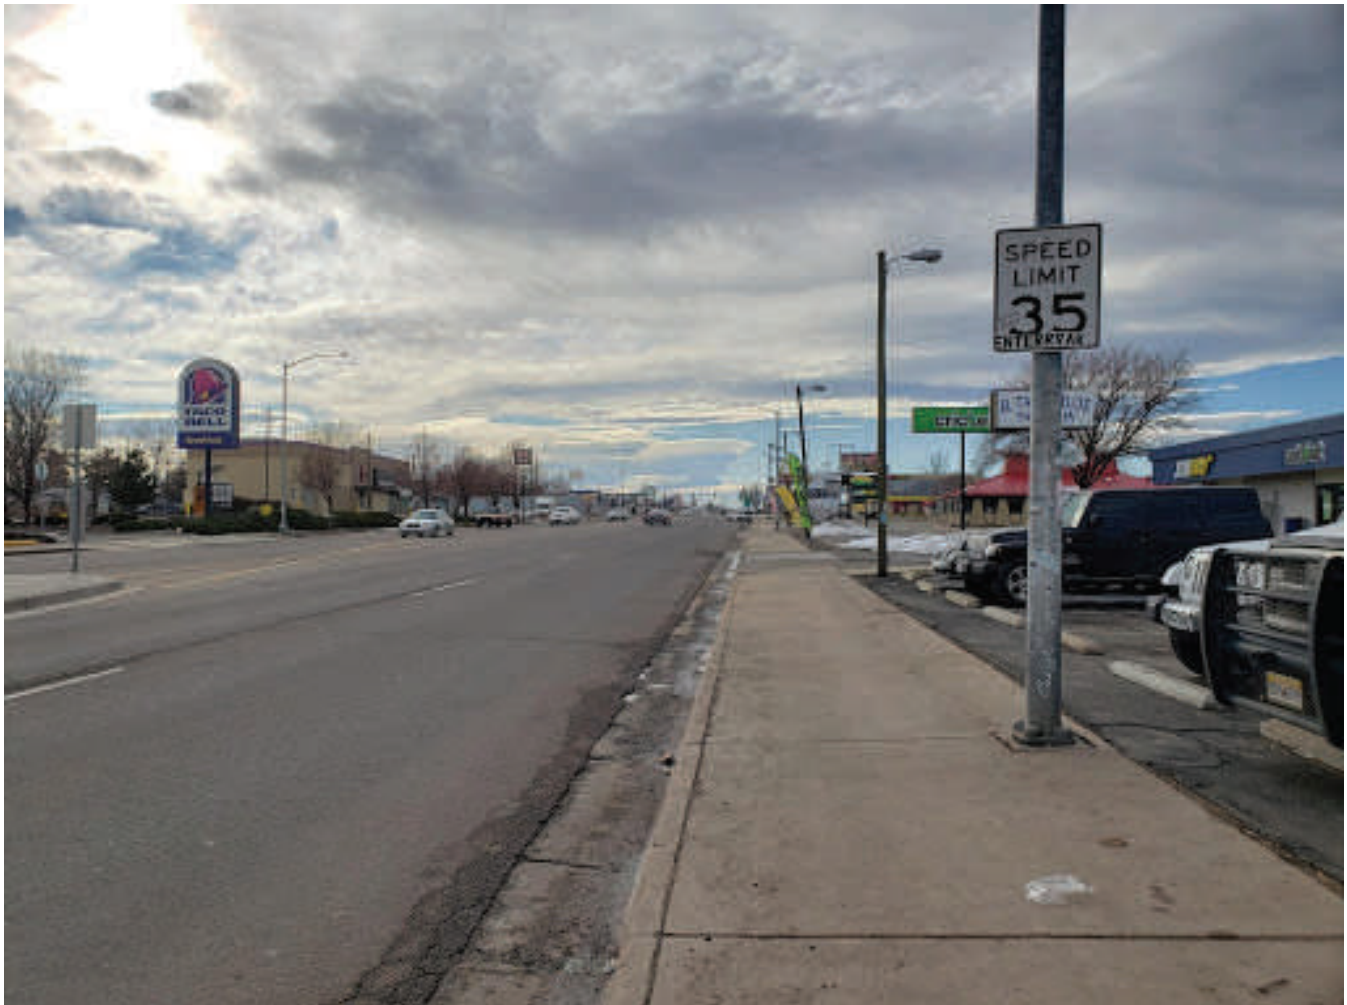
Figure 9: Picture of Federal Boulevard

Figure 9 shows deep setbacks, vehicle-oriented design, and spaces with little thought put into the connectivity between them as the zoning code for “General Mixed Use” and “Single-Unit” that makes up most of Regis-Berkeley calls for. The dip between the sidewalk and the road is the only buffer between the person walking along this boulevard and the lanes of traffic. In addition to the lanes of traffic, a person walking must be alert to cars coming and going from the businesses.

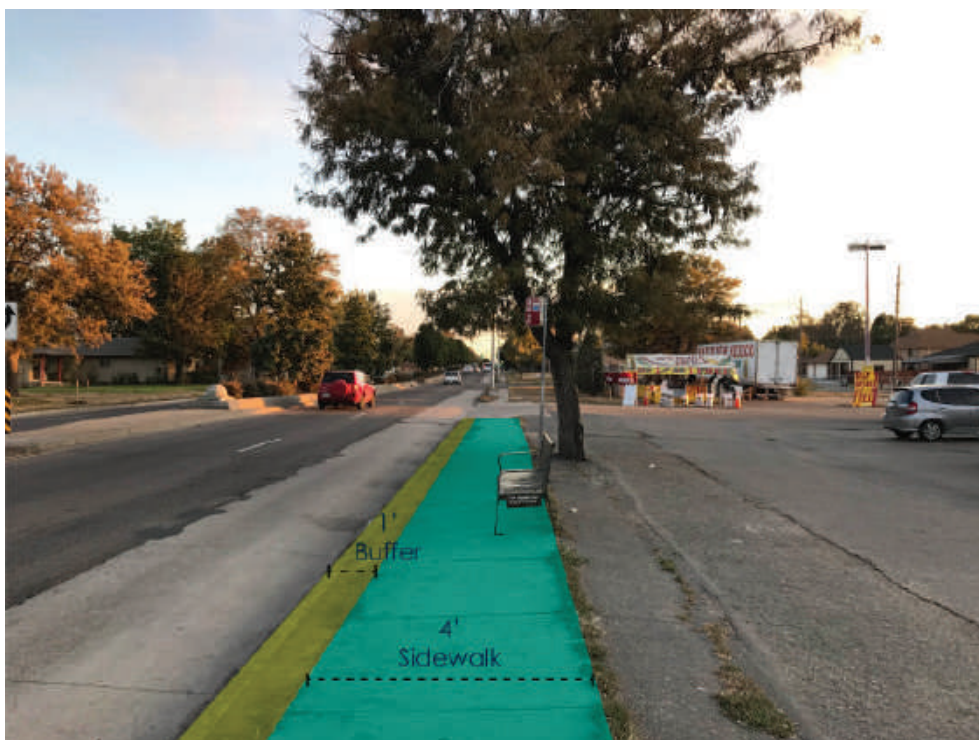
Figure 13: Federal Boulevard and 47th Avenue Bus Stop (#13726)

In Figure 13, the buffer and sidewalk create distance between the bus stop's bench and the two-lane traffic of Federal Boulevard. This image and graphic illustrates a combination of the variations of the attributes of safety, accessibility, and amenities present at the bus stops the team assessed. The team gave the bus stop below a rating of "2" for the Amenities category because it provides a bench, but not much else. It received a rating of "2" for the Safety category because it has some features but needs overhaul and it received a rating of "3" for the Accessibility category. The team gave it an overall rating of "3". The team's notes on it: "Bench is rusting, no overhead lighting. Generally feels unsafe, but is setback from the street."

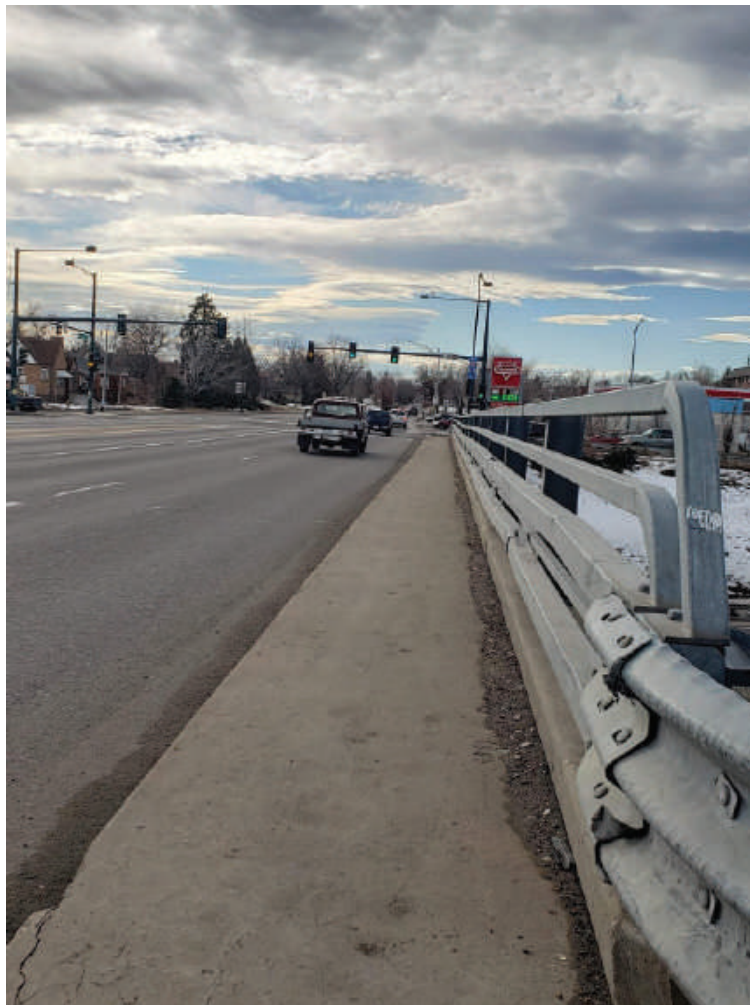
Figure 20: Sidewalk on I-70 Bridge

The planning team also observed that approximately between the north side of I-70 and 42nd Avenue, the sidewalks are approximately three feet wide, leaving little room between the pedestrian and the street. We found this problem to be worst along the bridge of I-70, in which pedestrians are squeezed between protective railing and the street. Furthermore, in our windshield survey, the team observed that in the neighborhoods surrounding Regis University, in particular, that the sidewalk curbs lack a defined edge, making it easier for vehicles to roll over the curb, putting pedestrians at higher risk on these sidewalks.

In order to encourage multi-modal transit along the route and to enhance pedestrian safety, it is the team's recommendation that Federal Boulevard be converted from a four lane street, to a three lane street with a protected bike lane. This bike lane would create an additional sense of security for pedestrians utilizing narrow sidewalks and provide a cost-effective alternative to widening sidewalks.

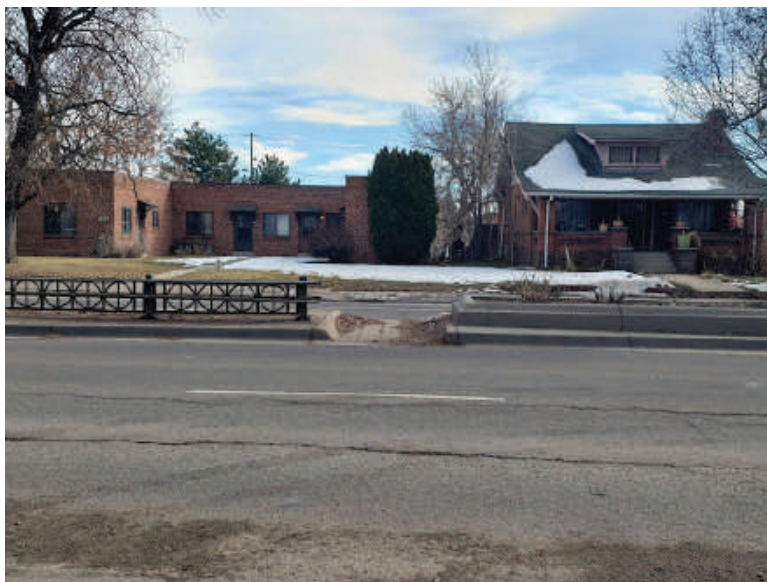
Figure 21: Offset Crosswalk at 41st Avenue

As US Census data demonstrates, 7% of residents in the study area walk to work, compared to 4% of residents in Denver, overall. Given this data, it would be beneficial for the city to invest in infrastructure that encourages more of the residents in the Regis and Berkeley neighborhoods to walk, as well as possibly explore other facets of multi-modal transportation.

In order for all transit-riders to be able to safely access the bus stops for both the north and southbound, it is highly recommended that cross-walks connecting bus stops be installed with appropriate signaling. Crosswalks should be made attractive, where possible, to encourage walkability and as a method of slowing the speed of vehicles.

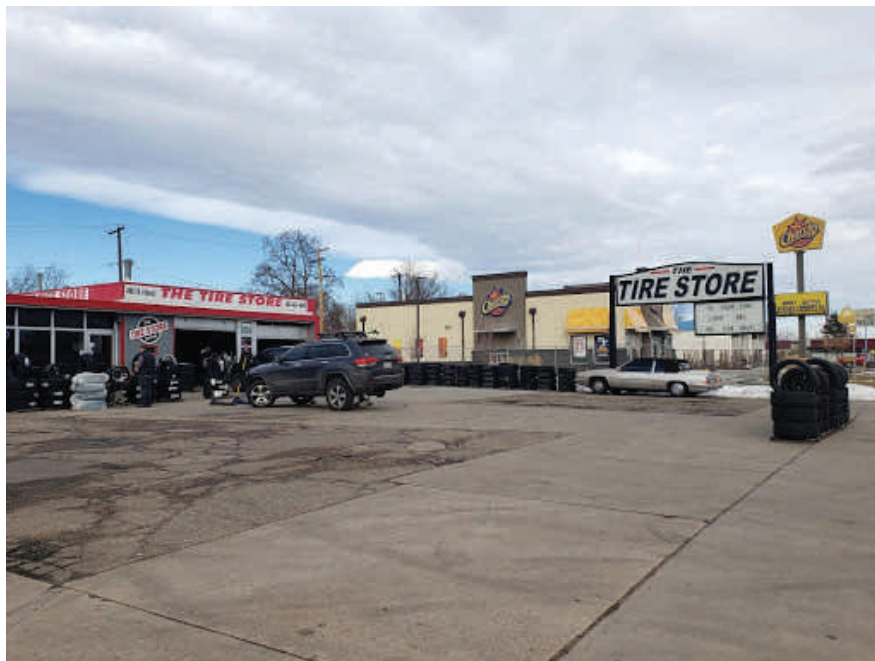
Figure 22: Businesses Located North of I-70 on Federal Boulevard

Federal Boulevard in the Regis and Berkeley neighborhoods are well serviced by RTD. Each of the six bus stops surveyed along the west side of Federal Boulevard are placed approximately one-quarter mile apart (Human Transit pg. 209) and Route 31 arrives approximately every fifteen minutes. An individual's experience utilizing the bus itself is, presumably, a comfortable one. The planning team, however, found that a transit user's experience could be improved through bus stop improvements focusing on improvements that improve the aesthetics, comfort and safety of the bus stops.

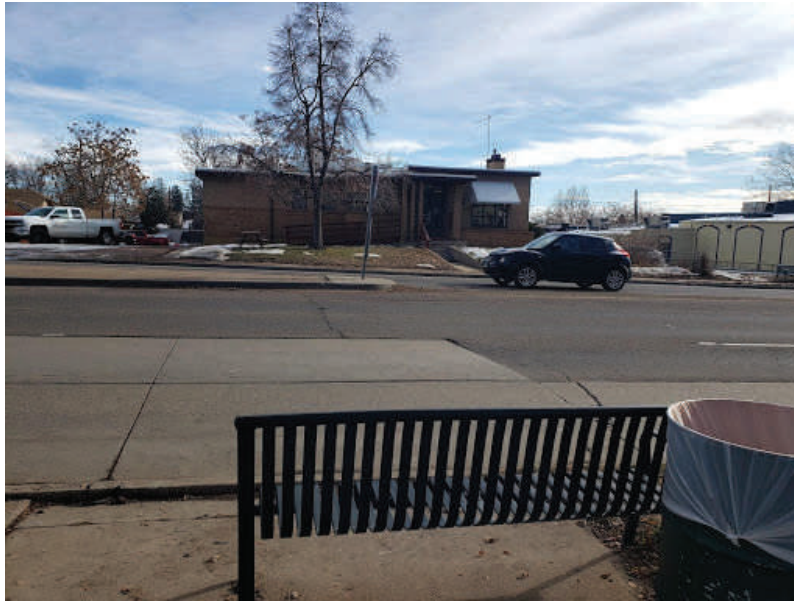
Figure 23: Bus Bench on Federal Boulevard and 39th Avenue

The planning team and interview participants also noted other safety concerns for those waiting at bus stops. The most noticeable concern was a lack of adequate lighting, which 15% of survey respondents said would improve the bus stops. The team had even heard from three of the respondents that they would not use the bus stop outside of daylight hours. Of the bus stops surveyed, the team noted that only 50% of the stops had a street light post within ten feet of the stop. Much of the lighting provided for the bus stops without a light post located nearby comes from either street signals or light posts located on private property, largely parking lots.

Another safety concern noted by the planning team was the placement of bus benches in relation to the street. Only one of the six bus stops assessed were set back from the curb, while the other five were placed within three feet of the edge of the curb. Team members found that sitting on bus benches placed so close to speeding traffic was an uncomfortable experience that discomfort would be compounded when the roads are slick with ice.

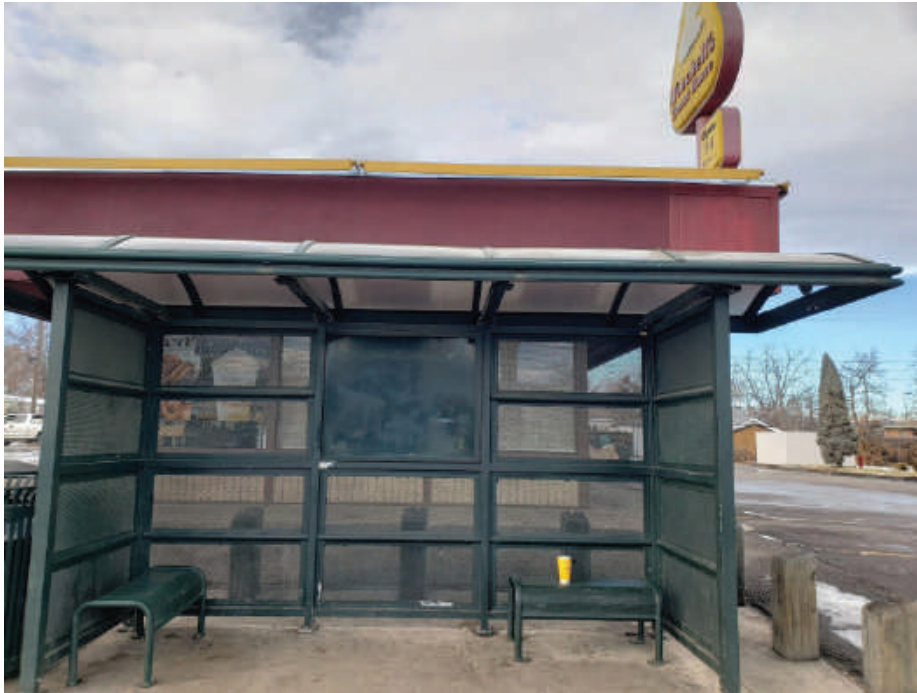
Figure 24: Federal Boulevard & W 50th Ave

Most importantly, for a city such as Denver, where the seasons can shift from oppressive heat to freezing conditions, only one of the six bus stops surveyed offered any shelter. This bus stop, located on Federal Blvd and W. 50th Avenue, had the most utilization when the planning team was in the field conducting surveys, with approximately 45% of all intercept surveys taking place at this stop. This may, in part, be due to the location of this stop – Regis University is located north of the same intersection and a variety of service industry businesses, particularly fast food establishments, are located along with this section of the study area.

Bus shelters should be placed strategically along this route, with at least one additional shelter being installed south of I-70. Additional shelters will protect riders from inclement weather, but may also help alleviate the pressures of the bus stop at Federal Boulevard & W 50th Ave, where riders have reported that there is insufficient garbage cans and safety concerns, due to the homeless population using the stop for its shelter. In addition, trash cans should be installed at bus stops currently lacking in proper refuse disposal.
