RUBY HILL + ATHMAR PARK

BUS STOP ASSESSMENT

URPL5010: PLANNING METHODS

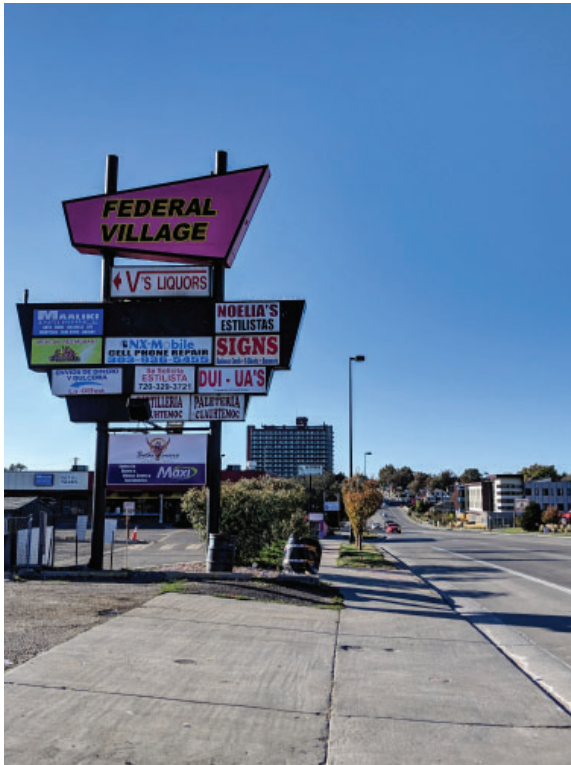
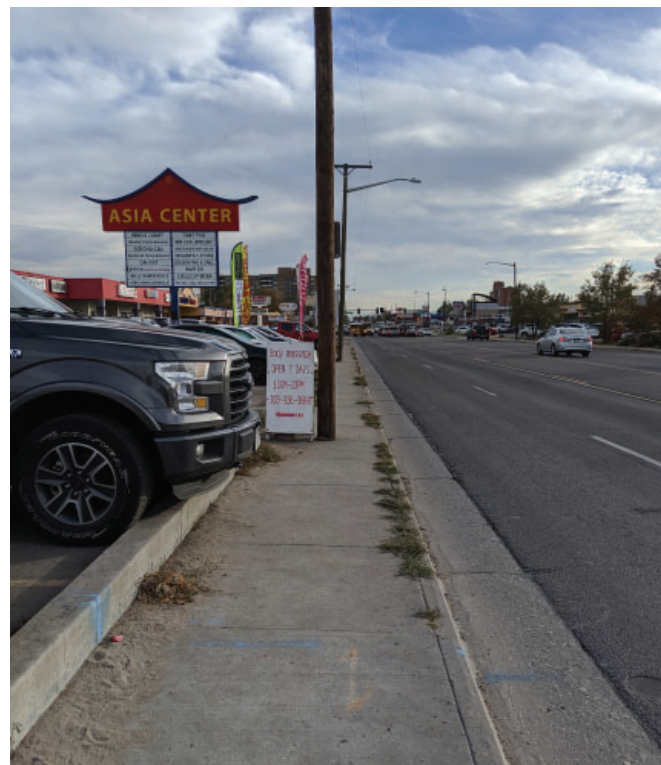
EXHIBIT 13: Sidewalks along Federal Boulevard

The two photos in Exhibit 13 are a good representation of Federal Boulevard. The photo on the right shows a narrow, unprotected sidewalk sandwiched between the street and a surface parking lot. It also has a utility pole placed in the middle of the sidewalk. Walking along this section,

the project team felt safer walking through the surface parking lot rather than along the sidewalk next to the high-speed traffic. Neither is a good choice. The photo on the right shows a large curb cut that the project team was required to walk through to continue along to the safer detached sidewalk further ahead.

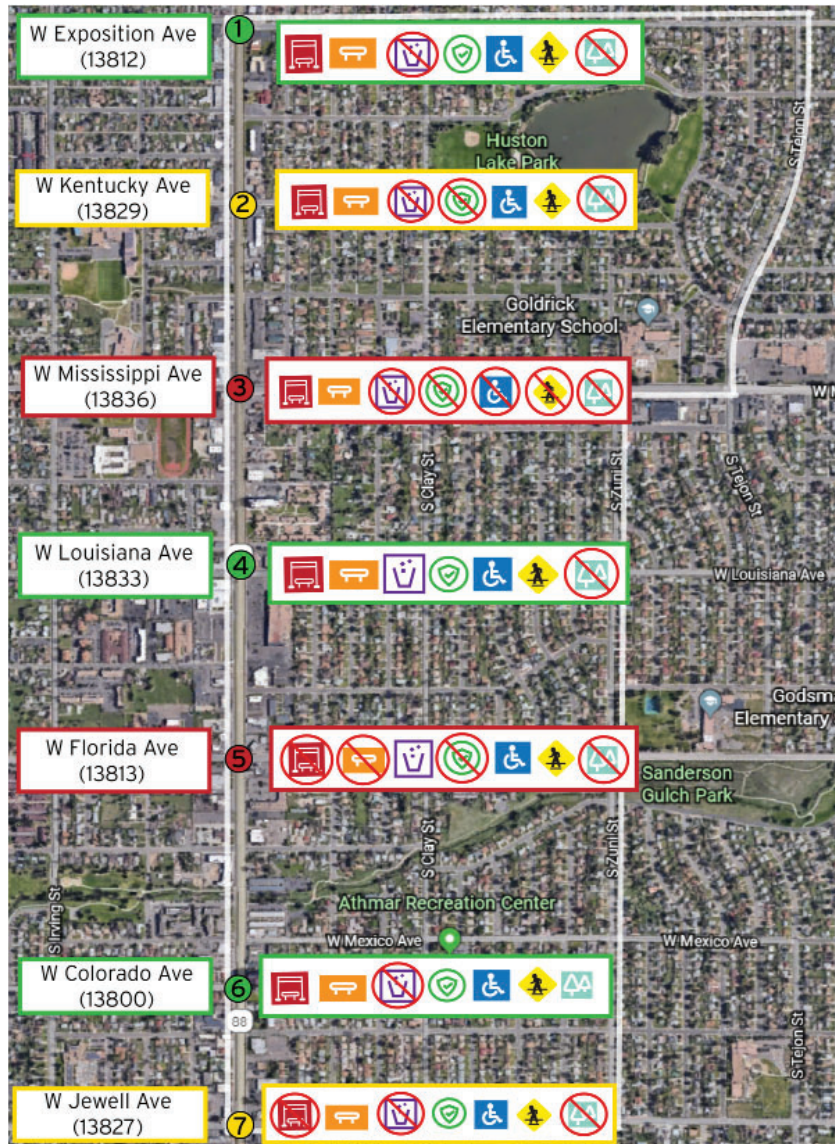
EXHIBIT 16: Bus stop attributes present + lacking

The map in Exhibit 16 displays the highlights from the bus stop assessments, including the ranking of the stops, the amenities and features present at each stop, as well as the pedestrian areas with particularly good and bad conditions.

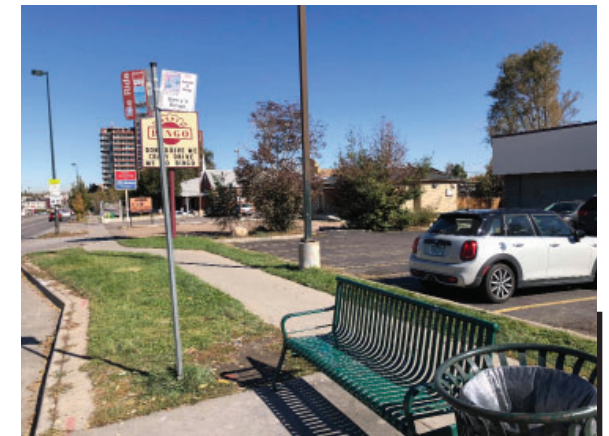
EXHIBIT 17: Federal + Jewell stop

This stop offered decent amenities including a trash bin and a bench and is accompanied by wide ADA accessible sidewalks as well as a large loading area. The stop received a high physical condition rating as all amenities are in good condition. The stop is located close to the Federal and Jewell intersection which provides a marked crossing and allows pedestrians to cross safely to access the stop. In addition, the stop is several yards away from the nearest curb cut, which provides a safer environment for individuals at this stop.

With that said, the cleanliness of the stop could be greatly improved. It is evident that it has not been cleaned regularly, as there is litter surrounding the waiting area. The surrounding landscape and parking strip area is also poorly maintained.

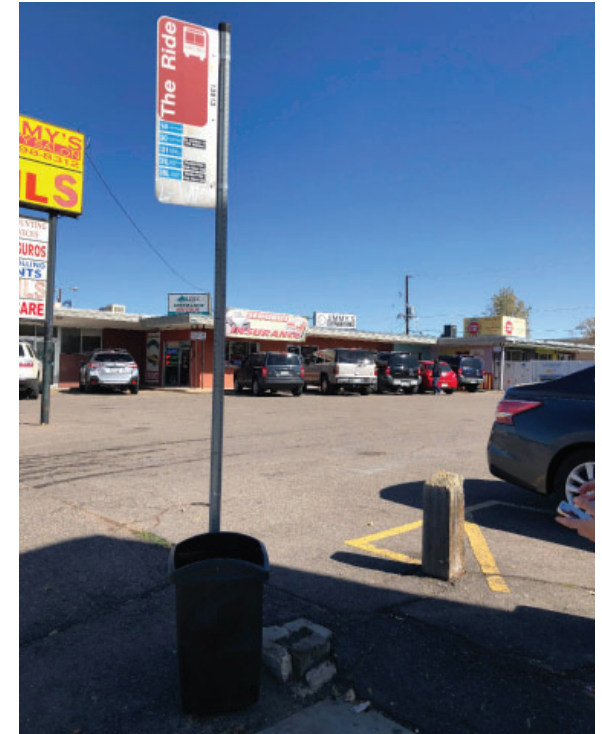
EXHIBIT 18: Federal + Florida stop

This stop has significant issues in many rating areas. As far as safety is concerned, the stop is sandwiched between an extremely busy gas station and a small plaza with a couple of restaurants. The stop sits right along the parking lot of this plaza. This makes access to the stop unsafe. In addition, while the stop sits near an intersection with a marked crossing, many pedestrians coming to the stop were seen crossing the street mid-block. A positive aspect of this stop location is that the setback from the road is large, meaning those waiting for their buses are not waiting dangerously close to the road.

Along with quite poor pedestrian safety, cleanliness and physical conditions are equally poor. A small trash can is strapped to the bus sign, and there is no available seating in the area. There are about four

posts meant to separate the sidewalk and the parking lot of the plaza (as seen in the middle photo below) and individuals were observed using these as a makeshift bench. The project team also observed that when individuals were not waiting for their bus by sitting on these posts, they would instead wait in the parking lot of the gas station. The area itself was also littered with trash despite the small trash bin, and there was no surrounding landscape (i.e. grass, plants, tree shading, etc).

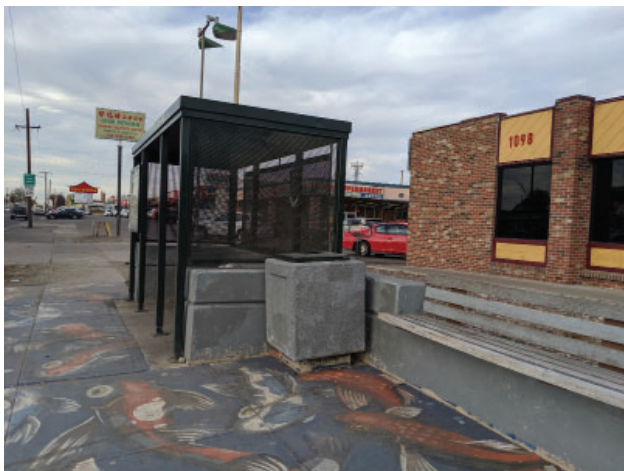
EXHIBIT 19: Federal + Mississippi stop

This stop is one of the better stops along Federal. The amenities are extensive in order to accommodate the high number of individuals that board and deboard at this stop. Amenities include a shelter, additional benches, trash disposal, and route map. The high quality of the ADA accessible sidewalks are equally sustained, and the boarding area and setback of the shelter and benches is large. In addition, the stop was quite clean without the presence of any litter.

While not near any driveways, it's situated about mid-block, which may dissuade pedestrians from using the marked crossing at either the north or south intersection. However, the stop sits in a popular location right outside of large apartment complexes, providing excellent accessibility to those residents in particular.

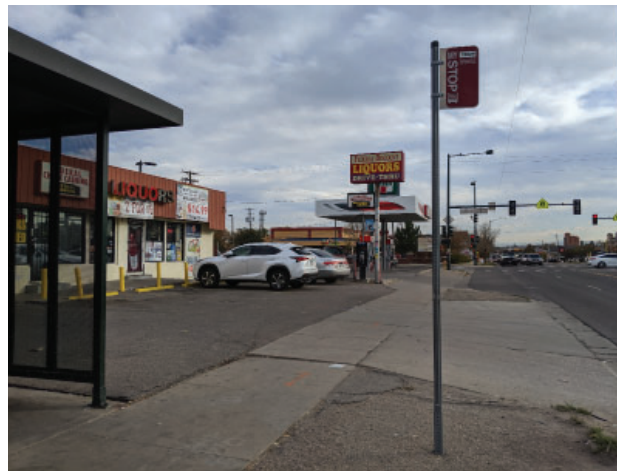
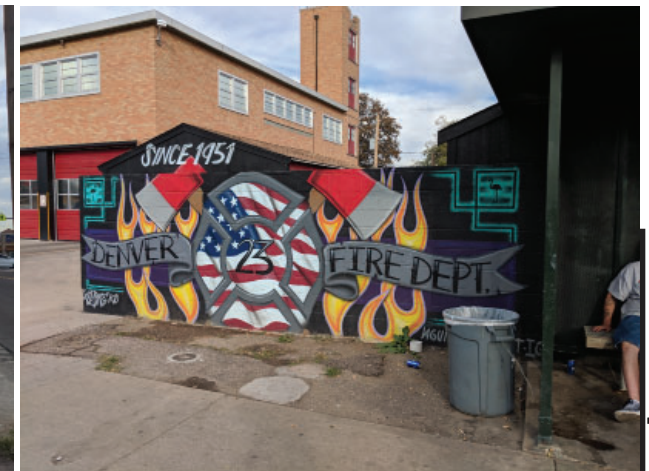
EXHIBIT 20: Federal + Kentucky stop

This bus stop's safety was impacted by the surrounding curb cuts. On one side there is a fire station with a vast entry and exit driveway, and on the other side there is surface parking for a strip mall with a very wide entrance for cars. This made the project team feel very exposed when standing at the stop. Some positive attributes included having a concrete and asphalt pad and being located close to the intersection, so most people would probably use it.

Exhibit 20 shows the adjacent strip mall. The center photo shows the amenities including a standard shelter with a bench and a route schedule on the back wall. The far-right photo shows the nice wall art to the north side of the bus stop, along with a plastic trash can that is chained to the bus shelter.

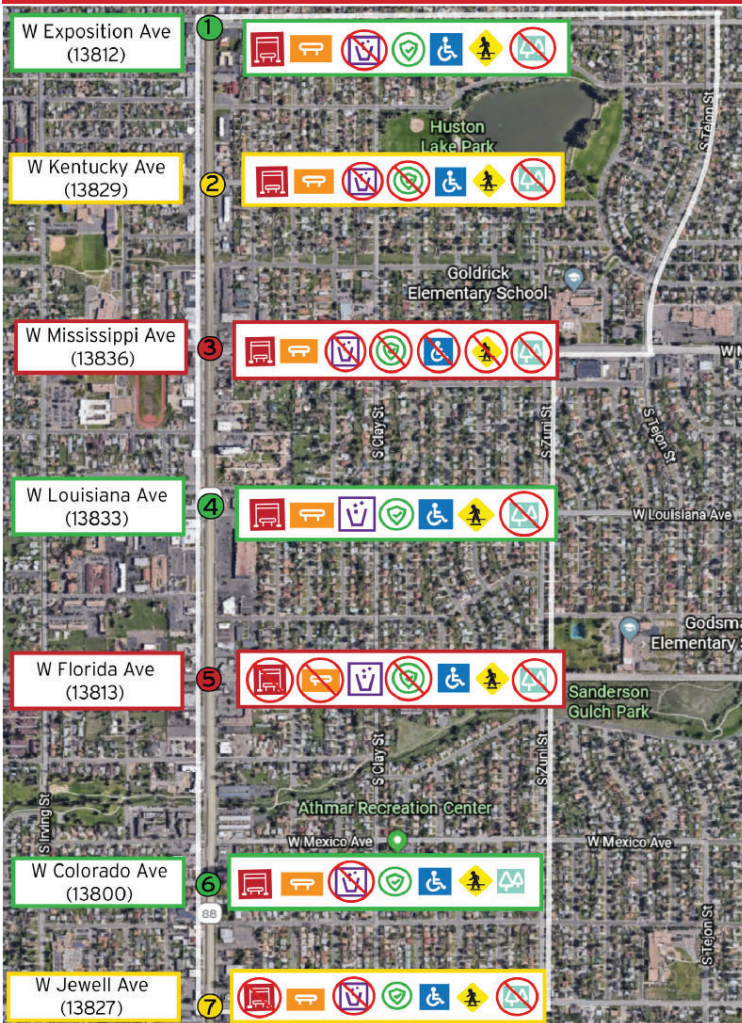
GAPS

Existing transit/pedestrian infrastructure gaps

Unprotected, detached, narrow sidewalks
 Vast curb cuts
 Obstructions blocking paths
 Bus stops near driveways
 Unpaved dirt paths
