Sun Valley

Bus Stop Amenities Project

Project Introduction

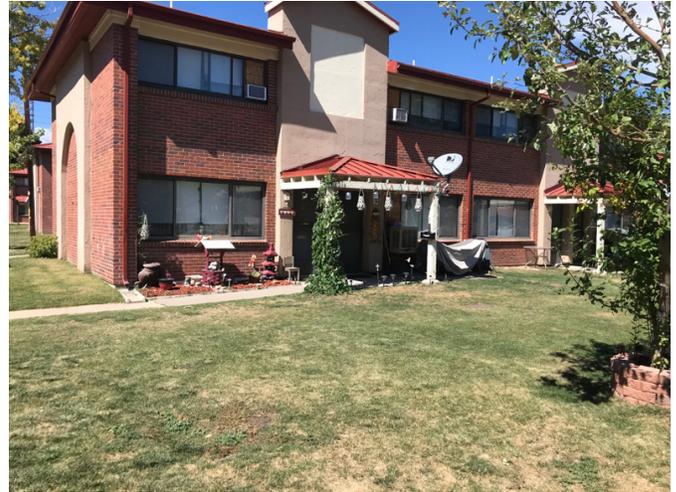
Exhibit 8: Sun Valley Homes

Sun Valley Homes stands in the middle of the community. Originally built in the 1950s, the 33-acre public housing project is one of Denver Housing Authority's oldest and most distressed properties. The two-story red brick rowhomes sit on large lots with open front and back yards, with clotheslines and small playgrounds dispersed throughout the community. Sun Valley Homes is currently undergoing large-scale redevelopment, with construction already underway at the West 10th Avenue and Decatur Street intersection. New construction will range from six to eight story apartment buildings, providing extra density and transforming the character of the neighborhood. The massive scale of the project will also result in significant construction zones that provide additional barriers to resident mobility. DHA has created healthy living guidelines in their design of new housing, which include addressing air quality and heat island impacts, planning natural spaces for reflection, implementing traffic calming measures, planning for bike sharing and bike transit, incorporating culturally based public art, and incorporating community gardens, community space, and play/outdoor spaces on each building site (Mithun 2-6). There is already some public art in the neighborhood, notably including painted dumpsters in Sun Valley Homes and murals on Fairview Elementary, the Sun Valley Opportunity Center, the Sun Valley Youth Center, and at Namaste Solar. There are also two community gardens, one located across from Fairview Elementary and the other adjacent to the South Platte River Trail and the Sun Valley Opportunity Center.

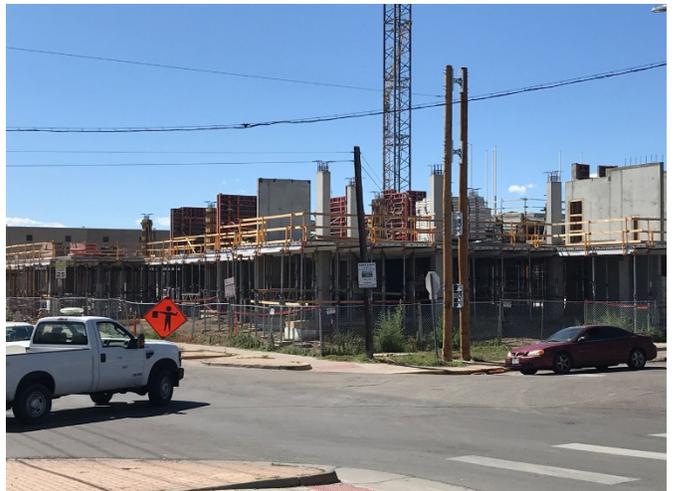
Exhibit 9: New construction at 10th & Decatur

For now, mobility in Sun Valley is restricted by suboptimal infrastructure and the introduction of large-scale construction projects, including the West 10th and Decatur site as well as the ongoing Federal Boulevard expansion. Decatur Street, the neighborhood's main thoroughfare, was plagued with closures and alternating lanes of one-way traffic. The lack of clear signaling and movement of heavy machinery made this stretch of Decatur a hazard for pedestrians, which is particularly concerning due to its proximity to Fairview Elementary School. The construction in Sun Valley will only increase over the next few years of redevelopment, resulting in traffic and mobility issues for a considerable period of time.

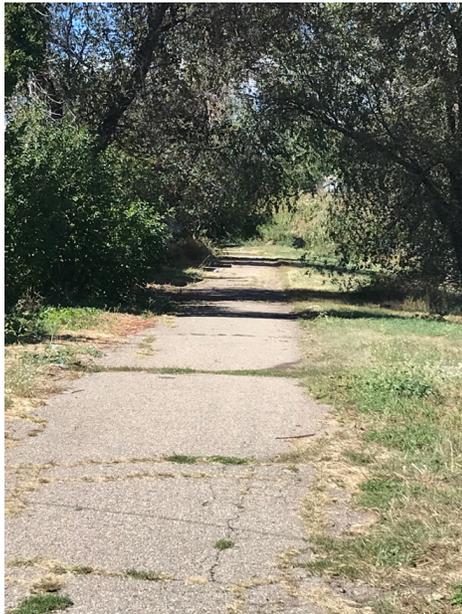
Exhibit 11: Part of the Platte River Trail running through Sun Valley

There is some green space in Sun Valley. The area around Rude Recreation Center has been developed into Rude Park, which includes a baseball field. Rude Park backs up to Lakewood Gulch Trail, which runs diagonally through the neighborhood, extending to the Decatur-Federal Station to the north. The Lakewood Gulch Trail connects to the South Platte River Trail, a brick and concrete pedestrian and bike trail which runs north-south along the eastern border of the neighborhood. While this green space increases the connectivity of the neighborhood, it is not always well-maintained, particularly the area underneath West Colfax Avenue. Better landscaping and maintenance could help the area feel safer and contribute to better activation.

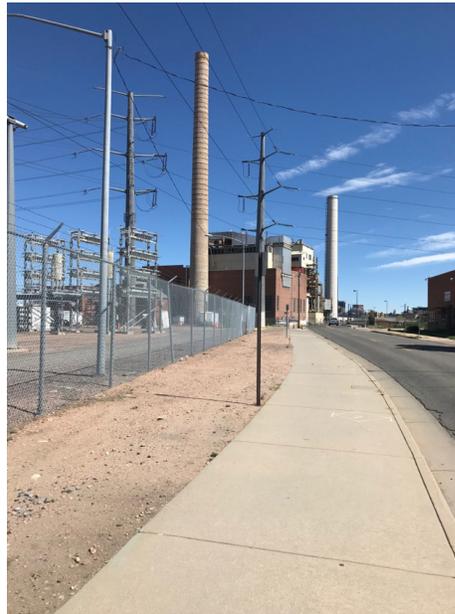
Exhibit 12: A view of the decommissioned Excel energy plant along 13th Avenue

There is little activation along the sidewalks in the area and much of the land is covered with surface parking or empty lots, including large lots connected to Denver Human Services, the Westside Clinic, Fairview Elementary, and across from the Sun Valley People Hub. The buildings in the area are primarily modern, large and blocky with brick and concrete exteriors. Empty lots along West 13th Avenue on the eastern edge of the neighborhood currently house decommissioned Excel energy infrastructure; these will also be redeveloped into housing as part of Denver Housing

Authority's Master Plan. In general, landscaping in the neighborhood is nonexistent or poorly maintained.

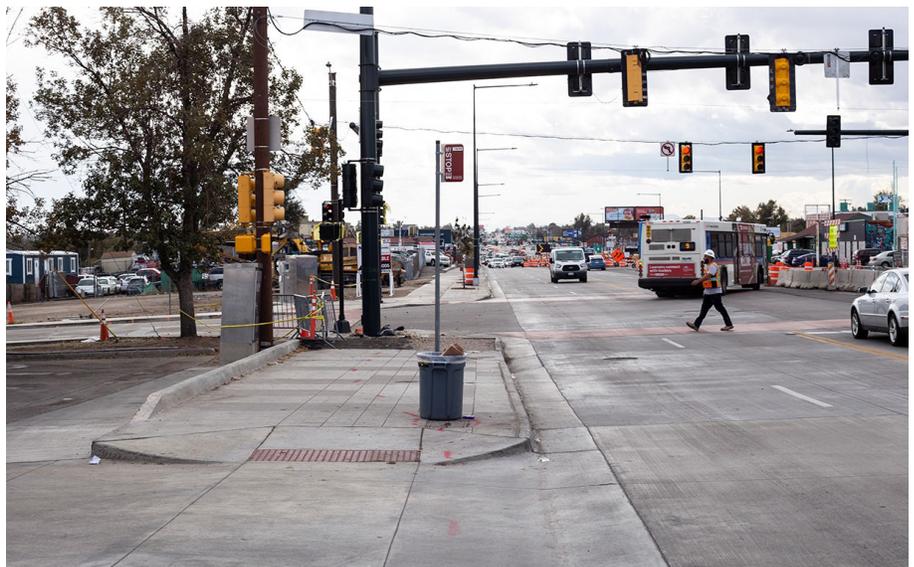
Exhibit 3: Federal Boulevard at 10th Avenue - #13698

The Sun Valley study team found that the bus stop at West 10th Avenue deserved a two-star rating. With a nice, wide waiting pad, the stop had some potential but lacked amenities other than a trash can (probably provided by the gas station to the east) and had significant accessibility and connectivity challenges. As the Exhibit 3 above shows, the sidewalk to the south abruptly ends in an uneven, narrow dirt patch just before the intersection. Immediately to the north was a wide, heavily trafficked entrance to a gas station that made getting to, and standing at, the bus stop feel dangerous. Addressing these issues would help this bus stop feel safer and more comfortable.

In some cases, the absence of any shelter or seating contributed to unsafe conditions. This is particularly true at the Federal Boulevard and West 10th Avenue stop, where riders are confronted by traffic on all sides of the stop: along Federal Boulevard, West 10th Avenue, in the 7-Eleven parking lot behind them, and at the entrance to the 7-Eleven lot. Cars continuously move around the stop, with the only protection being a small curb-sized barrier between the stop and the parking lot behind it. This stop seemed particularly dangerous for riders travelling with children; this is concerning, considering the high proportion of children living in the adjacent Sun Valley neighborhood.

Measures should be taken to improve the safety of riders at the West 10th Avenue stop. Shelter and seating would significantly reduce the risk of individuals falling over the short wall into the 7-Eleven parking lot. If shelter or seating is not possible, warnings via paint or signage should be installed to reduce the risk of injury to riders. Another method to reduce the issues of the 10th Avenue stop is to remove it altogether and serve the location through a different stop placement with a safer surrounding area. The redistribution of stops will be covered in the Macro Recommendations section.

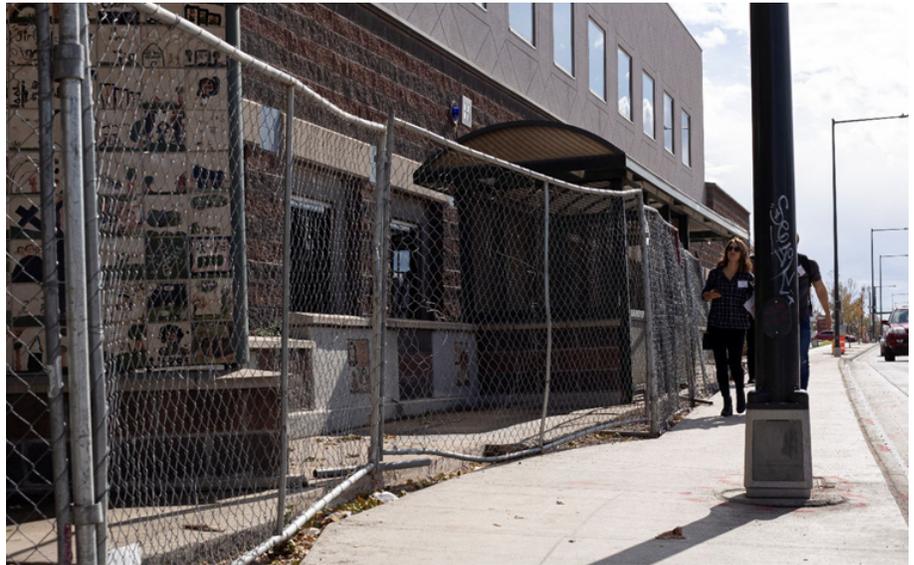
Exhibit 4: Federal Boulevard at West Holden Place - #13700

The bus stop at West Holden Place, shown above in Exhibit 4, was a challenge to score because the amenities present, which included a bench, shelter, and trash can, were inaccessibly enclosed behind a chain-link fence. Although this situation may be only temporary (perhaps due to the road construction on Federal), the receptionist at Denver Human Services told the team that the fence had been up for about 5 months. Given the duration of the amenities being out of reach, the team decided to treat the stop as though it lacked any amenities and awarded it only two stars. A narrow sidewalk in front of the fence left little room for passage or waiting and the heavy traffic on Federal was dangerously close. In spite of being located so close to Denver Health and Human Services, there was no lighting at the stop. In the picture above, one can see that the stop did have a public art installation that featured ceramic tiles hand-painted by school children. Due to the fence and amount of litter in the area, the installation did little to increase the comfort of the stop. The team determined that this stop will also need some improvement to make it safe and comfortable.

Currently, the stop at Holden Place is fenced off and obstructed from use by riders, possibly in anticipation of sidewalk reconstruction. However, Denver Health employees stated that the stop had been fenced off for at least three months, significantly preceding construction work. In addition to rendering all amenities unusable, the fencing decreases the safety of the stop and the surrounding area, cutting off an already narrow sidewalk. Transit riders must wait in close proximity to the busy traffic on Federal Boulevard, making it difficult for pedestrians to pass. Additionally, despite the stop being fenced off, its trash cans are overflowing and the entire stop is relatively unkempt. This stop is located in front of Denver Human Services and should presumably see a high volume of transit riders. However, the research team noticed little to no utilization during the site investigations, likely due to these conditions. Visitors to Denver Human Services, who may be disabled or elderly, were forced to use less convenient stops at West 10th Avenue or Decatur Place.

Presumably, the sidewalk at the West Holden Place stop will be reconstructed to be more pedestrian friendly, similar to other stops to the south. In the meantime, it is worth investigating why the stop is fenced off, despite construction not having started. The stop is large with a significant amount of amenities that could be used to improve rider comfort and experience until construction begins. After the reconstruction of the sidewalk at West Holden Place, the stop should be reevaluated to be consistent with the recommendations made for other stops in this report.

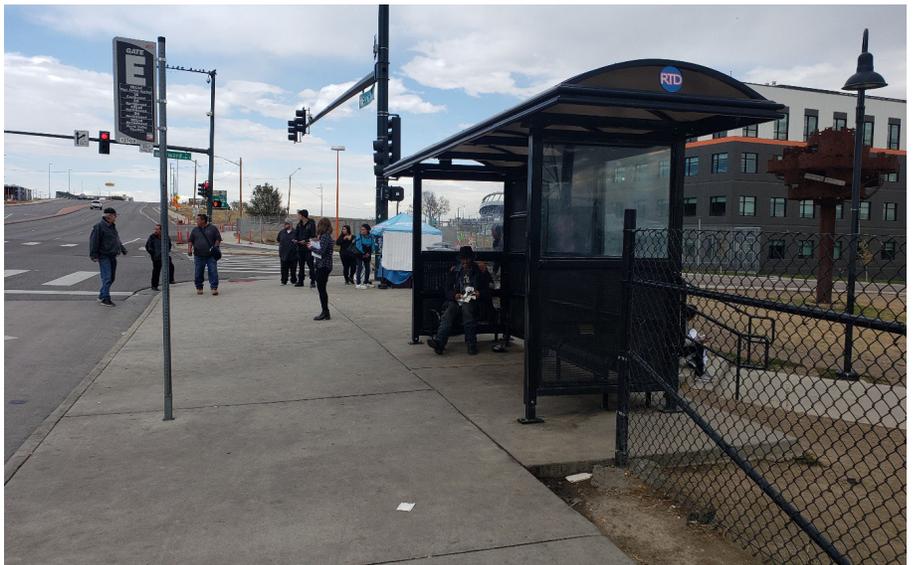
Exhibit 5: Decatur-Federal Station at Federal Boulevard and West Howard Place - #13703

The Sun Valley study team gave the Decatur-Federal Station bus stop, shown above in Exhibit 5, a three-star rating. The stop included several basic amenities, such as a shelter, bench, trash can, and public art. The accessibility and connectivity of the stop was good, with wide, well-maintained adjacent sidewalks and crosswalks leading in all directions across nearby intersections. The shelter's distance from the curb also offered a modicum of safety and comfort from passing motorists.

Perhaps it is no coincidence that Decatur also seemed to be the most frequented stop in the study area (it also serves as a common transfer point). In fact, the popularity of the stop meant that the amenities it did have were inadequate for the number of people that needed them. Upwards of 15 people at a time were waiting at the Decatur Station stop with only one small shelter with benches that seat four to accommodate them. The team determined that this is a good bus stop that could be further improved by adding more amenities and lighting.

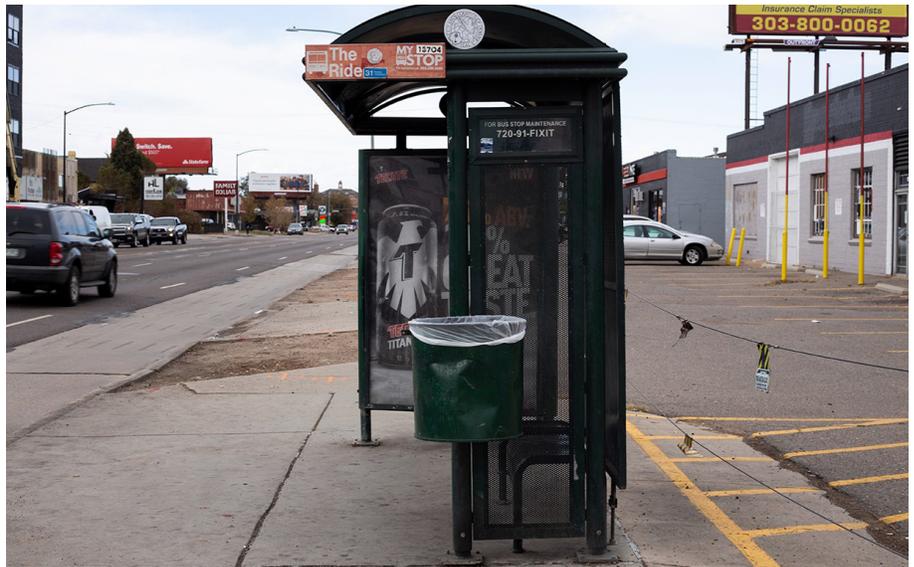
Exhibit 6: Federal Boulevard at West 17th Avenue - #13704

The project team gave the West 17th Avenue bus stop, pictured above, a three-star overall rating. The stop was clean, accessible, and provided good connectivity. It also had several basic amenities, such as a shelter, bench, and trash can. The area felt safe and the shelter was set back from the curb far enough to provide some protection from traffic. Nevertheless, lighting, wayfinding and bus information, as well as public art would improve the feeling of security and comfort at this stop.

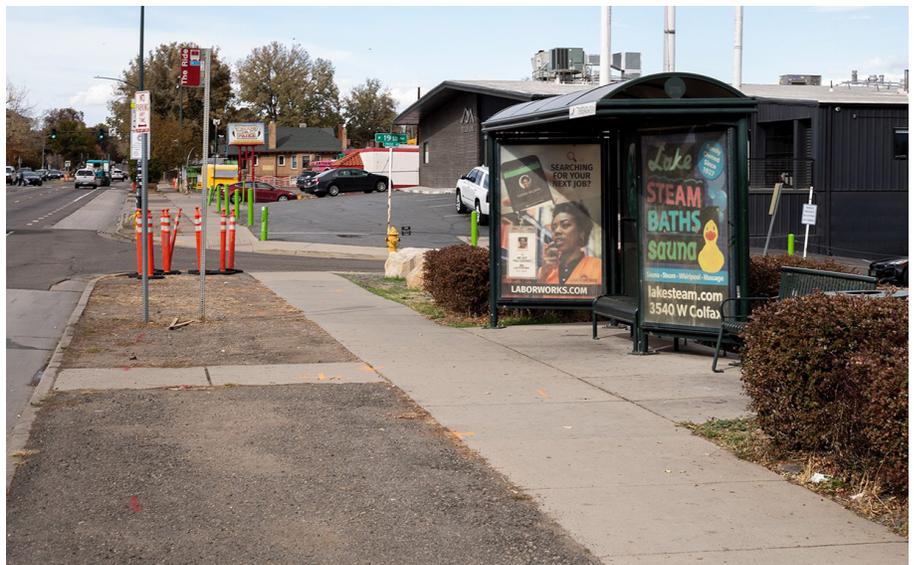
Exhibit 8: Federal Boulevard at West 19th Avenue - #22773

The Sun Valley team gave the West 19th Avenue bus stop, pictured below, a three-star rating. This stop included basic amenities, such as a shelter, bench, and trash can. It was also clean, in decent state of repair, and was a fairly safe distance from the road. Although public art and lighting were absent, the major downfall of this stop was its lack of connectivity. The intersections at West 18th and West 19th Avenues have no marked crosswalks. The nearest marked crosswalks were almost two blocks away, potentially influencing pedestrians into dangerous crossing situations. The team determined that white paint and crosswalk infrastructure were the most pressing needs for this stop.

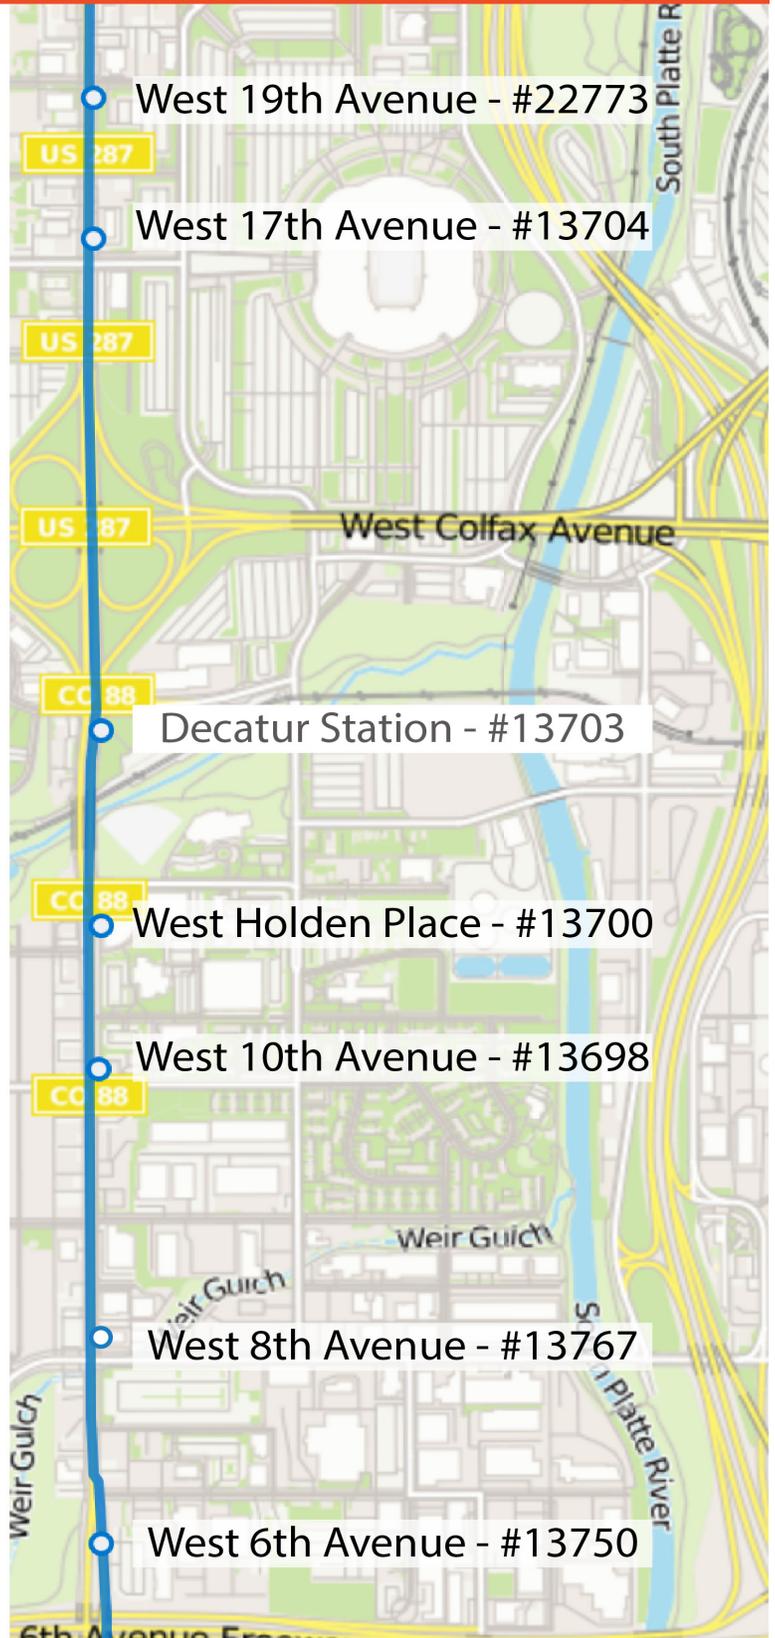
Exhibit 7: Summary of Bus Stop Conditions and Amenities in Sun Valley Study Area

Bus Stop Amenities and Overall Ratings
