# West Colfax and Villa Park Bus Stop Assessments

URPL-5010 Planning Methods December 11, 2019

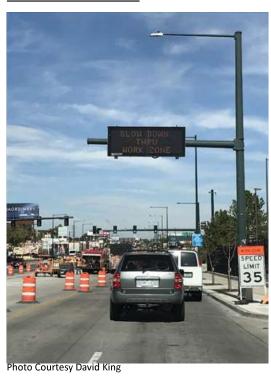
<u>Figure B-1, Federal Boulevard and 7th</u>
Avenue Northbound

Traffic cones blocked one stop, which was located next to the bus buffer lane. The next stretch of Federal Boulevard was under heavy construction, and the next stop was inaccessible by foot or car. The sidewalk on Federal's southbound side adjacent to the stop was closed. The project team located the bus stop sign pole but noted there was no sign. The remaining bus stops were outside of the heaviest construction zone and did not appear to be affected by the work.

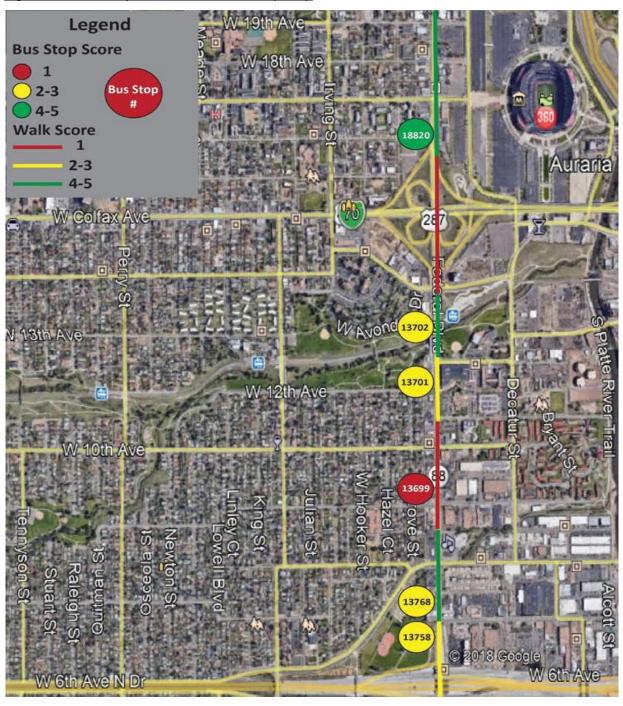
Figure B-5, Bus Stop Assessment Summary Map

Aside from Bus Stop 13699, all stops in the West Colfax and Villa Park portion of Federal Boulevard were rated at a three or better. While many of the stops lacked amenities other than a concrete pad, they were all serviceable to riders, who later mostly said they felt comfortable taking the bus on most days.

This bus stop was unusable at the time of the assessment. Therefore, the project team rated it at one, the lowest score, by default. Construction prevented buses and pedestrians from accessing the stop.

Construction had just been completed at the West Holden Place bus stop. No riders were seen waiting at this stop during the project team's assessment. This may have been because of its recent re-opening and its location in the spatial context of the area. The team gave this station a three overall. The station was dirty but safe, thanks to a lane buffer. It is near the Lakewood Gulch bike path so bicyclists could easily access this stop. Its pedestrian connectivity and accessibility for people with disabilities was rated a three, as there was a crosswalk nearby but not close enough to where most would consider the stop "conveniently located." There are no amenities at this stop.

While it was without amenities, stop 13702 was the busiest of all the stops during the team's assessment. Due to its popularity, this station should see some improvements in the future. This stop did not feel safe, given its proximity to a liquor store where people loiter throughout the day. The stop 13702 was located at the bottom of an overpass so cars sped by this stop (shown in red on Figure 5 below). The stop was in decent physical condition, but also had a lot of litter in the vicinity. There was excellent pedestrian connectivity and disability accessibility as the stop was next to a crosswalk. This stop is also considered a gate, where buses wait for a few minutes to serve transfers -- a connectivity plus. The team gave this stop a three.

This stop was on an island in the context of the study area. While close to stop 13768, it also was located close to 6th Avenue, so the rest of the stops felt farther away as a result. Accessibility was rated at a two, due to decent connectivity but a lack of accessibility. While this stop has no amenities, it is well lit and received a score of three. High traffic presence and proximity to a major arterial are likely deterrents for transit riders.

Stop 13768 shared the same conditions and qualities of 13758. However, pedestrian connectivity and disability accessibility were exceptional in comparison. The stop was clean, but there were no amenities other than a concrete pad as was the case for most of the other stops. This stop was also rated a three overall.

This stop had several unique amenities, including two benches, an enhanced shelter and trash cans. It also had great connectivity for able-bodied pedestrians and people with disabilities alike. This stop was located up the hill from Mile High Stadium and was at the north end of the study area, approaching the Sloan Lake and West Highland neighborhoods. It was also close to several restaurants and shops -- including KFC and A&W, a Denny's and a new Mexican restaurant. But the stop was not clean, so the team rated it a four.

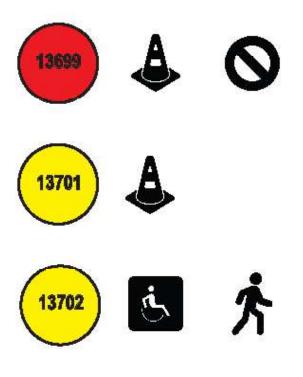
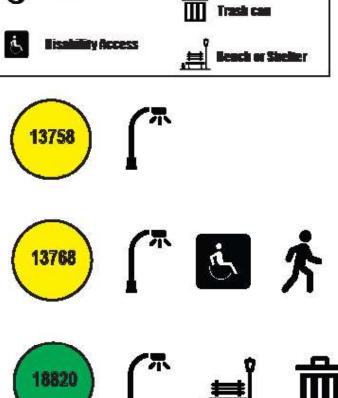
### Figure C-1, Bus Stop Gaps

In the team's study area, Bus Stop 18820 had the most amenities, including two benches, an enhanced shelter and trash cans. It was near a crosswalk, and sidewalks in the area were wide and in good condition. But the stop was also the dirtiest the study area; the two trash cans were small and chained to one of the benches.

These three stops had no amenities beyond signs and concrete pads. Bus Stop 13702 was near a liquor store, where people tended to loiter. Bus Stop 13758 was farther away from other stops and not as accessible.

There were several gaps in the transit-rider/pedestrian experience throughout the study area. The area around Colfax Avenue was particularly problematic, as there are several on and off ramps without adequate pedestrian-crossing signage. It is dangerous for pedestrians to walk along Federal Boulevard to either the northern or southern side of Colfax Avenue. Additionally, there were piles of trash in the greenspace around Colfax Avenue and Federal Boulevard, adding to the unsafe atmosphere. At the Holden Place stop, there was a liquor store directly behind the bus stop, with people waiting outside the store for it to open on a Saturday morning. The presence of the liquor store could lead to a less safe bus stop.

At the same stop, it was noted that many people wait across the street at the northbound stop, presumably because of the enhanced amenities, and make their way over to the southbound stop once the bus arrived. This led to pedestrians crossing the street in an unsafe manner, both in and out of the crosswalk. There is a general lack of shade along southbound Federal Boulevard. There is a constant presence of speeding vehicles, often only a step away from transit-riders and pedestrians. The aesthetics of the corridor seem to be on the verge of a shift, as there is increased road and building construction throughout. The construction, ranging from 6th Avenue to 12th Avenue, appeared to serve as a deterrent to transit-riders and pedestrians, as sidewalks were closed, and a bus stop was inaccessible.

In addition to improved connectivity, the bus stops should be better buffered from the traffic in this neighborhood with a minimum setback or lane pull-over at each stop. The current conditions of the bus stops which are directly adjacent to a lane of traffic travelling at speeds in excess of 50 mph is unsafe.

The team is also recommending that each stop be required to have minimum standards for upkeep and amenities. These minimum standards should include a shelter, adequate lighting, and a permanent trash receptacle.

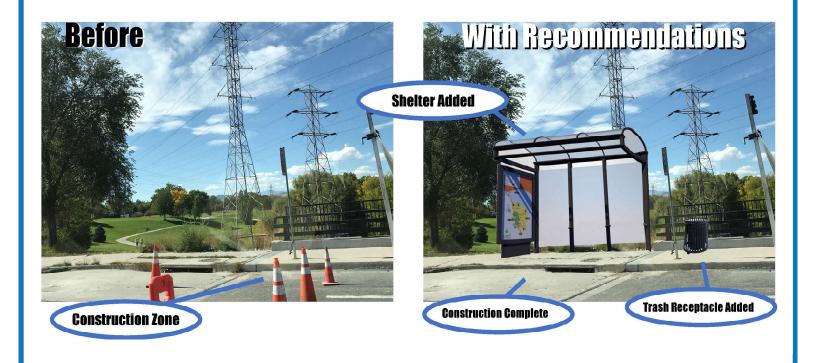
Figure C-2, Bus Stop Recommendations

The team's suggestion for all five of these stops is to recommend the installation of a shelter and permanent trash receptable at each location. The team is recommending the installation of a shelter which would protect from the elements, but not recommending benches be installed. It was suggested during the team's site visits that members of the community feel benches would encourage loitering at the stops, but shelters would be less inclined to promote loitering by non-riders. See Figure 2, Bus Stop Recommendations Exhibit, below as an example of bus stop 13702 with added shelter and trash receptacle amenities.
