BUS STOP ASSESSMENT STUDY: WEST HIGHLAND + SLOAN'S LAKE

PREPARED FOR: CITY AND COUNTY OF DENVER

PLANNING METHODS - URPL 5010.001 PROF. KEN SCHROEPPEL

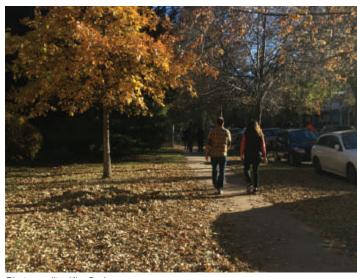
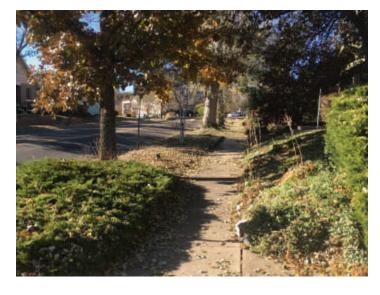
Nearly all of the residential streets have fairly well-maintained sidewalks, with a majority of them buffered from traffic and many of them shaded by trees.

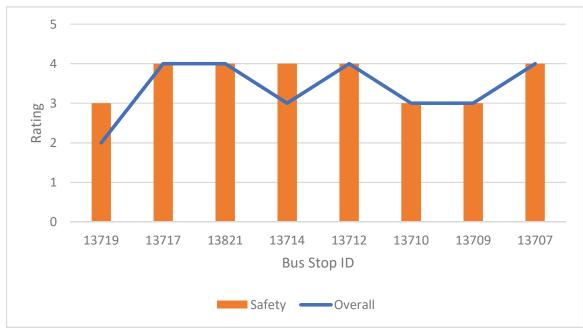
Chart 2-1: Ratings for Bus Stop Safety

For safety, the assessment used a 1-5 rating, but there was an additional question to clarify the rating: "What, if anything, makes the stop feel unsafe?" Two answers, traffic and lighting, were prominent for the stops. Three of the stops felt too close to the street, and without any buffer from traffic, were loud and felt unsafe with proximity to the traffic. Lack of lighting showed up on seven of the eight stops. Chart 2-1, below, represents how the safety ratings generally correlated to the overall ratings.

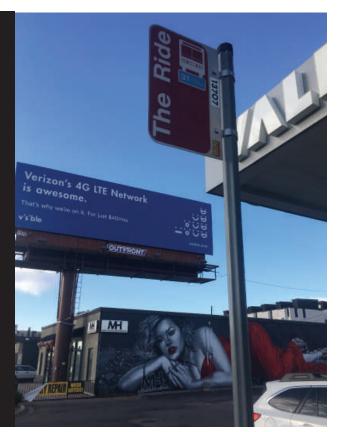
There was not any public art present at any of the study area bus stops, with the possible exception of a large mural on the side of a nearby business in proximity to the study area's southernmost stop, near the gas station at Federal Boulevard and West 20th Avenue (Stop ID 13707).

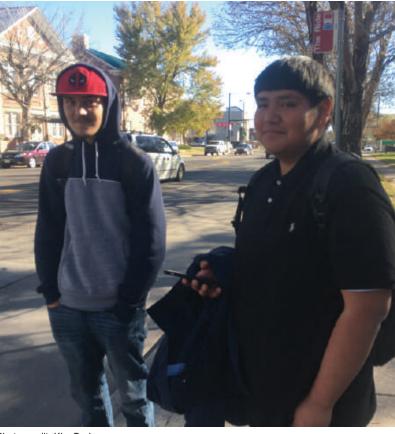
Photo credit: Kim DeJong

For the most part, amenities provided at the bus stops were deemed satisfactory, particularly at Stop ID 13712 and Stop ID 13821 where the majority of interviews took place. In a few interviews and also identified in the team's bus stop assessments, the proximity to Federal Boulevard and its quick moving traffic was unsettling and to some respondents, made the bus stops feel unsafe. Overall, 76 percent of respondents deemed the bus stops average or better. The top four recommended improvements were more seating, better lighting, shelter and more space to wait. Exhibit 2-3 provides a visual summary.

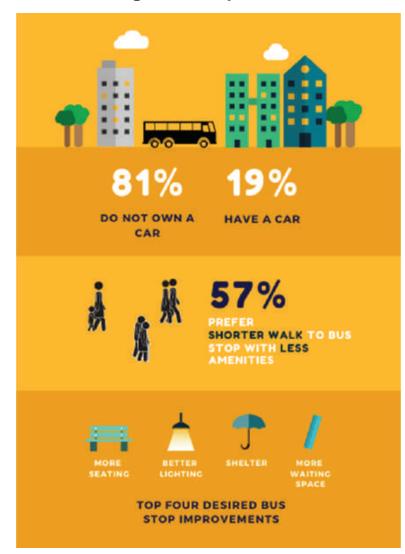
Exhbit 2-3: West Highland Bus Stop Interviews

Approximately 60 percent of the respondents were under the age of 40, and due to the study area's proximity to North High School, almost forty percent of the respondents were under the age of 20. The majority of respondents identified as either Hispanic/Latino (42 percent) or White (42 percent), and one-third of the respondents identified as female with the remaining two-thirds identifying as male. Across all respondents, lack of car access was the impetus for public transit utilization as 80 percent did not own a vehicle and 60 percent identified this specifically as the reason for taking transit.

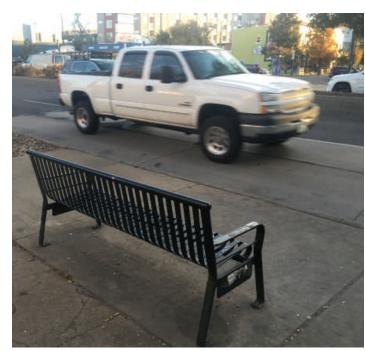
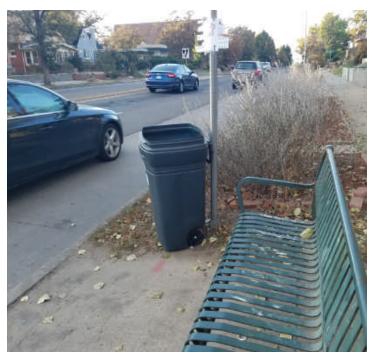
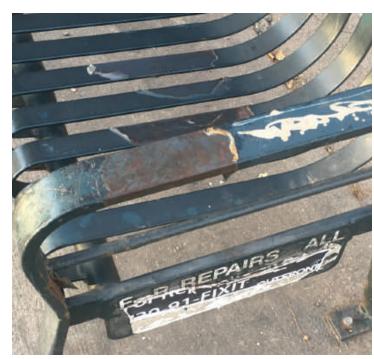
The team identified gaps relating to the existing elements of transit and pedestrian infrastructure at or near the bus stops in the study area. These gaps largely included space at each of the stops. For example, some of the most popular bus stops did not appear to have adequate space to accommodate all of the users. This leads to an unpleasant experience as users felt crowded and there was not enough benches or space to sit while waiting for a bus. Additionally, another gap relating to space included the lack of a buffer between the stop and automobile traffic on Federal Boulevard. On Federal Boulevard, the speed limit is 40 mph, and often traffic may be moving even faster than that. Many bus stops were no more than a few feet away from the curb. This contributes to a general feeling of lack of safety and may lead to users not using those bus stops without an adequate buffer.

The most concerning existing transit/pedestrian infrastructure gap was that the benches and platforms for transit riders to wait for the bus were extremely close to the street and traffic with no buffer whatsoever. Bus Stop ID 13719 was one where the bench looked like it was in the middle of traffic as seen in the photo shown to the right. If a car lost control or if there was a crash, there is nothing buffering the pedestrians on that bench from the dangers of the heavily trafficked street. To improve this stop, the team recommends at the very least, to move it back from the street and create a buffer around the stop so the cars pulling in and out of the parking lot cannot get as close as the car in the photo below. The buffer could include a structure for the bus stop so that it is at least more visible for people operating vehicles around it.
