East Colfax Walk Audit Report

July 31, 2016

OVERVIEW

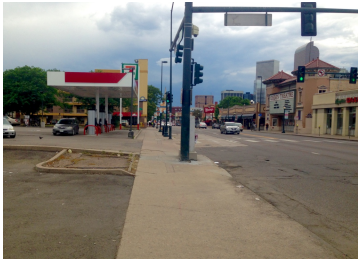
Colfax Ave between Ogden and Corona; 5 ft or more attached; overall quality rating 1 (low)

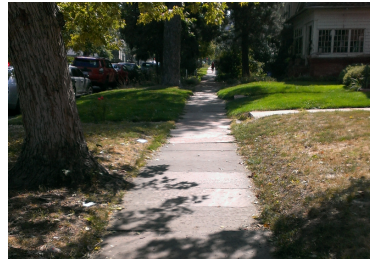
High St between Colfax and 16th Ave; Less than 5-ft detached; overall quality rating 3 (moderate)

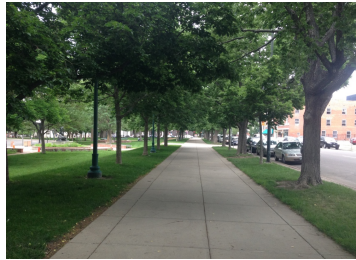
Grant St between Colfax and 14th Ave; 5-ft or more detached; overall quality rating 5 (high)

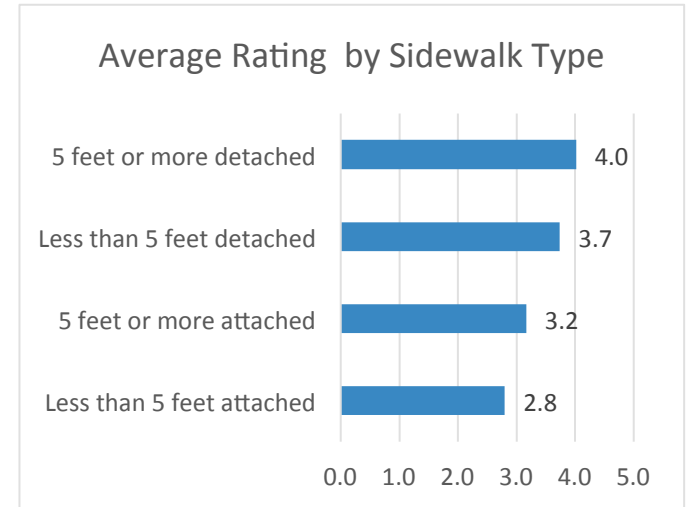
Sidewalk Type

Detached sidewalks, with a buffer between the sidewalk and street (78% of the sidewalks surveyed), received the highest quality ratings regardless of sidewalk width. Attached sidewalks directly adjacent to the street (22% of sidewalks surveyed) received lower quality ratings. The majority of the study area is served by detached sidewalks, with Colfax Avenue and Josephine St being served primarily by attached sidewalks.

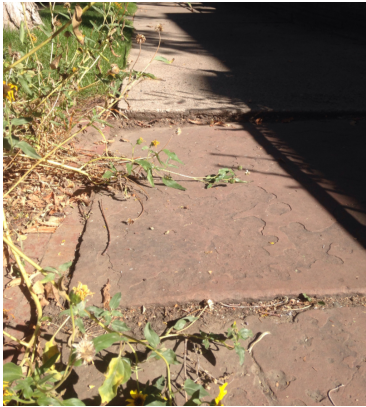
Significantly cracked and uneven sidewalk along Lafayette St between Colfax and 16th Ave.

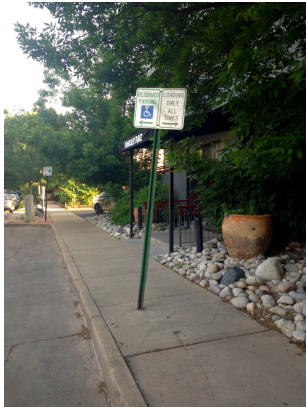
A sign obstructs the sidewalk on Humboldt between Colfax and 14th Ave.

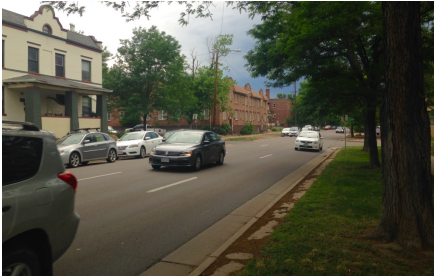
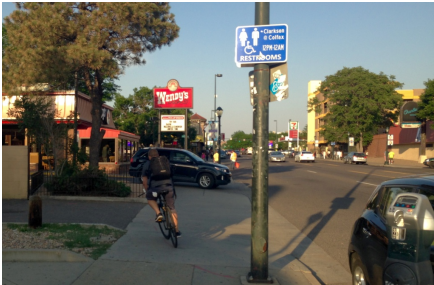
(Top) Unsafe traffic speeds were a concern on some stretches of 14th Ave.
 (Bottom) Cyclists riding on sidewalks as well as driveway/alley curb cuts like these on Colfax b/w Clarkson and Emerson are examples of "other" safety concerns.

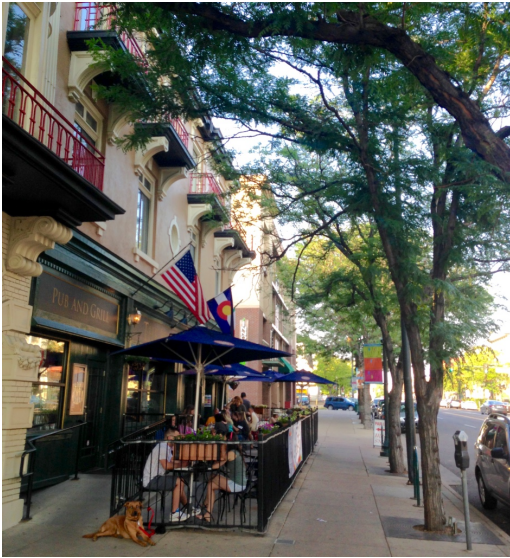
Large street trees and a wide sidewalk café area help create a pleasant pedestrian environment along Colfax between Marion and Lafayette.

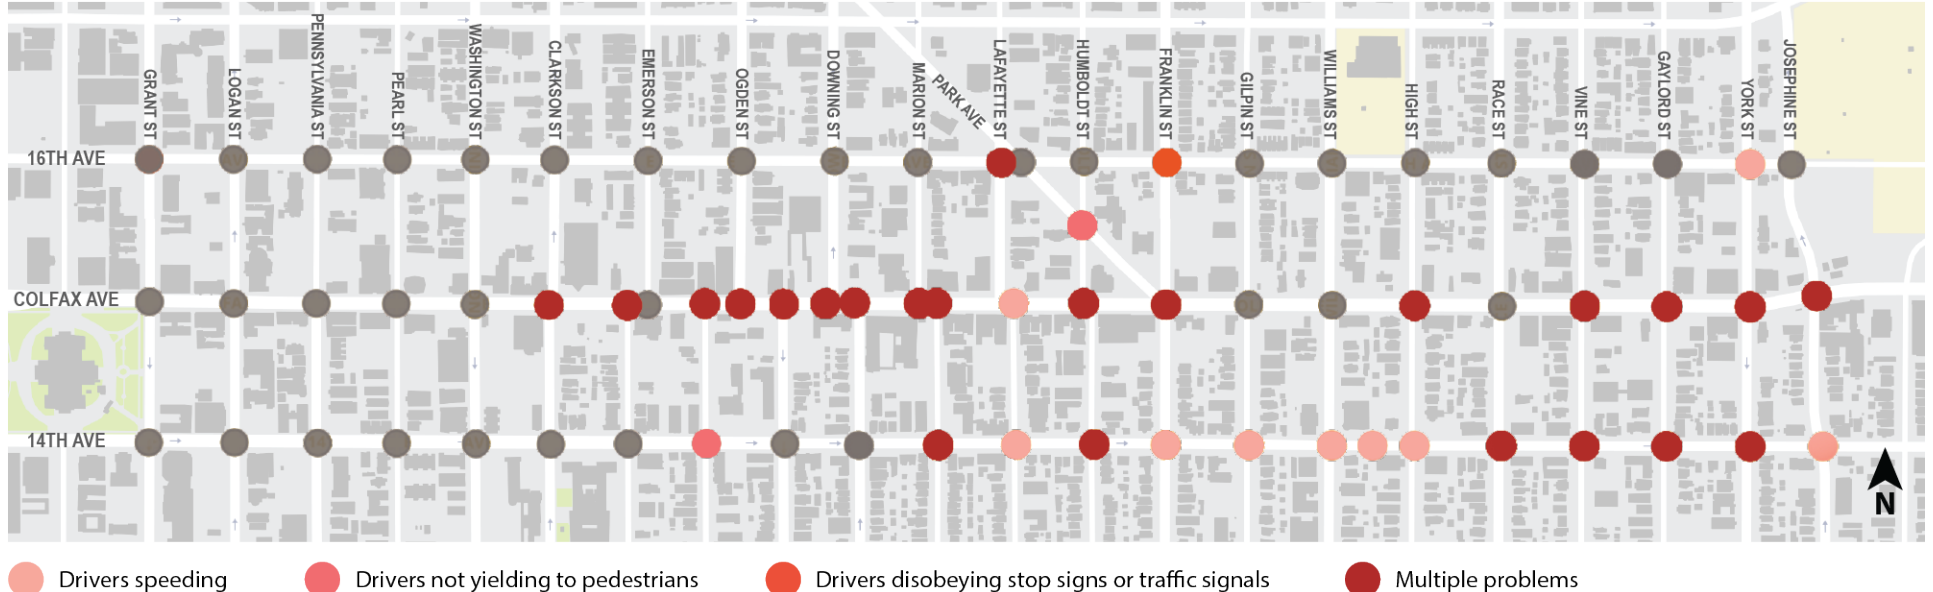
Intersection Safety Problems

Instances of poor driver behavior (based on brief field observations by data collectors), particularly speeding and failure to yield to pedestrians, correlated with overall intersection quality ratings. For intersections rated 1 or 2 (the lowest ratings), data collectors reported that drivers obeyed speed limits at 54% of intersections, yielded to pedestrians at 50%, and obeyed traffic signals and stop signs at 88% of intersections. For intersections receiving a 4 or 5, data collectors reported that drivers obeyed the speed limit at 72% of intersections, yielded to pedestrians at 50% of intersections surveyed, and obeyed traffic signals and stop signs at 88% of intersections. Overall, data collectors reported that drivers obeyed speed limits at 56% of intersections, yielded to pedestrians at 65%, and obeyed stop signs/traffic signals at 90% of intersections. Problems with driver behavior were reported most frequently along Colfax Ave and 14th Ave.

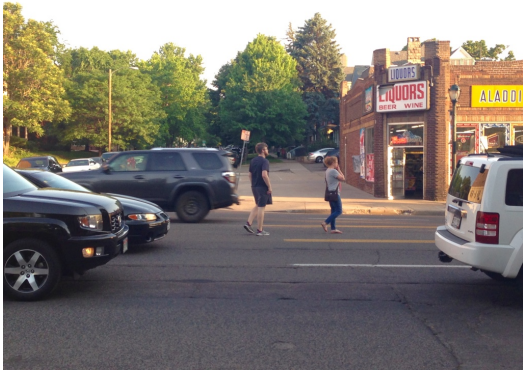
Pedestrians wait in the center turn lane as they cross Colfax at Vine St, an unsignalized intersection with no crosswalks.

3. Add additional signalized pedestrian crossings along Colfax at Emerson and Vine/Gaylord

While many of the intersections along Colfax currently have signalized pedestrian crossings, noticeable gaps occur near the bus stops located at Emerson and between Vine and Gaylord. As a result, pedestrians frequently cross midblock at these locations. New signals at these locations could be traditional traffic signals, or pedestrian hybrid beacons that are only activated by pedestrians when needed, consistent with the City and County of Denver’s recently adopted pedestrian crossing guidelines.

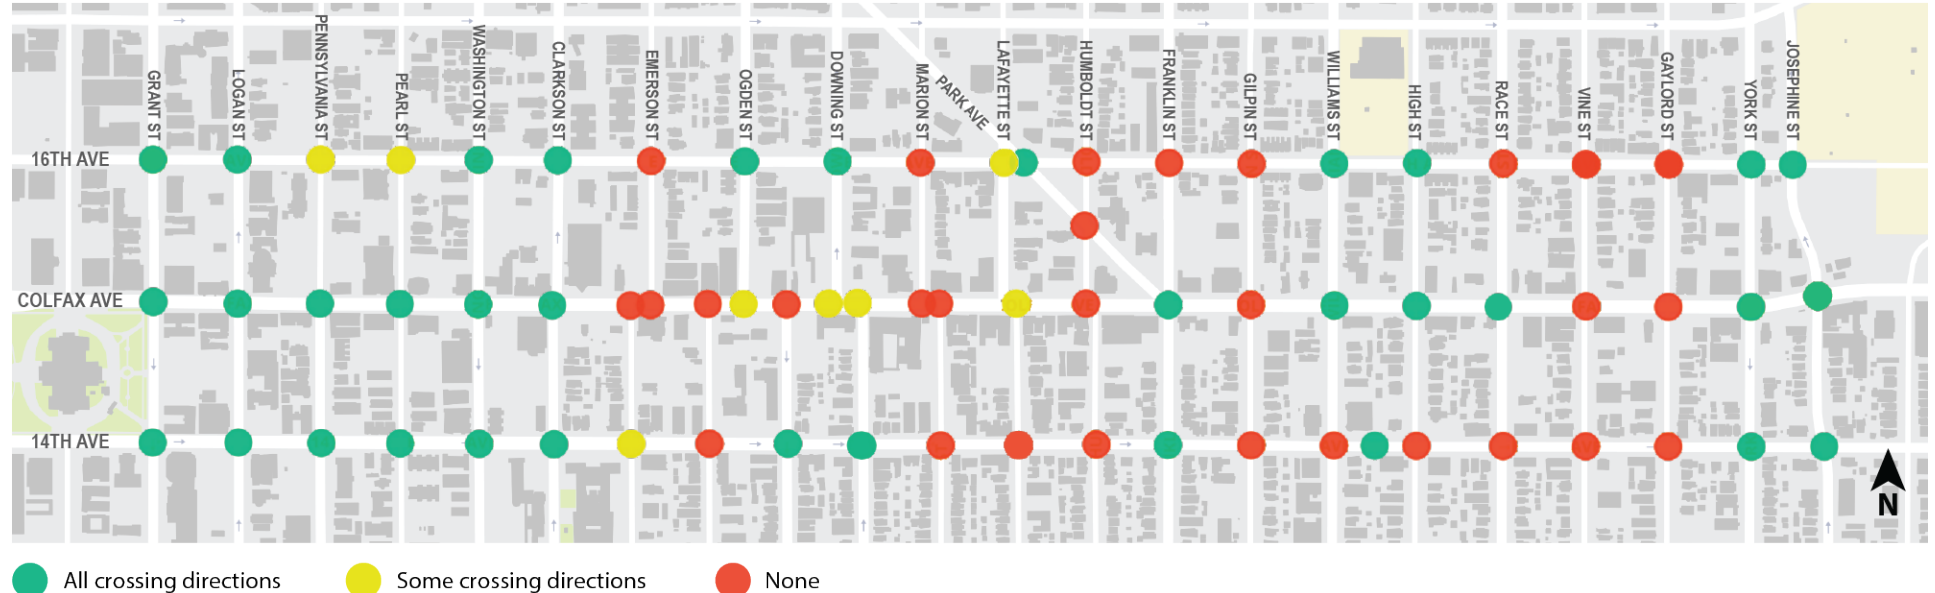
Marked Crosswalks

Overall, 51% of intersections had marked crosswalks for all crossing directions, and 10% had crosswalks for some crossing directions. Although a majority of intersections along busy Colfax Ave and 14th Ave have crosswalks, notable gaps exist in the central and eastern part of the study area. Crosswalks are somewhat sparse (generally spaced two blocks apart) on Colfax between Clarkson St and Williams St. The three block stretch of Colfax Ave between Race St and York St also lacks crosswalks. The 4-block stretch of 14th Ave between Downing St and Franklin St is also missing crosswalks, and the stretch of 14th Ave from Franklin St to York St (a 7 block stretch) is served only by a single mid-block crossing between Williams St and High St.

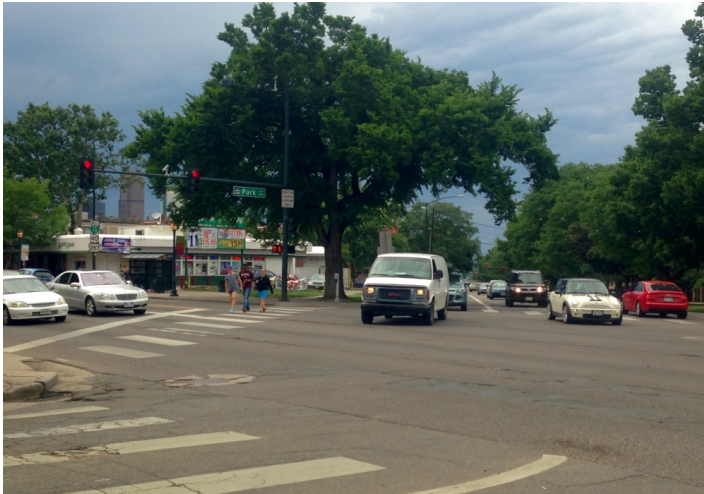
The odd angles created by the 5-way intersection at Colfax/Franklin/Park significantly increase the crossing distance for pedestrians.

4. Redesign the Intersection of Colfax Avenue, Franklin Street, and Park Avenue

The complex design of the intersection of Colfax with Franklin Street and Park Avenue means that this intersection is not only the top location for pedestrian crashes within the study area, but also one of the top five most dangerous intersections for pedestrians in the entire City. Simplifying the intersection by vacating the section of Park Avenue between Humboldt and Franklin (so that Park Avenue ends at Humboldt) would increase safety for all users by slowing down turning vehicles, reducing crossing distances, and enhancing overall clarity and visibility of the intersection with Colfax (See Concept 1). In the long term, Humboldt Street north of Colfax could also be shifted to the east, to better align with Humboldt Street south of Colfax and facilitate the flow of traffic to/from Park Avenue (See Concept 2).

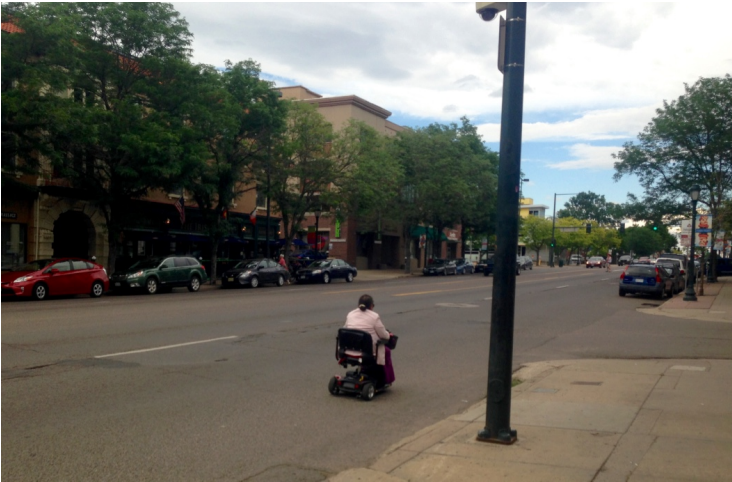
At intersections where streets north of Colfax do not align with streets south of Colfax (such as this one at Colfax and Marion) the curb ramps on one side of Colfax are often not aligned with curb ramps on the other side, causing wheelchair users to travel in the street when crossing at these locations.

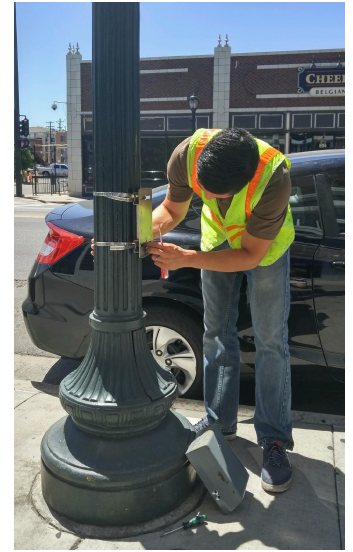
Pedestrian counter being installed at Colfax Ave and Pearl St.

Pedestrian counts on Colfax Ave were recorded over nine one-week periods between mid-May and mid-July 2016, with different locations recorded during different weeks. Data from these counts show higher levels of pedestrian traffic on the west end of the study area (at Grant St) and near the intersection of Colfax, Franklin and Park. The proportion of pedestrians heading east vs heading west was roughly even but varied somewhat by location. Similarly, pedestrian traffic was roughly evenly split between the north and south sides of the street, though the proportion varied by location. Note that counts on Colfax west of Williams St and Colfax east of York St were only obtained on the south side due to malfunctioning equipment. It is assumed that counts on the north side would be similar, and, therefore, the total counts shown at these locations are actually the counts for the south side multiplied by two. Also note that counts may include a small number of cyclists riding on the sidewalk.

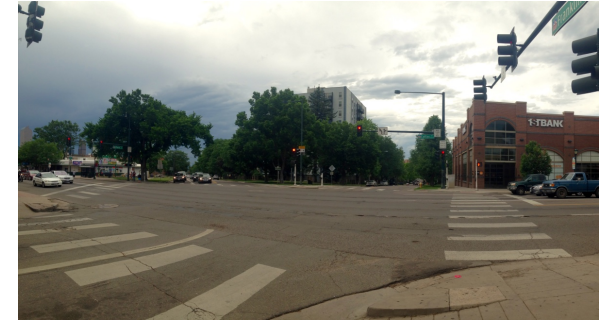
The intersection of Colfax, Franklin, and Park Ave saw more pedestrian-involved crashes than any other intersection in the study area.

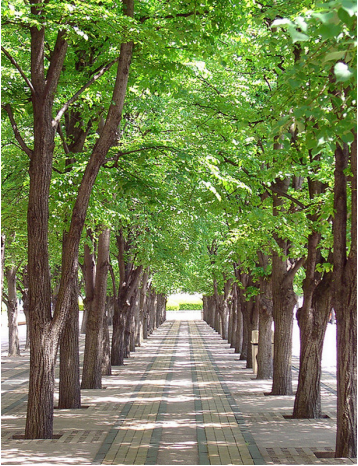
Trees in a suspended pavement system in Boston. Source: walknboston on Flickr.

1. Provide additional trees and quality landscaping along Colfax.

One of the starkest contrasts between Colfax Avenue, which generally received low overall quality ratings, and other streets in the study area, which generally received high overall quality ratings, is the lack of trees and quality landscaping along Colfax. During hot summer months, the lack of trees not only makes walking uncomfortable, but can also pose a health hazard for pedestrians. In addition to creating a more pleasant pedestrian environment, street trees offer a wide variety of benefits including significant reductions in stormwater runoff; improved water and air quality; reductions in greenhouse gases like ozone and carbon dioxide; improved pedestrian and driver safety; reduced crime; and higher taxes resulting from increased property values and commercial sales. To maximize this return on investment, the trees should be planted in a suspended pavement or structural cell system specifically designed for challenging urban environments. In this type of system, the pavement is supported by a network of pillars, piles, or structural cells, which support the weight and forces of the pavement above and allows the soil below to remain uncompacted, accommodating tree roots and filtering and managing stormwater runoff. The Business Improvement District should also develop a plan for maintaining the health of the tree canopy over time. The EPA document, *Street Trees: Engineering Urban Forests for Stormwater Management*, provides detailed guidance on design considerations that will allow street trees to survive and thrive well into maturity (EPA 841 B 13 001).

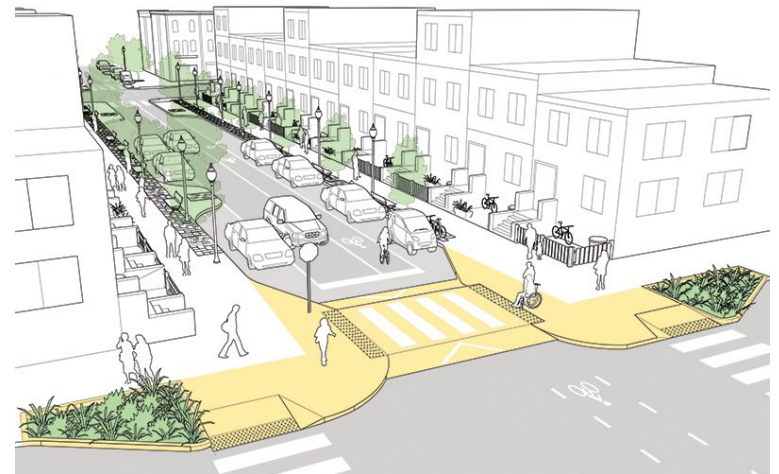
Extended curbs and raised crosswalk. Source: NACTO Urban Street Design Guide

- Add curb extensions at the corners to shorten crossing distances and increase the visibility of pedestrians by aligning them with the parking lane. Curb extensions can also provide additional space at transit stops.
- Use leading pedestrian intervals (LPIs) to give pedestrians a 3-7 second head start when entering an intersection with a corresponding green signal in the same direction of travel. LPIs have been shown to reduce pedestrian-vehicle crashes by as much as 60%.
- Include an automatic pedestrian phase at all traffic signals (rather than requiring pedestrians to push a button). Pedestrian pushbutton devices are not activated by about one-half of pedestrians, and even fewer activate them where there are sufficient motor vehicle gaps. Including an automatic pedestrian phase will increase

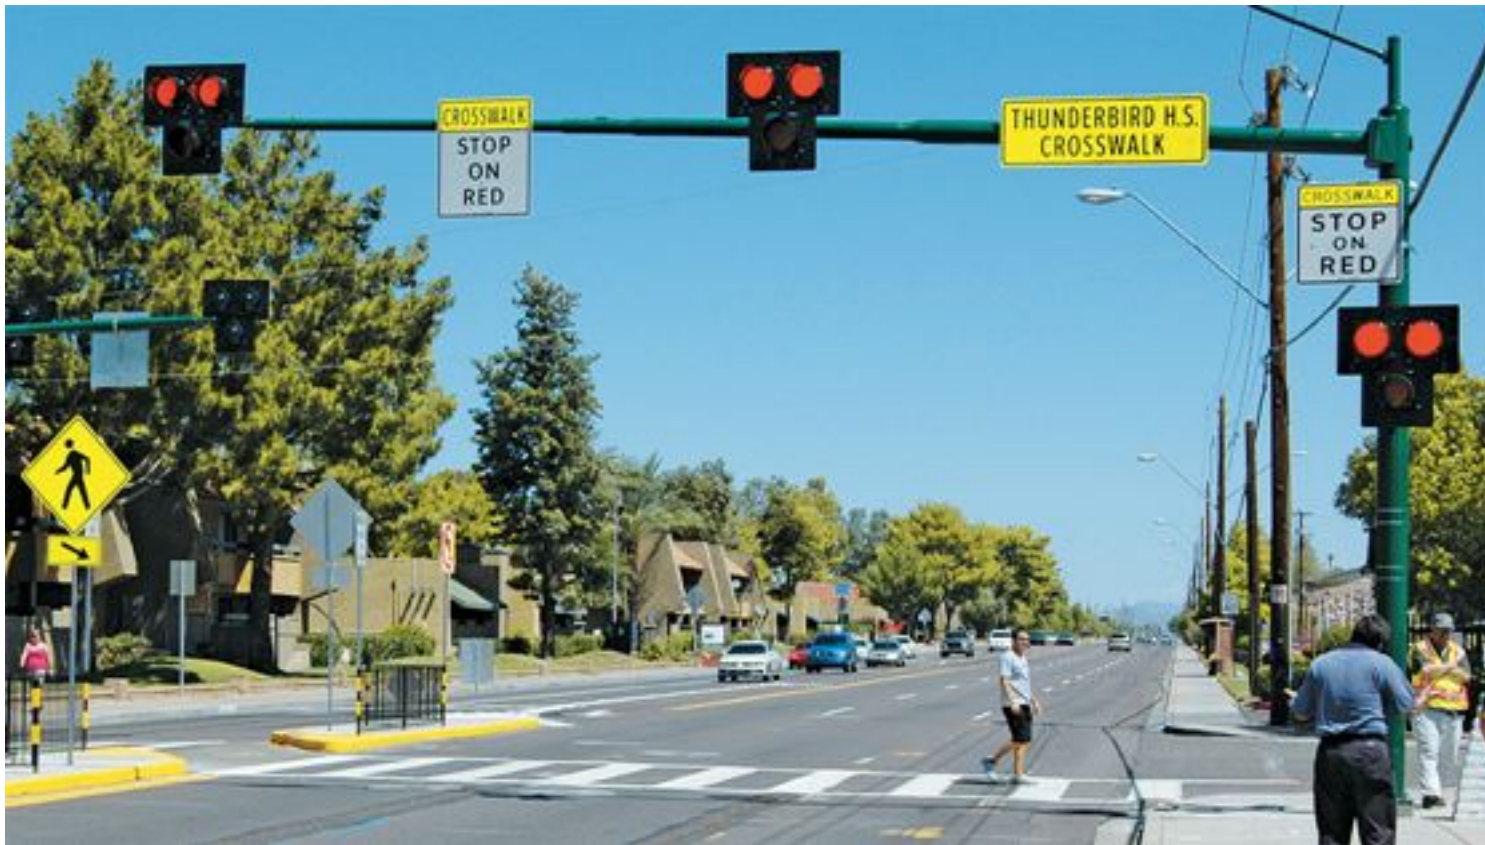
Pedestrian hybrid beacon. Source: Federal Highway Administration.

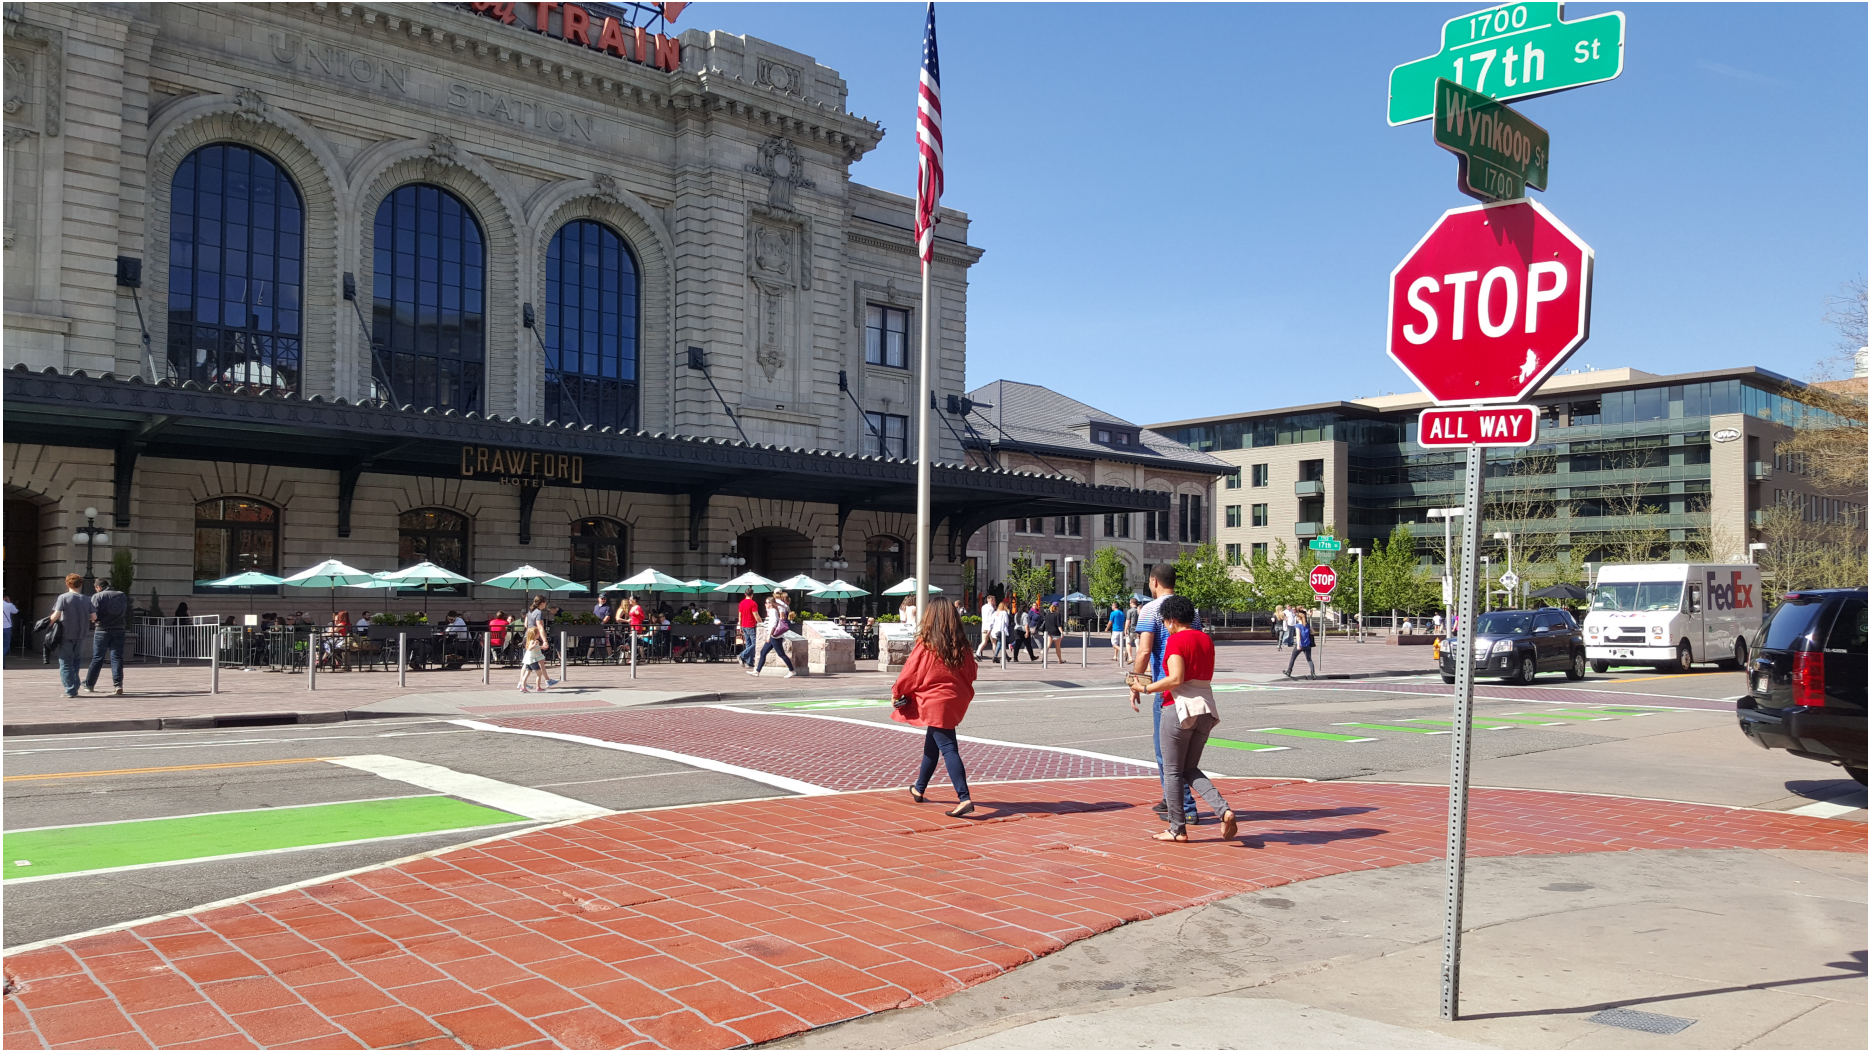
The City and County of Denver used pavement markings to create temporary curb extensions at the intersection of 17th and Wynkoop. Source: WalkDenver

6. Use Low-Cost, Interim Design Strategies

Recognizing that it may take several years to identify funding for and implement the changes outlined above, the Business Improvement District can deploy low-cost, interim strategies to test out some of the design concepts in the near term. For example, curb extensions can be simulated using materials such as epoxied gravel, planter beds, and bollards.
